# ARBORIST REPORT

## 3300 PANORAMA

Location:  
3300 Panorama Drive  
Morro Bay, CA 93442

Revised:  
June 5, 2023

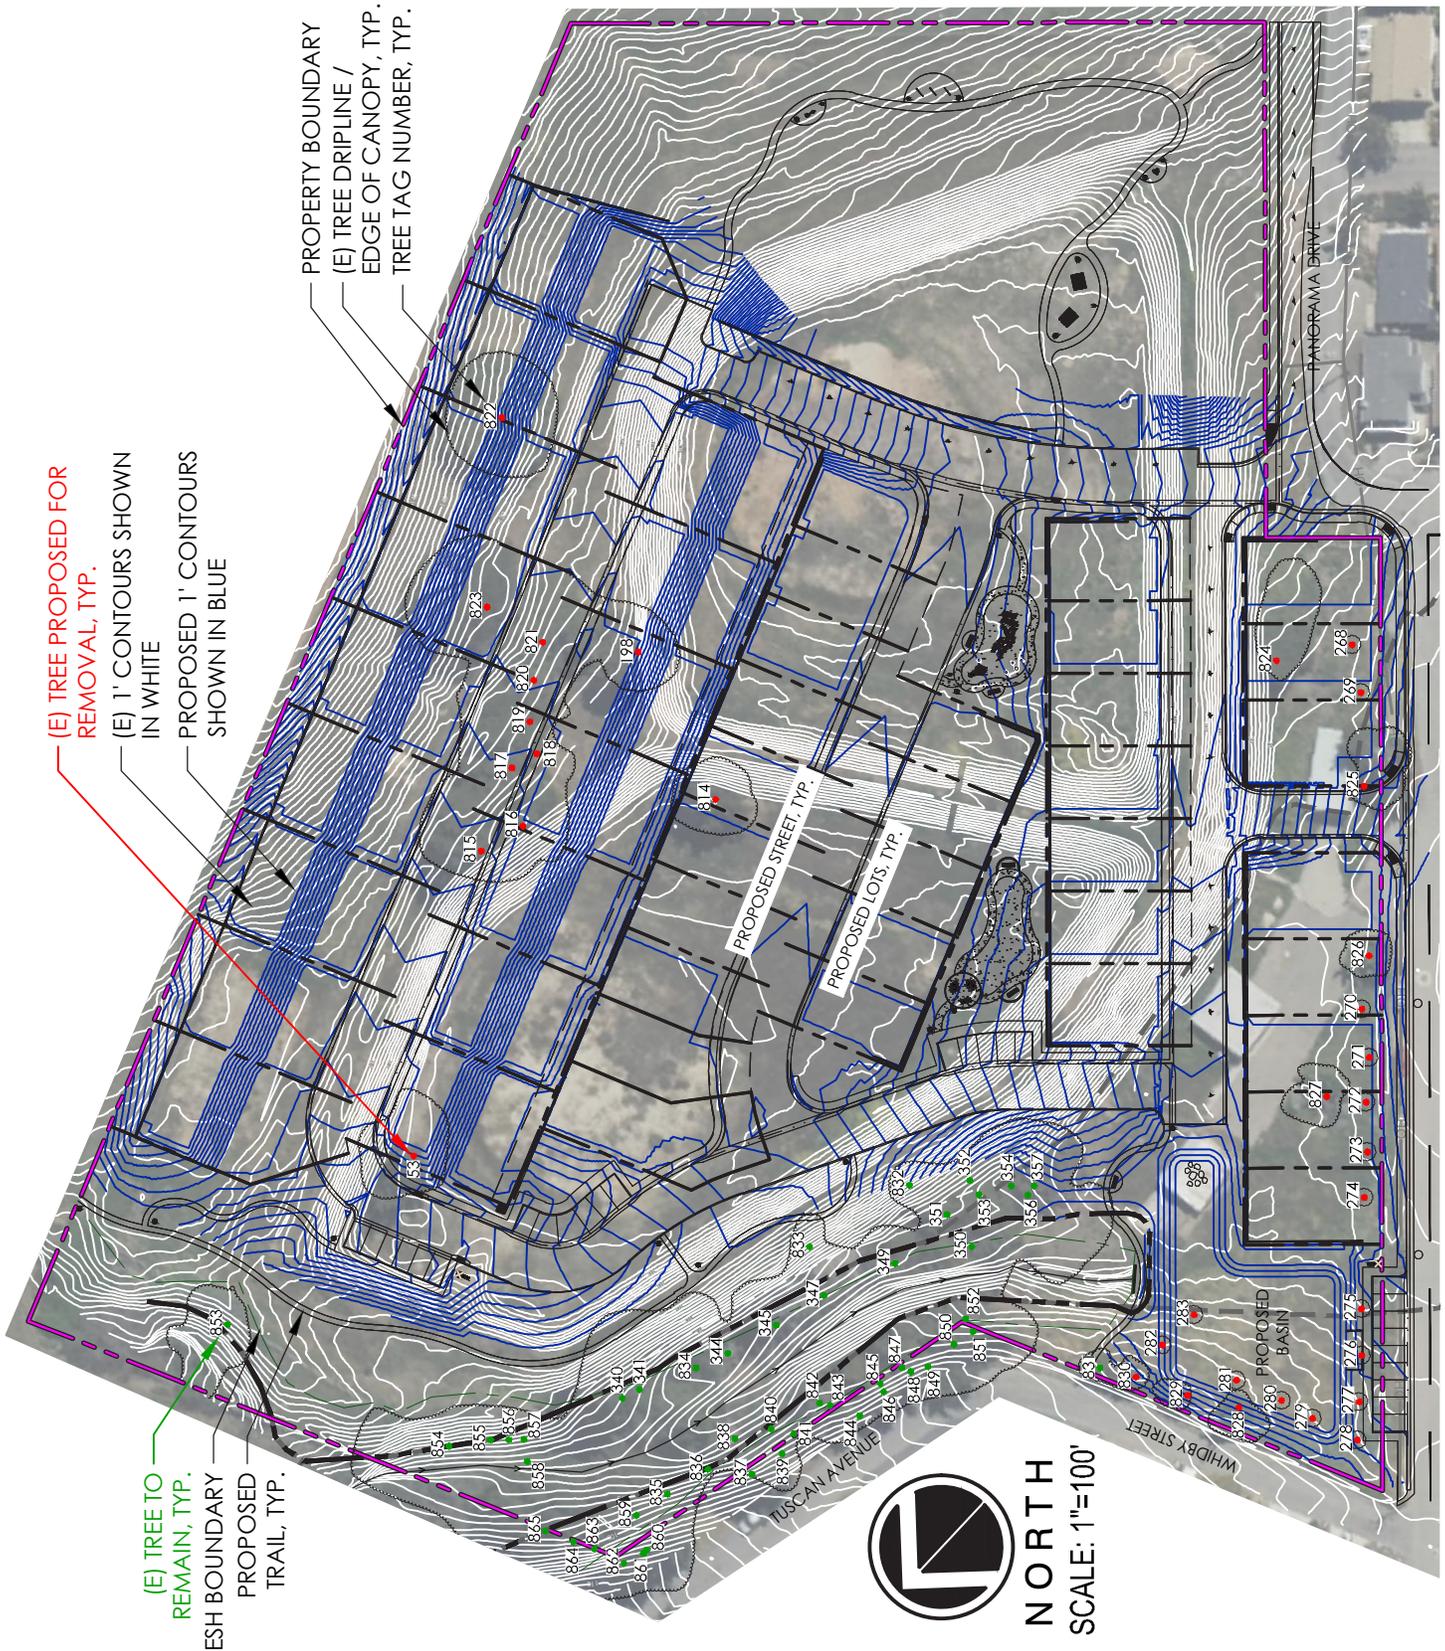
# FIGURE 2 - SITE PLAN REVIEW

The proposed site plan shown in *Figure 2 - Site Plan Review* indicates forty-eight trees are proposed for preservation, thirty-five trees are proposed for removal, and at least fifty-one trees are proposed to replace those removed.

Forty-eight trees in total will be preserved. The project proposes the preservation of all trees within the ESH area, along with nine trees located just outside the ESH area. This is a thoughtful concept on paper, but given the health and structure of some of these specimens, careful consideration should be given to which trees should remain given the proximity to adjacent roadways and homes. A level 1 ISA Basic Tree Risk Assessment should be performed on all trees proposed to remain, based on the proposed site conditions. The results of the tree risk assessment should drive long-term tree preservation goals for this development.

Thirty-five trees are proposed for removal in favor of the proposed development project. All tree removals represent conflicts with proposed grading associated with the building lots, public improvements, infrastructure improvements, and a proposed stormwater basin. Preservation of any of these trees would require a site plan redesign and preservation would likely lead to reduced dwelling density.

Sixteen of the trees proposed for removal were planted as required mitigation trees associated with the 2018 demolition of the DFSP facility. Two of these trees are dead (268 & 269), and two are in declining health (272 & 280). It should be noted that none of these trees meet the minimum size threshold of a protected tree per the City's 2007 *Major Vegetation Removal Guidelines*.

specific guidance in the policy directing mitigation requirements for previously planted mitigation trees under the size threshold. For that reason we recommend replacing those sixteen trees at a 2:1 ratio of the quantities called for in the *Major Vegetation Removal Guidelines*.

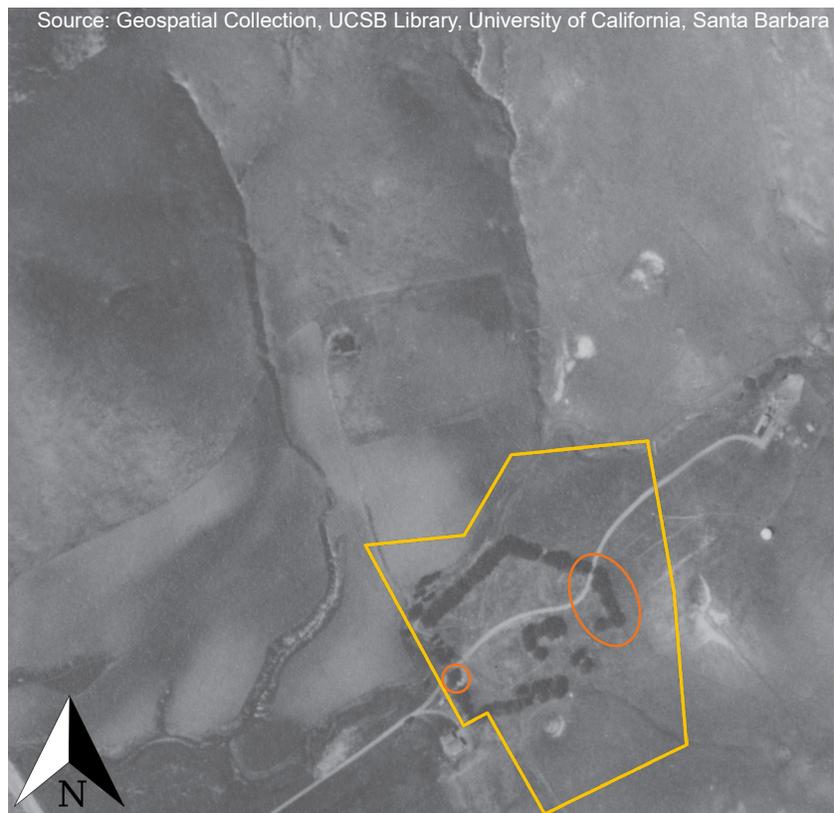
### 1930

This aerial image dates back to 1930 and shows the original trees located within and nearby the property. The watersheds were compared between images to determine the property extents as they exist today, outlined in yellow. The ESH drainage that exists today appears devoid of vegetation. Trees 815-821 and 198 are encircled with an orange ellipse. Tree 825 is located at the entrance to the southwest and is also shown circled in orange.

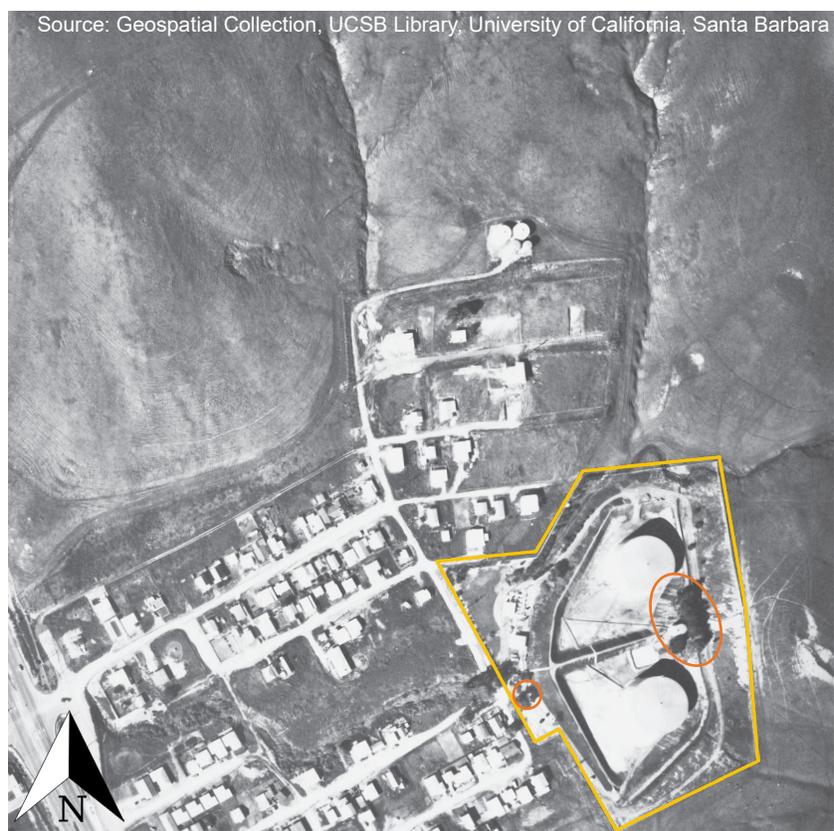
### 1969

Observations: The aerial image circa 1969 included in *Figure 3* indicates these trees were originally planted as a screen hedge along the fence line of the DFSP facility. Most have died or have been removed over the years. The interesting form of these trees can lead to structural defects, such as pockets of decay low in the main stems. As the trees put on foliage and additional weight, these pockets of decay can lead to the failure of large portions of the crown.

This aerial image was taken in 1969 and shows the operational DFSP facility. The same trees described above are also encircled in this image. It appears the remaining trees shown in the above image were removed to construct this facility and a new windrow along the ESH drainage was planted, which remains today in a similar form.

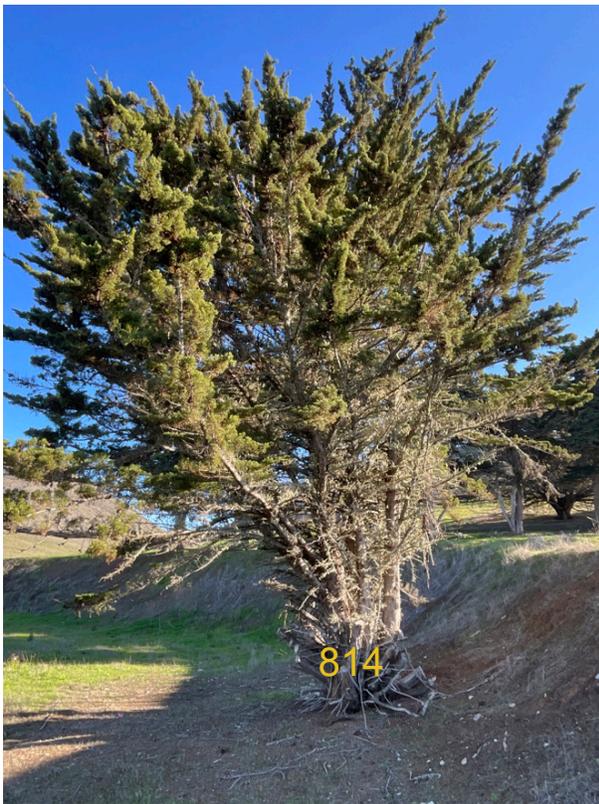
Photo of sap flows from tree 814, typical of most Monterey cypress onsite. Trees exude sap to trap and remove boring insects from the cambium.
