CITY OF MORRO BAY PLANNING COMMISSION AGENDA

SUBJECT: Application for a Coastal Development Permit (CDP22-023) for the proposed demo of an existing home and construction of a new home on the parcel providing 3,335-sf of conditioned living space with a 715-sf garage. The home is single story with a side yard courtyard/entryway on an 8,100 square foot parcel adjacent to the sand dunes and ocean beyond. The project zoning is R-1/S2.A and is located within the coastal appeals jurisdiction. The Coastal Land Use and proposed new zoning designation is Moderate Density Residential (RS-B).

Structural Investigation Report

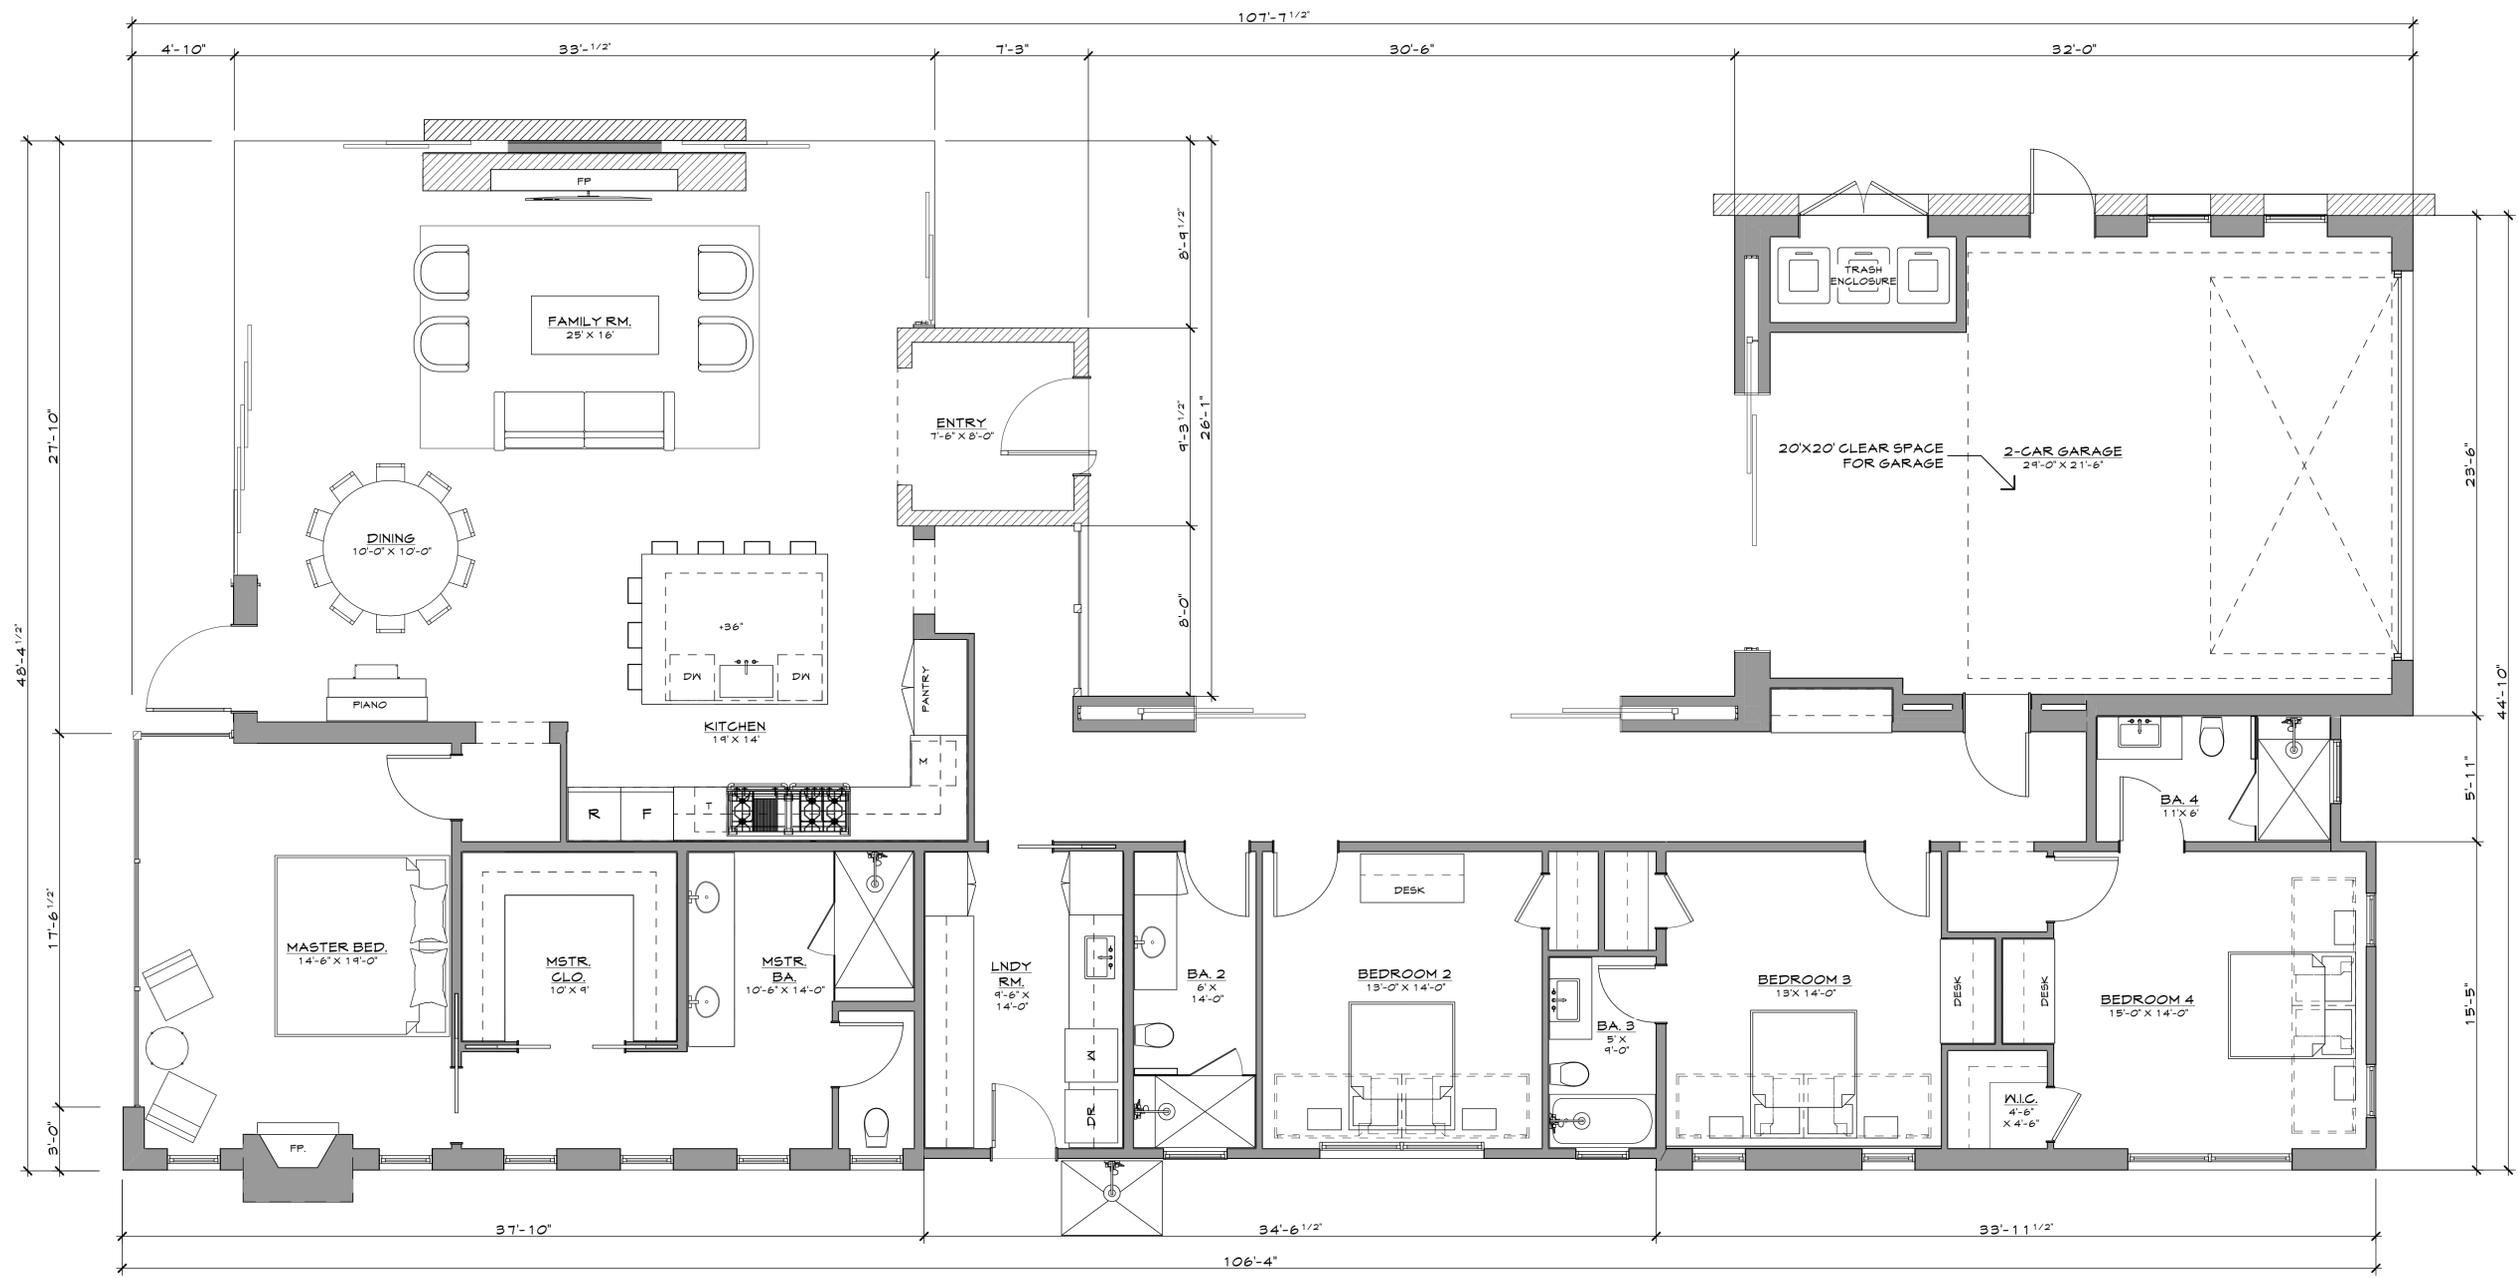
A3.0 FLOOR PLAN

- WOOD FRAMED WALLS
- CONCRETE RAMMED EARTH WALLS

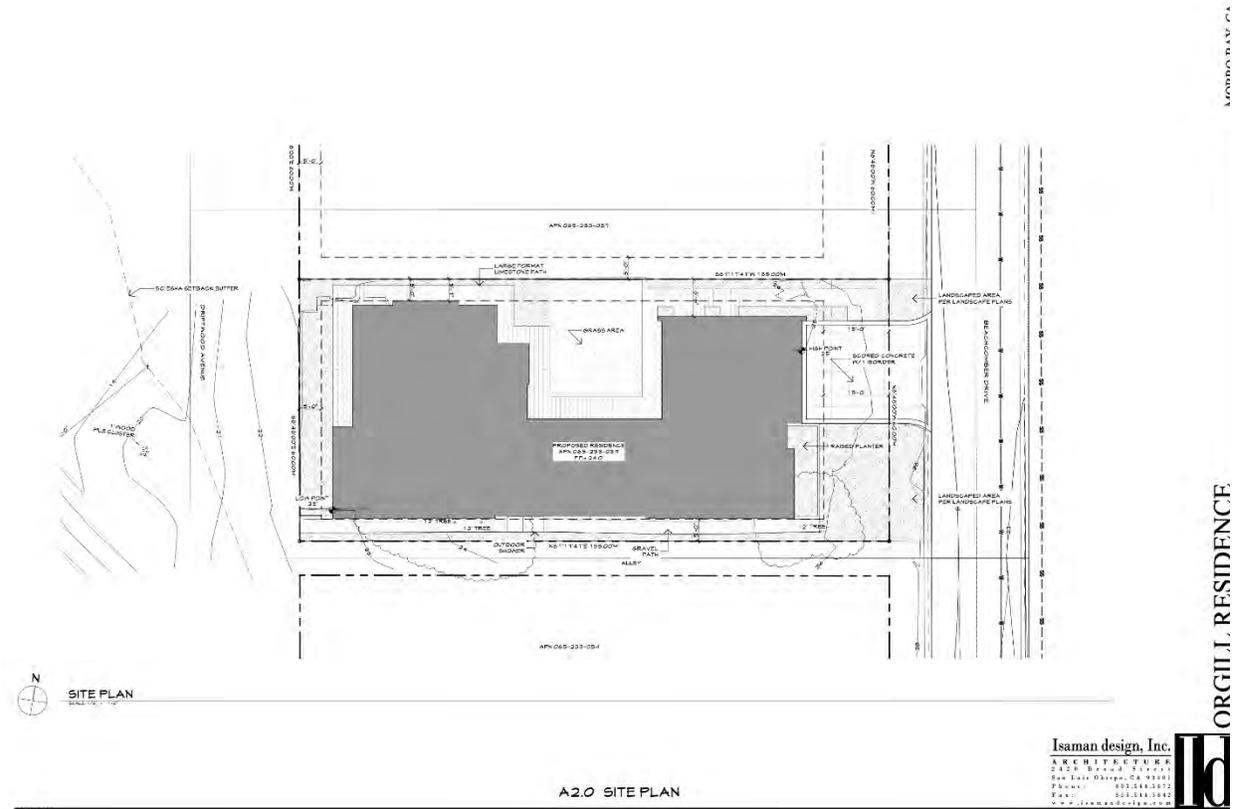
10/11/2022
Figure 2: Site Plan (Isaman Design, Inc. 2022)

The proposed project is to consist of a new single-story single-family residence with 2-car garage (see Figure 2). At the time of the preparation of this report, the proposed single-family residence is to be constructed using light wood framing. Grading quantities are not known. It is anticipated that the foundations will be excavated into over excavated engineered fill. Retaining wall are not anticipated at this time.

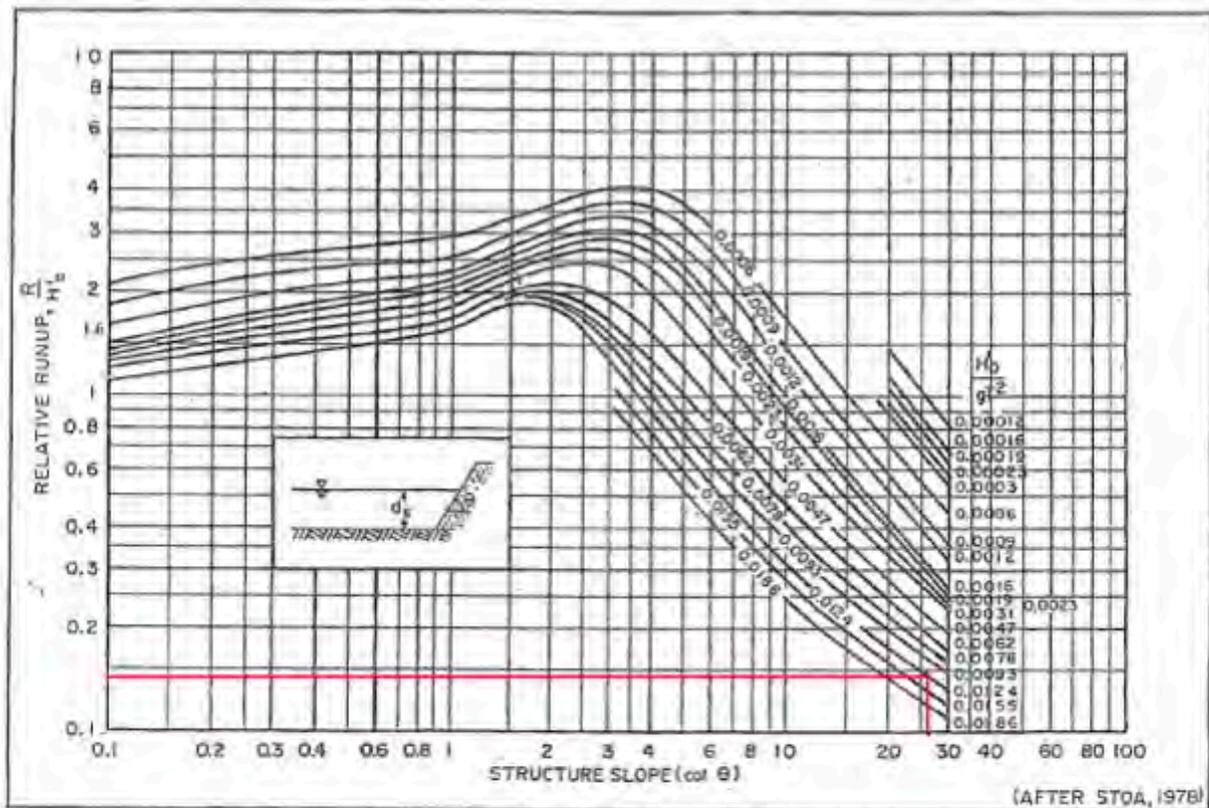
Figure 5: NAVFAC Wave Height Chart

$R = H_b \times 0.14 = 2.1$ feet

FIGURE 72
Relative Runup, R/H_b , on a Smooth Embankment or Revetment for Relative Depth, $d_s/H_b \leq 3.0$

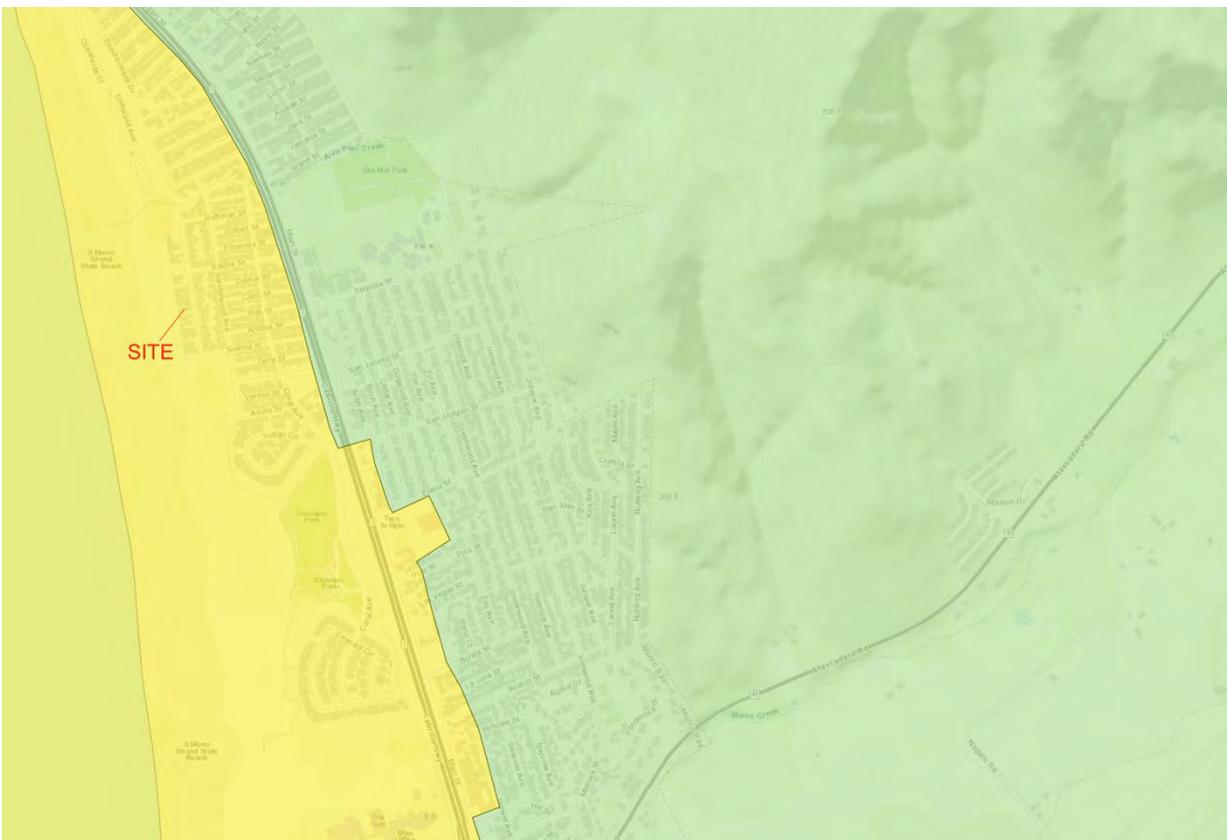
Figure 6: Tsunami Inundation Map (California Geological Survey, 2021)

Tsunamis and seiches are two types of water waves that are generated by earthquake events. Tsunamis are broad-wavelength ocean waves and seiches are standing waves within confined bodies of water, typically reservoirs. Based on elevation and location, the potential for a tsunami to affect the Site is moderate to high. The site is located within the tsunami inundation area (see Figure 6).

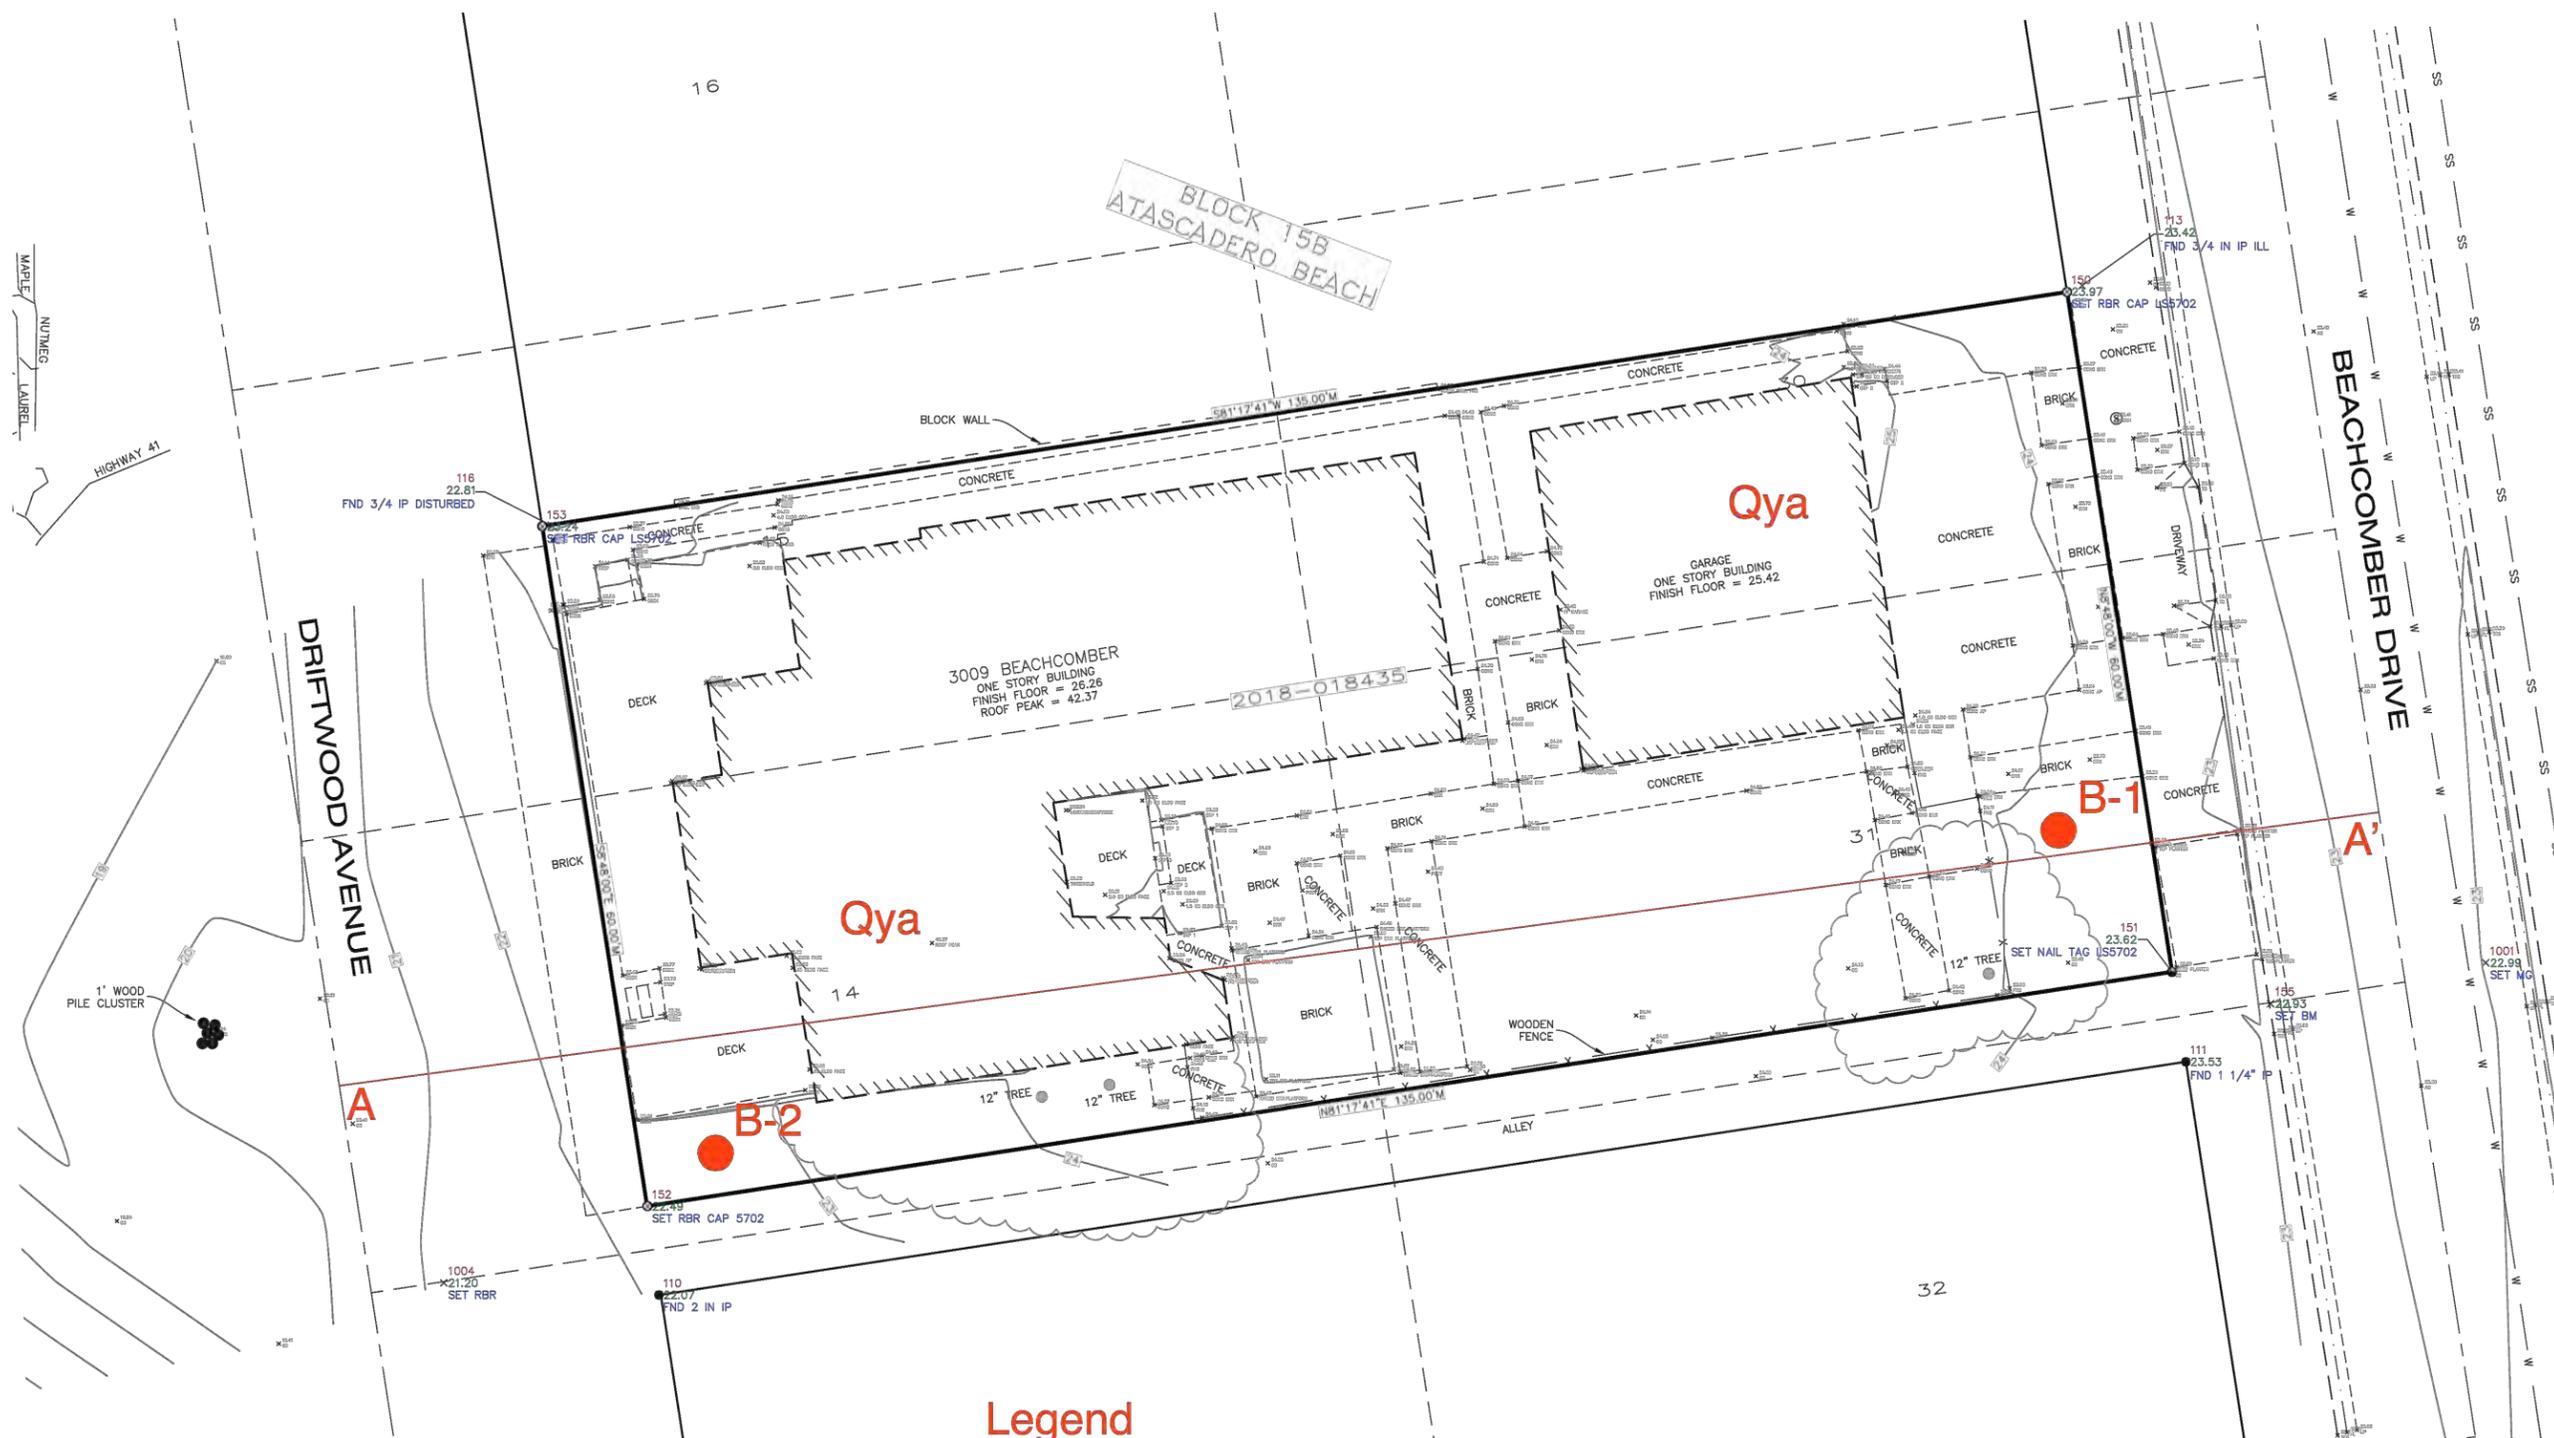
PLATE
 1A
 PROJECT
 SL12943-2

Legend
 Qya - Alluvial Deposits (Holocene to Pleistocene age)
 ● - Boring Location
 A - A' - Cross Section

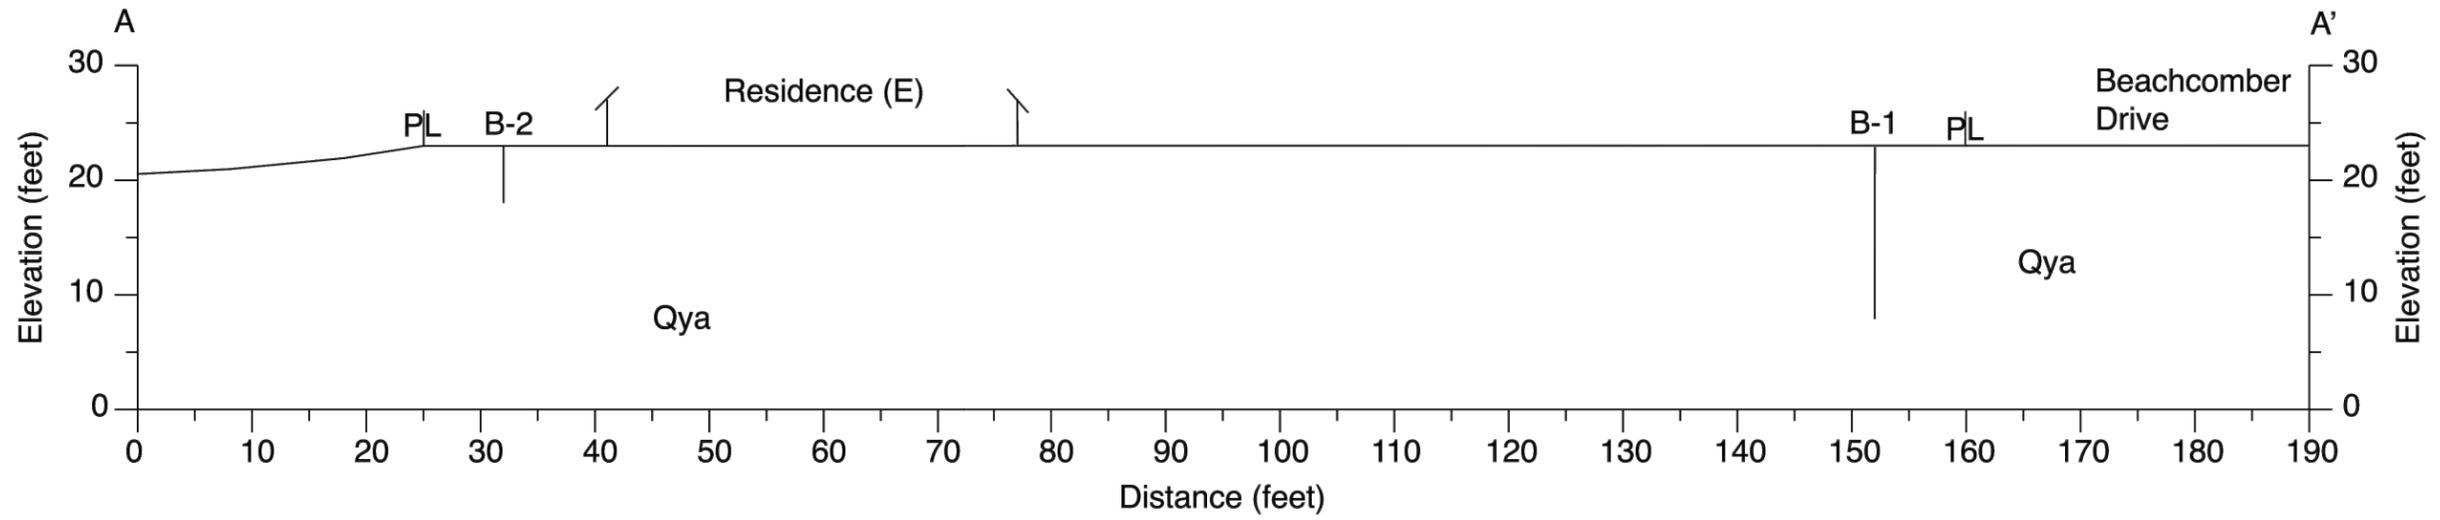
PLATE
1B
PROJECT
SL12943-2

Legend
Qya - Alluvial Deposits (Holocene to Pleistocene age)
— - Contact

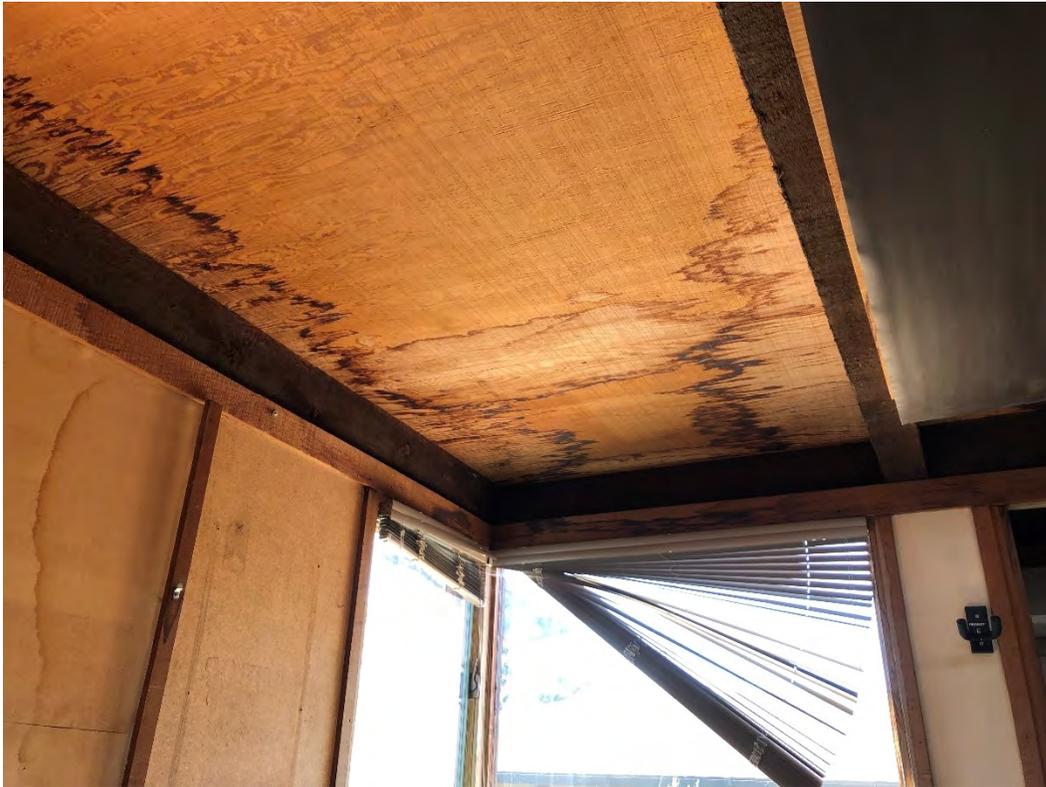
Figure 1: Water intrusion visible at ceiling

and upon a structural review of the existing conditions, it was determined that the aging home had significant structural damage and could not be restored as a habitable space. The new owners have submitted a proposal to demolish the existing home and build a new modern home.

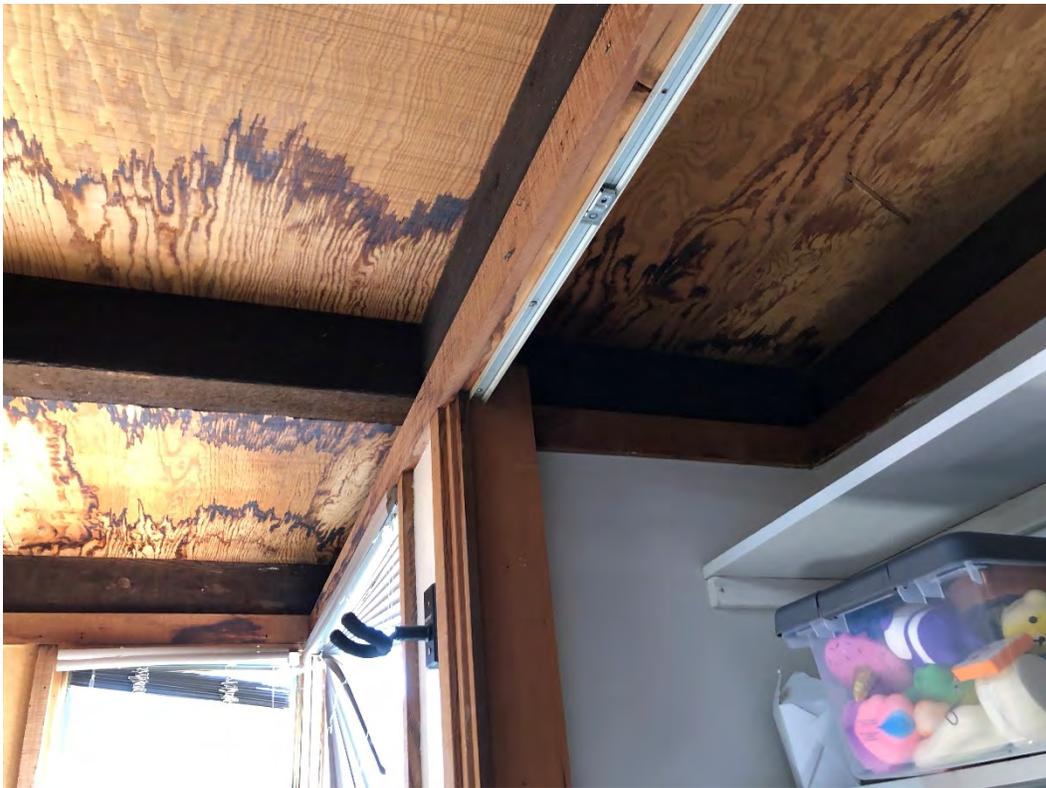
Figure 2: Water intrusion visible at ceiling

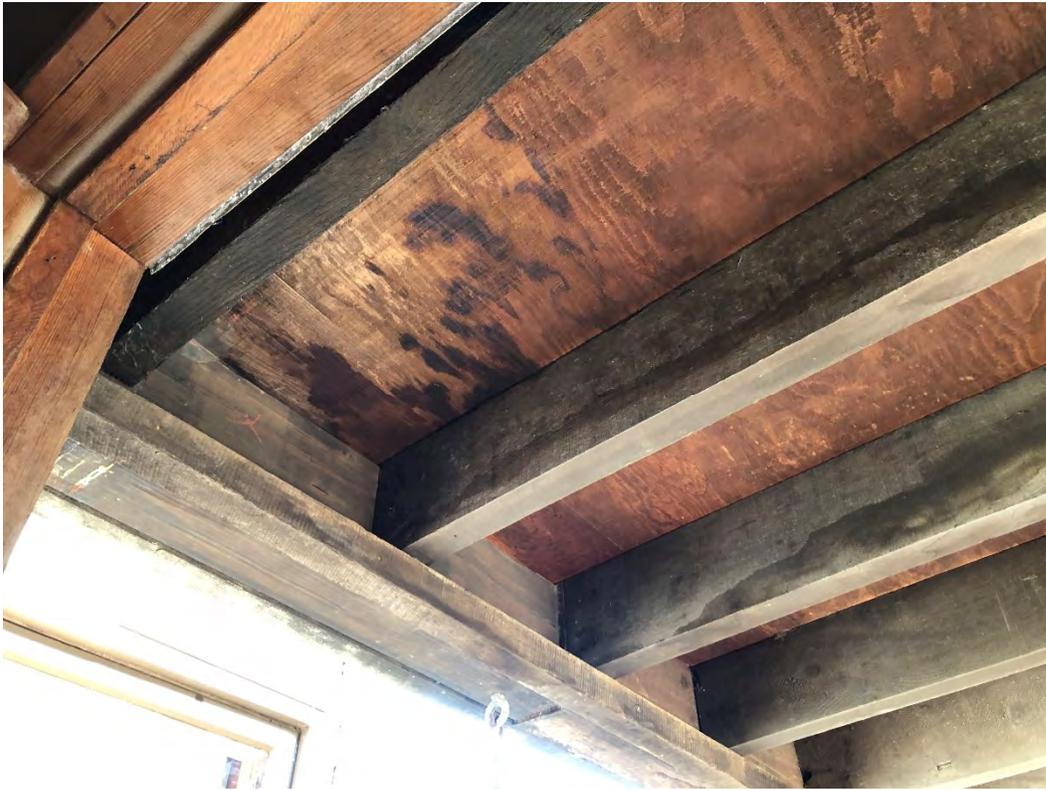
Figure 3: Water intrusion and wood rot visible at ceiling

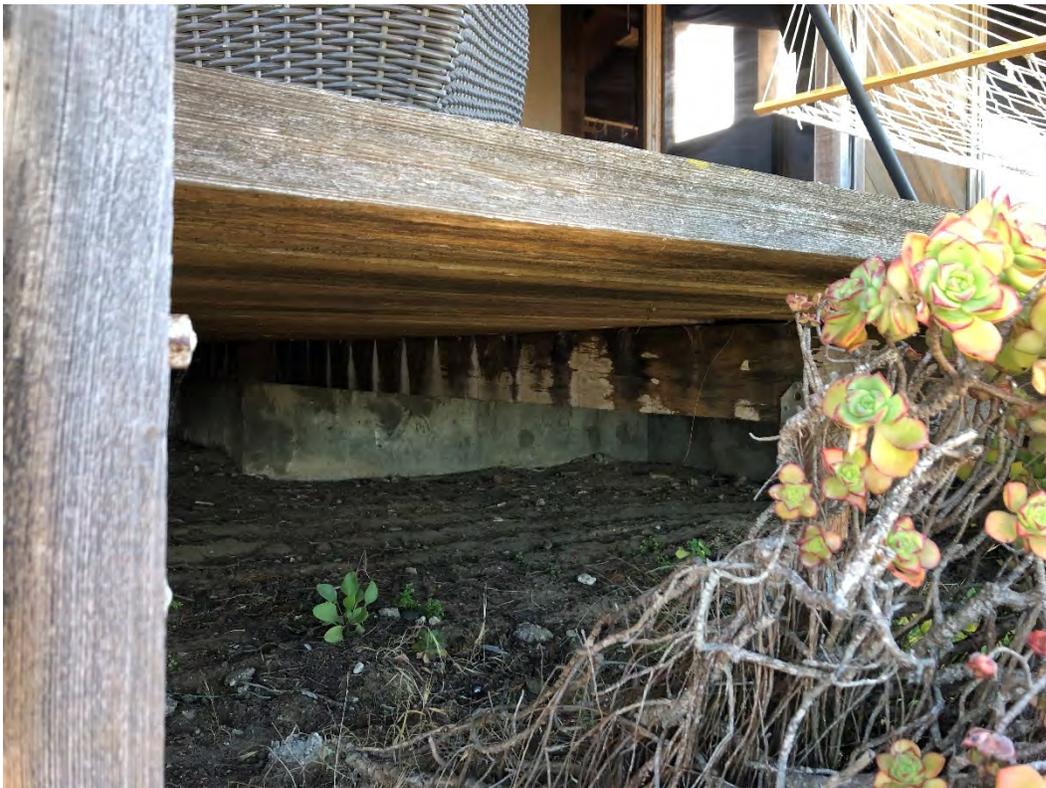
Figure 4: Original exposed deck beam with visible water damage and wood rot

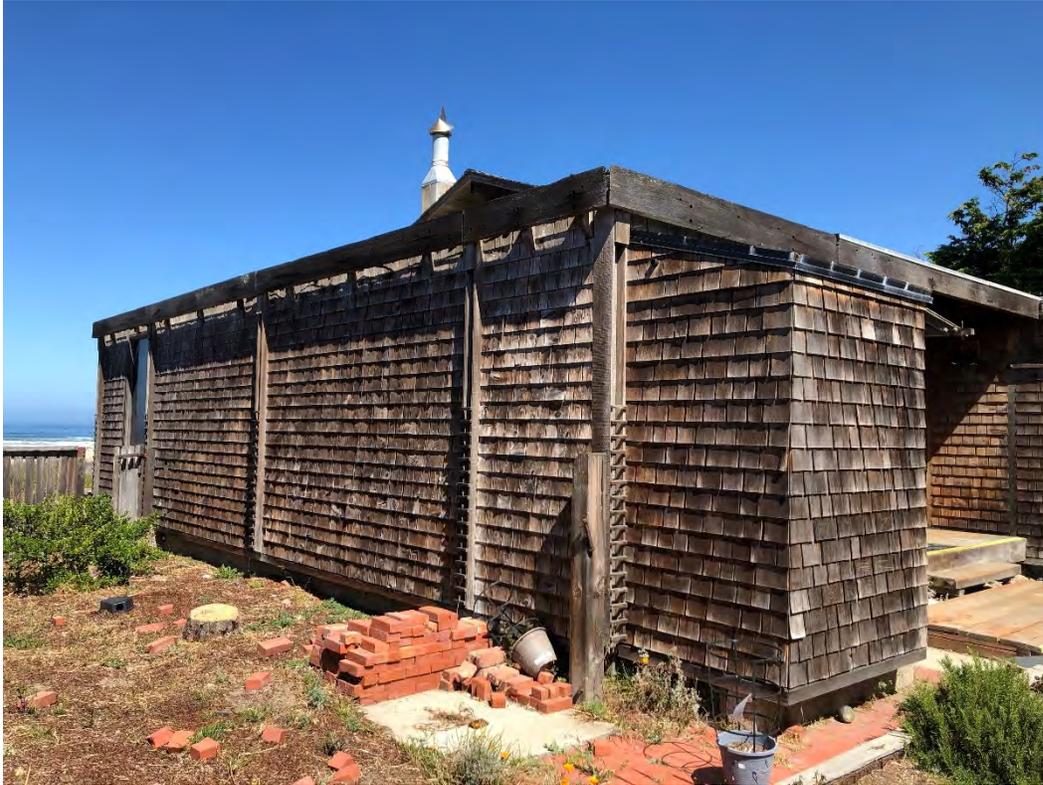
Figure 5: Typical exterior wood shingle cladding

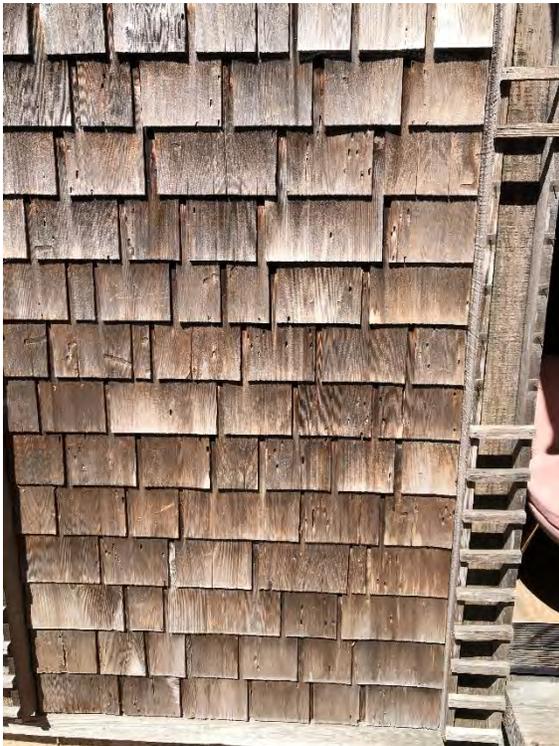
Figure 6: Visible termite damage at siding

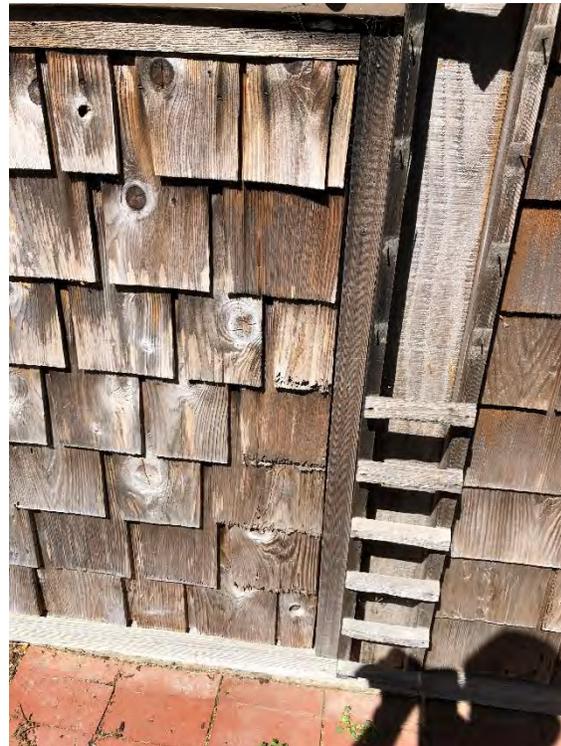
Figure 7: Visible termite damage at siding

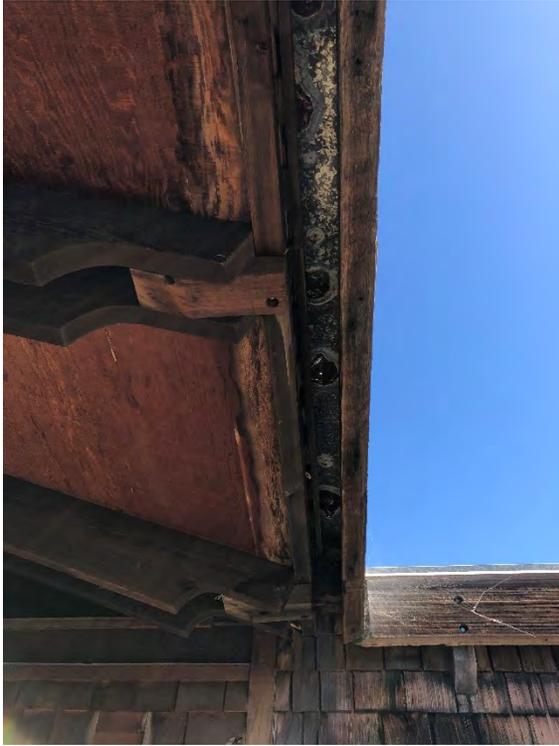
Figure 8: Visible water damage and wood rot at exterior eave. Also, visible corrosion of existing flashing and gutters

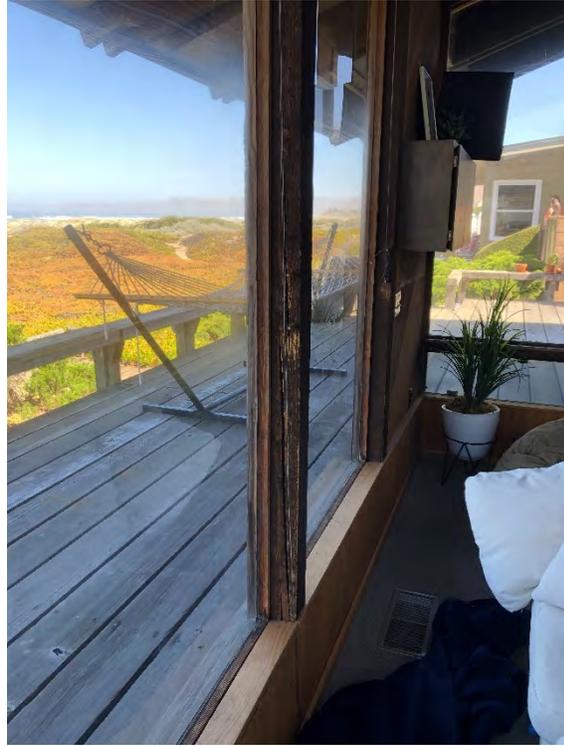
Figure 9: Interior post with visible wood rot and splitting

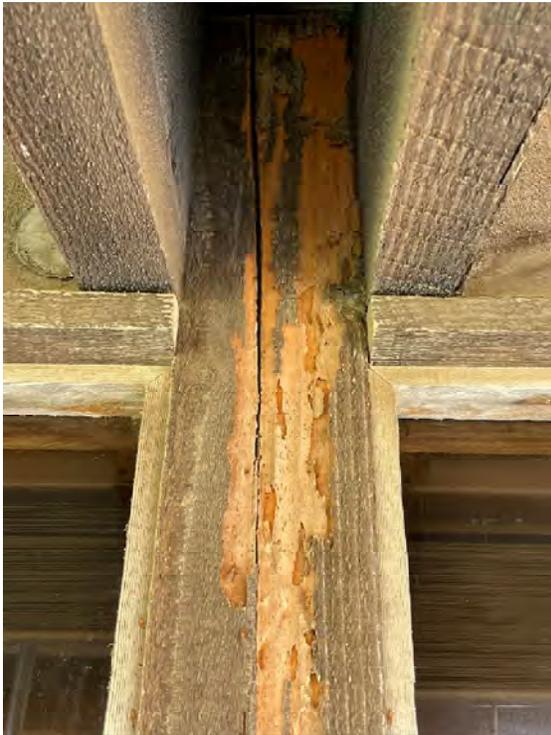
Figure 10: Visible water and termite damage at exterior foundation post.

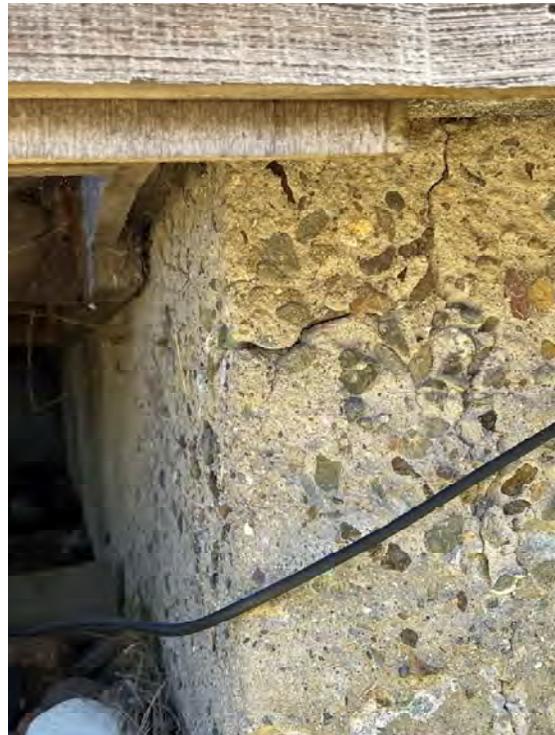
Figure 11: Visible cracks in the foundation stem wall

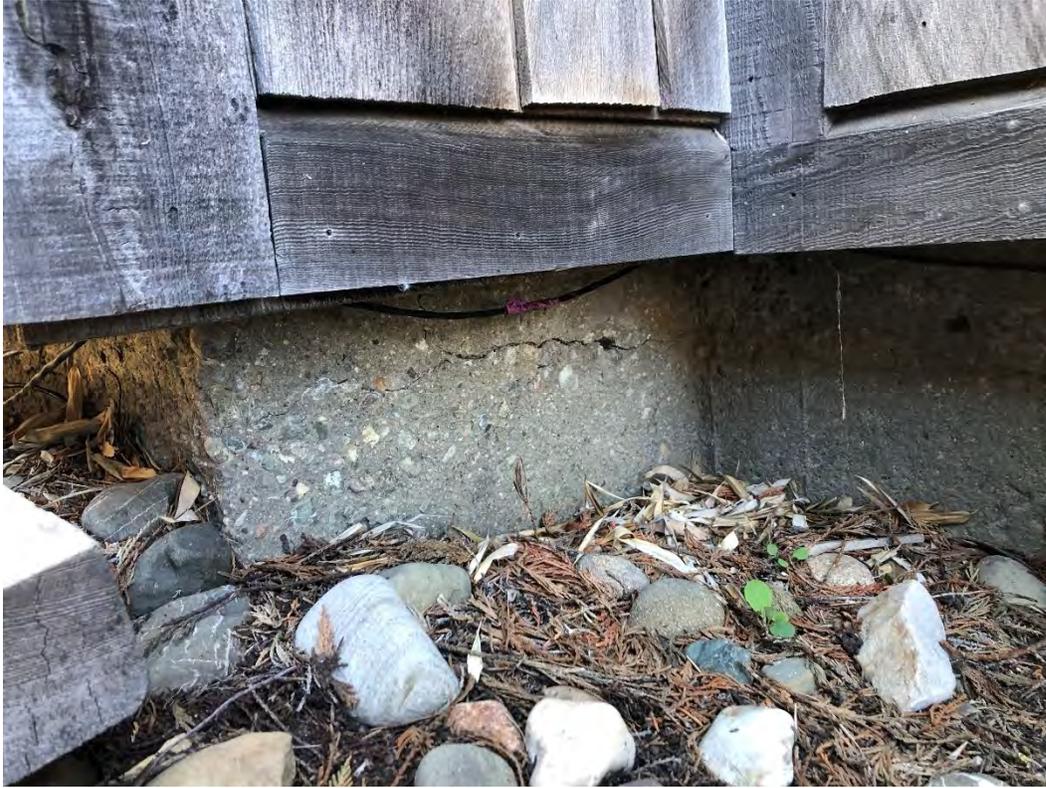
Figure 12: Visible cracks in the foundation stem wall

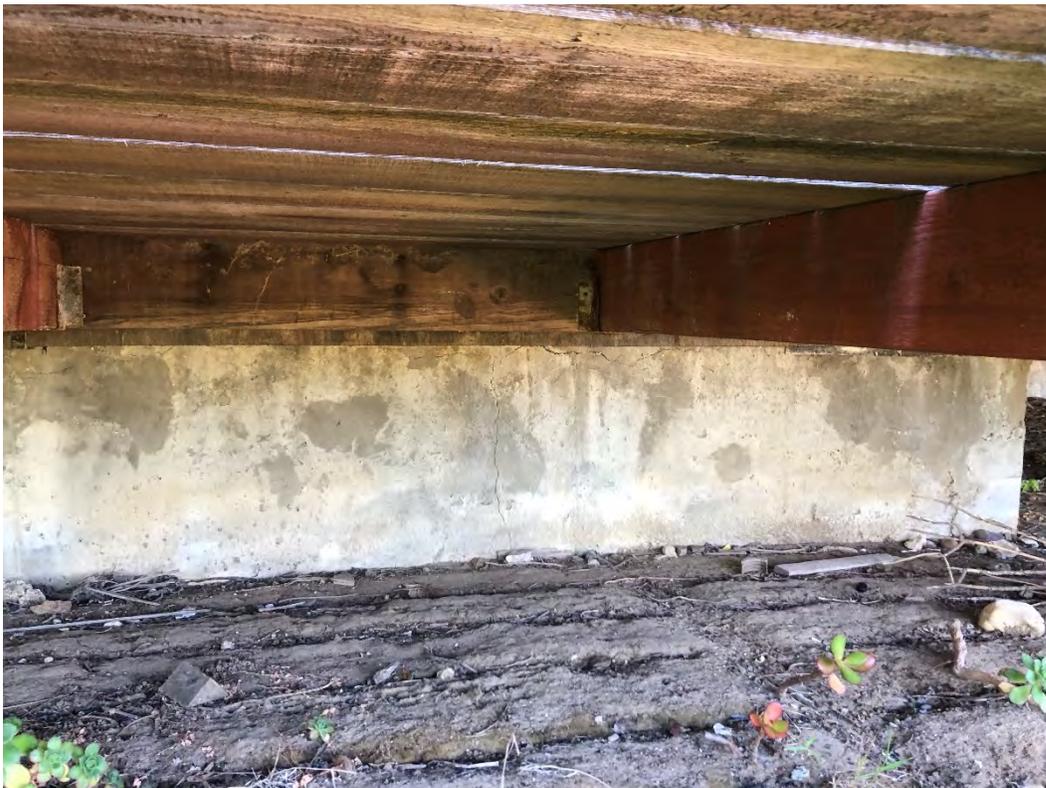
Figure 13: Visible cracks in the foundation stem wall

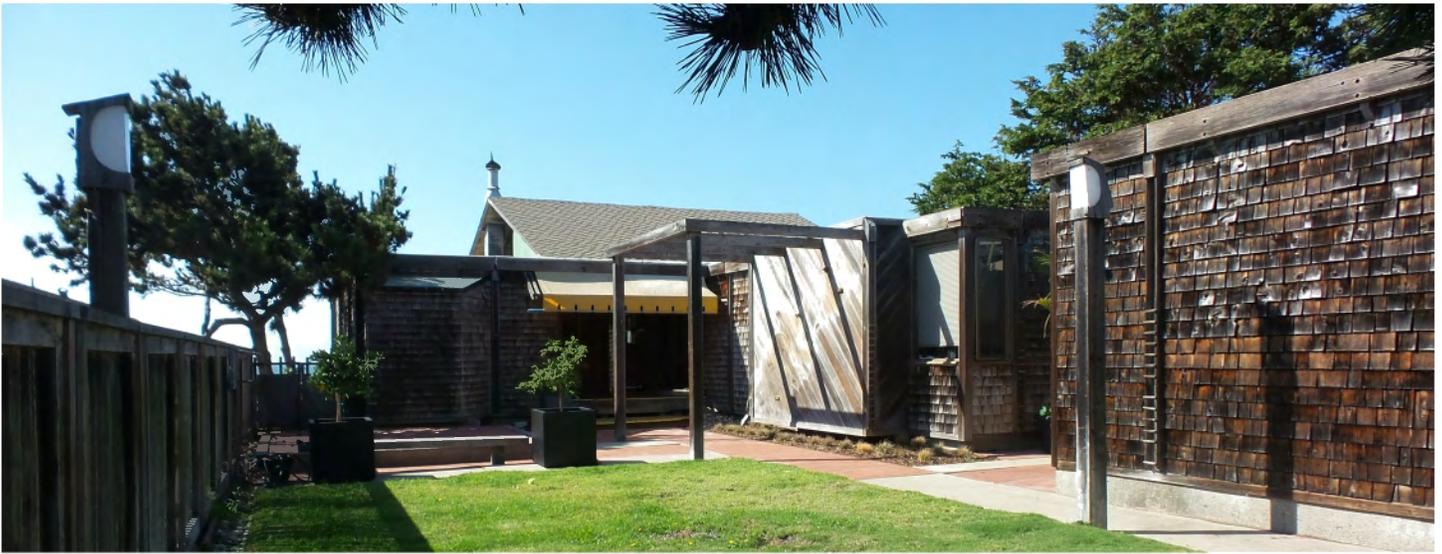
Wood shingles and diagonal redwood boards, front of house

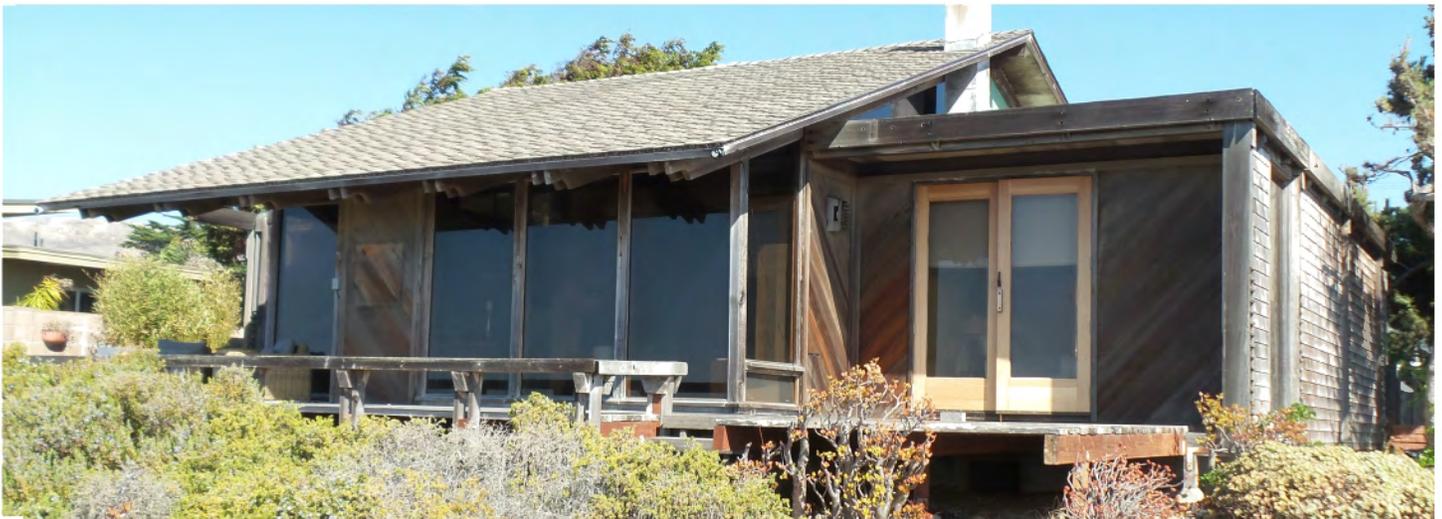
Diagonal redwood boards, rear of house

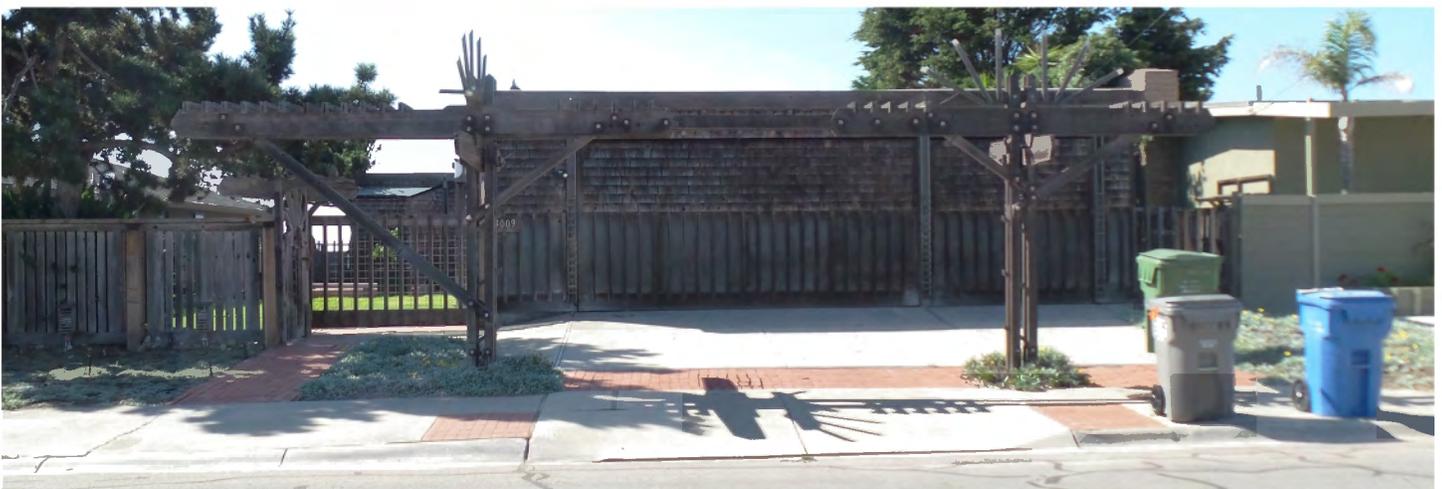
Custom garage door with shingles and board & batten
