CITY OF MORRO BAY PLANNING COMMISSION AGENDA

SUBJECT: Application for a Coastal Development Permit (CDP22-023) for the proposed demo of an existing home and construction of a new home on the parcel providing 3,335-sf of conditioned living space with a 715-sf garage. The home is single story with a side yard courtyard/entryway on an 8,100 square foot parcel adjacent to the sand dunes and ocean beyond. The project zoning is R-1/S2.A and is located within the coastal appeals jurisdiction. The Coastal Land Use and proposed new zoning designation is Moderate Density Residential (RS-B).

Structural Investigation Report

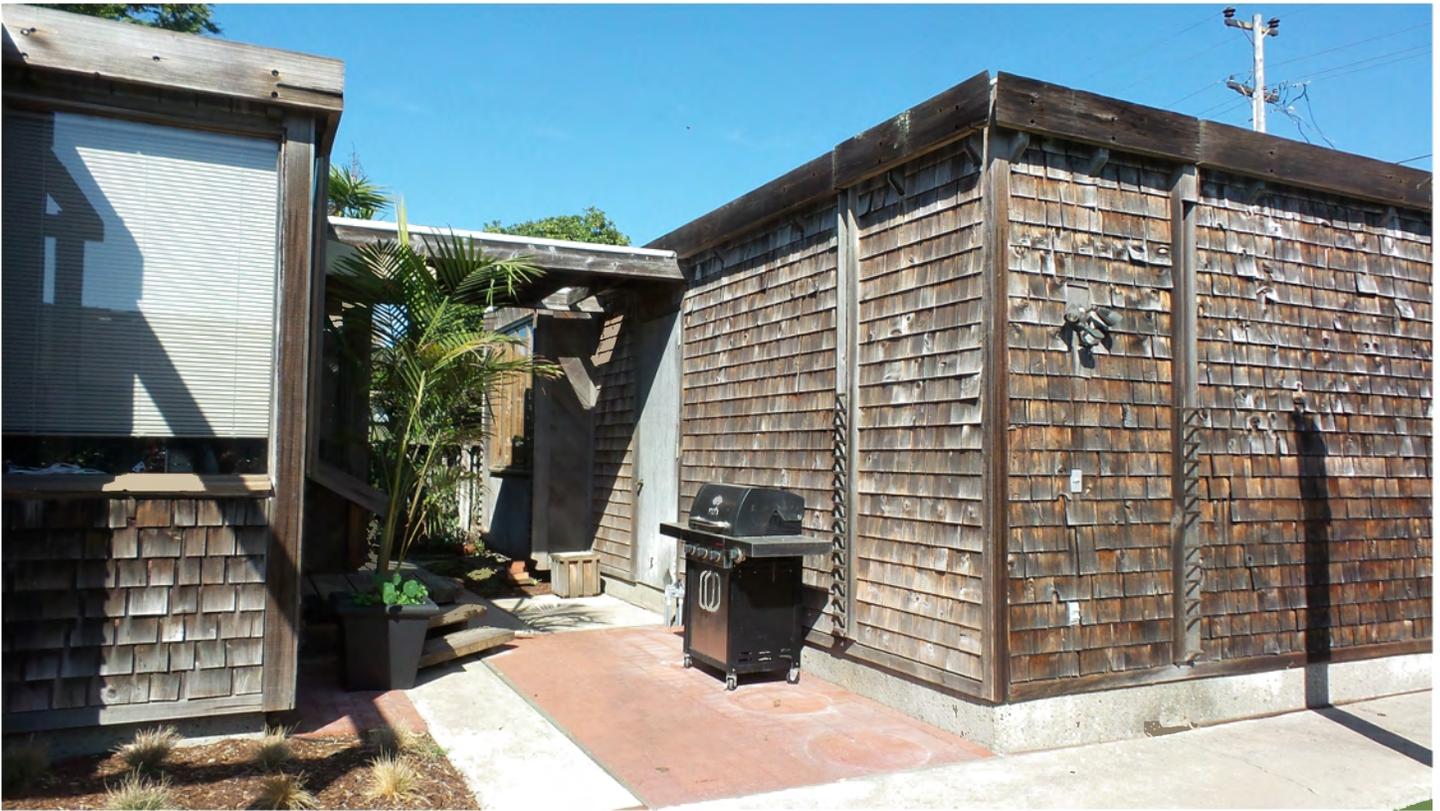
Fascia, corner boards, base boards

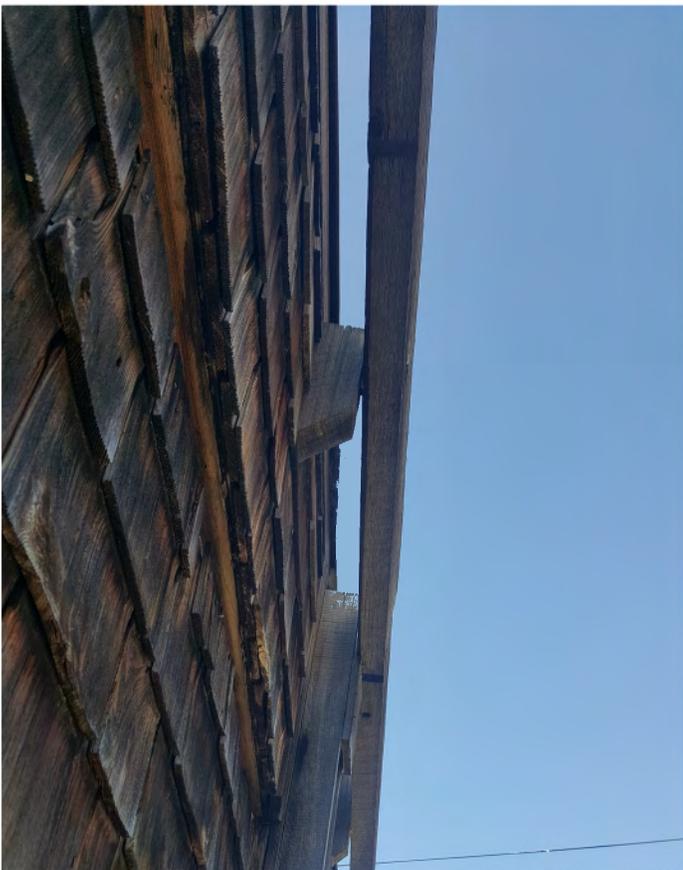
Fascia spacing for downspout

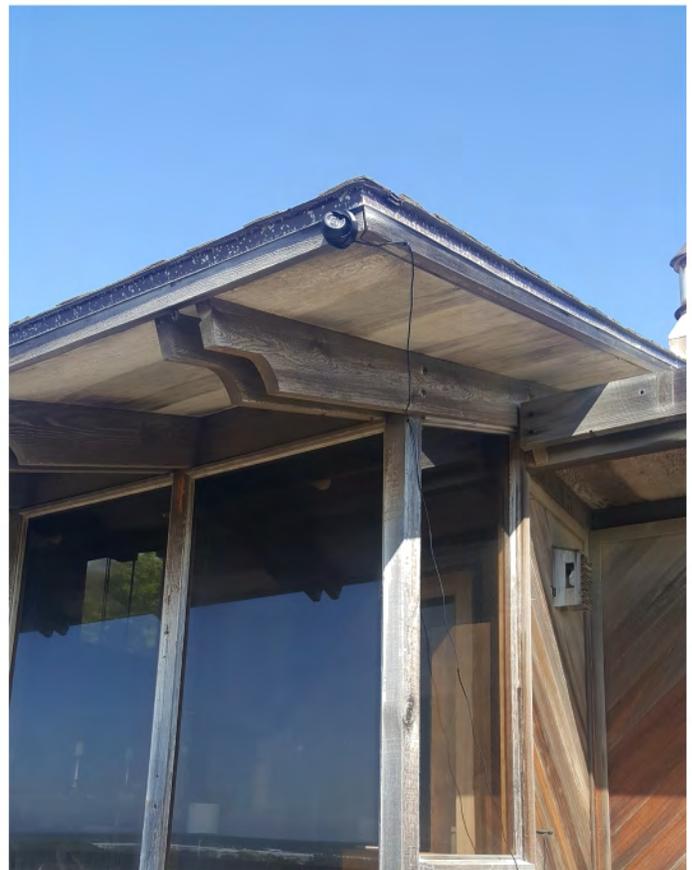
Exposed paired roof rafters

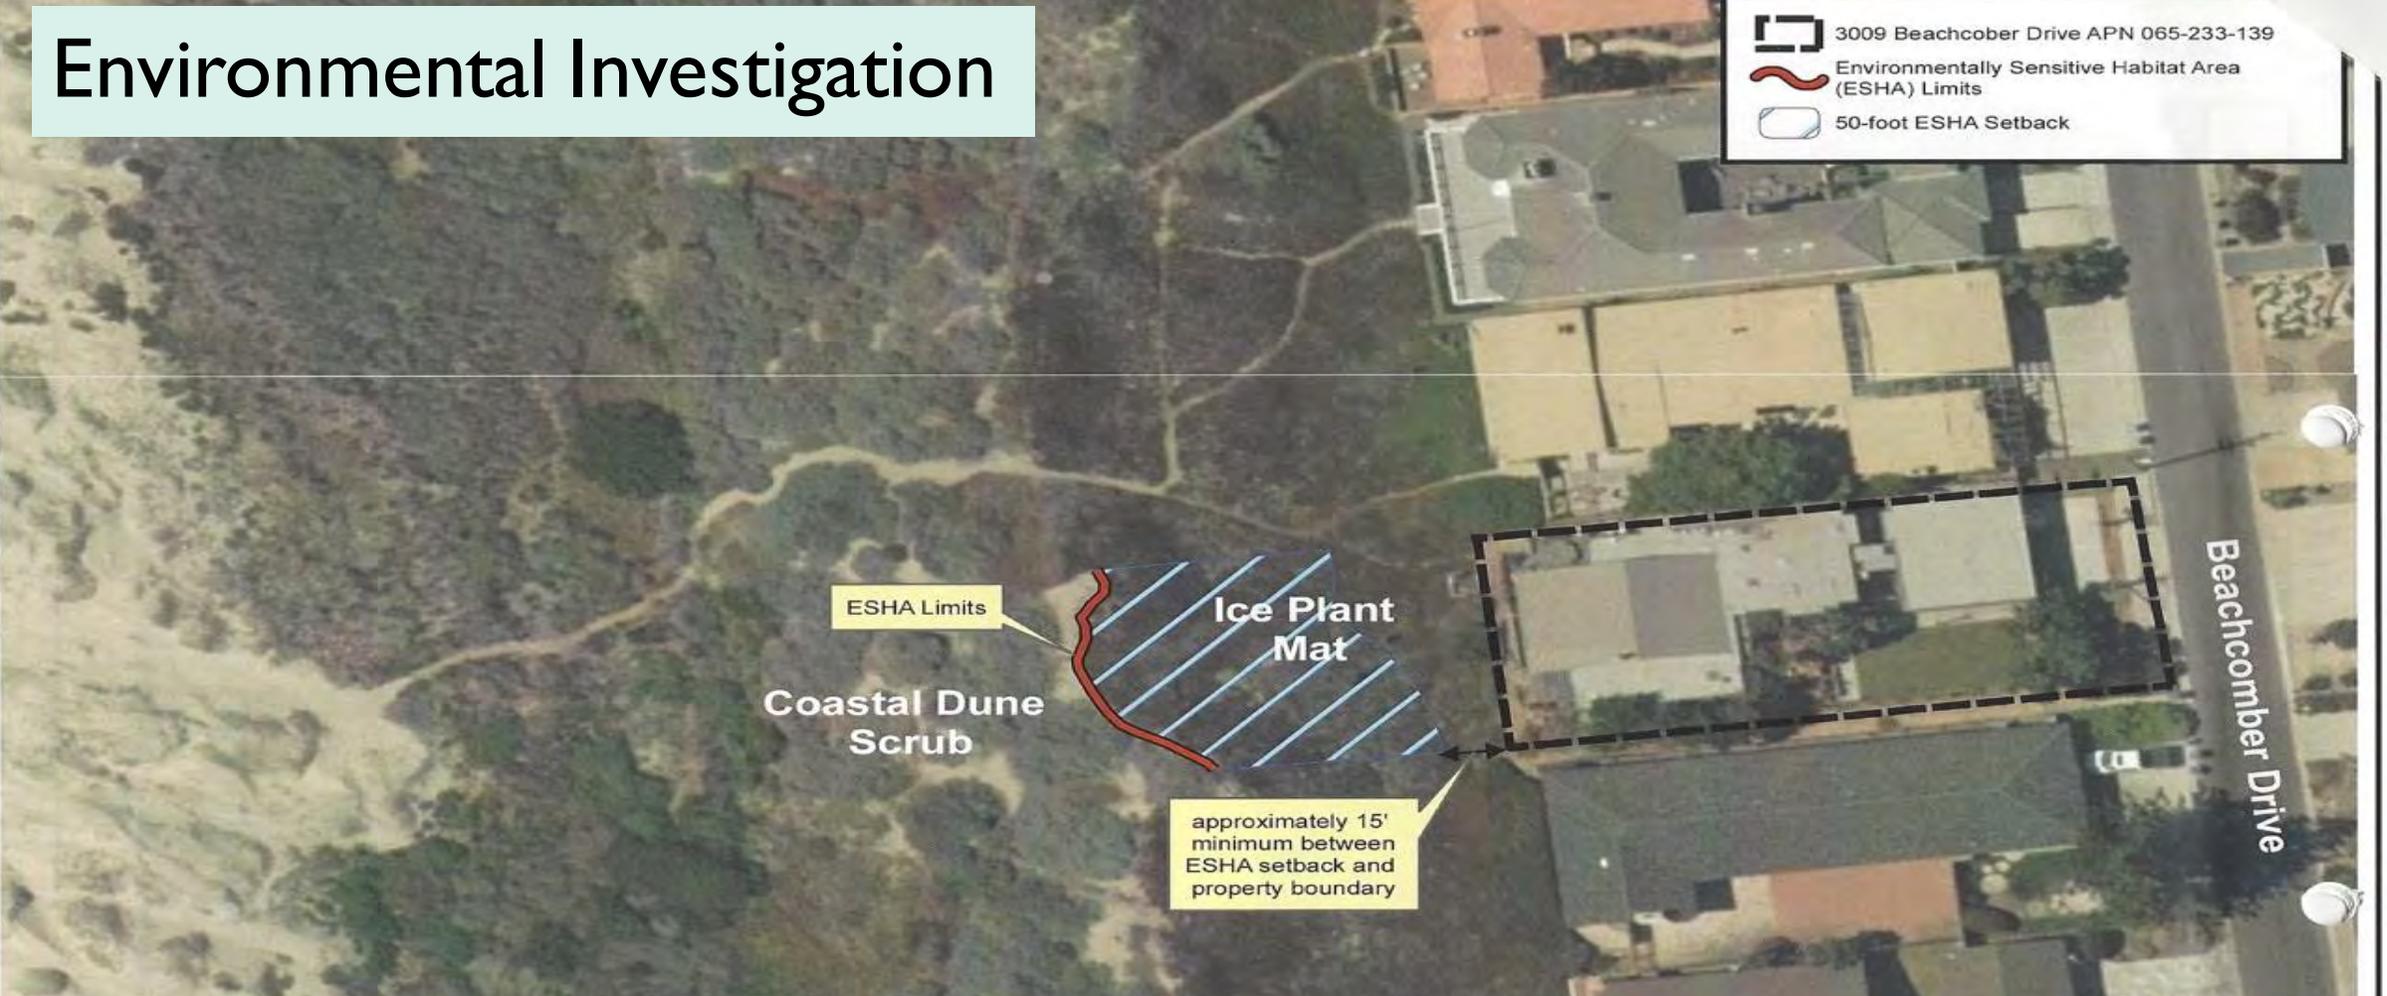
Sage Institute determined the ESH limits and 50-foot buffer.
The property line is 15 feet away from the ESH buffer area
No effect to ESH from proposed work – bricks and hardscape materials
spilling onto the OA area will be removed.
