# **BIOLOGICAL RESOURCE ASSESSMENT REPORT**

## **MORRO BAY POWER COMPANY, LLC BATTERY ENERGY STORAGE SYSTEM CITY OF MORRO BAY, CALIFORNIA**

**Project No. 1902-1172**

**FEBRUARY 2021**

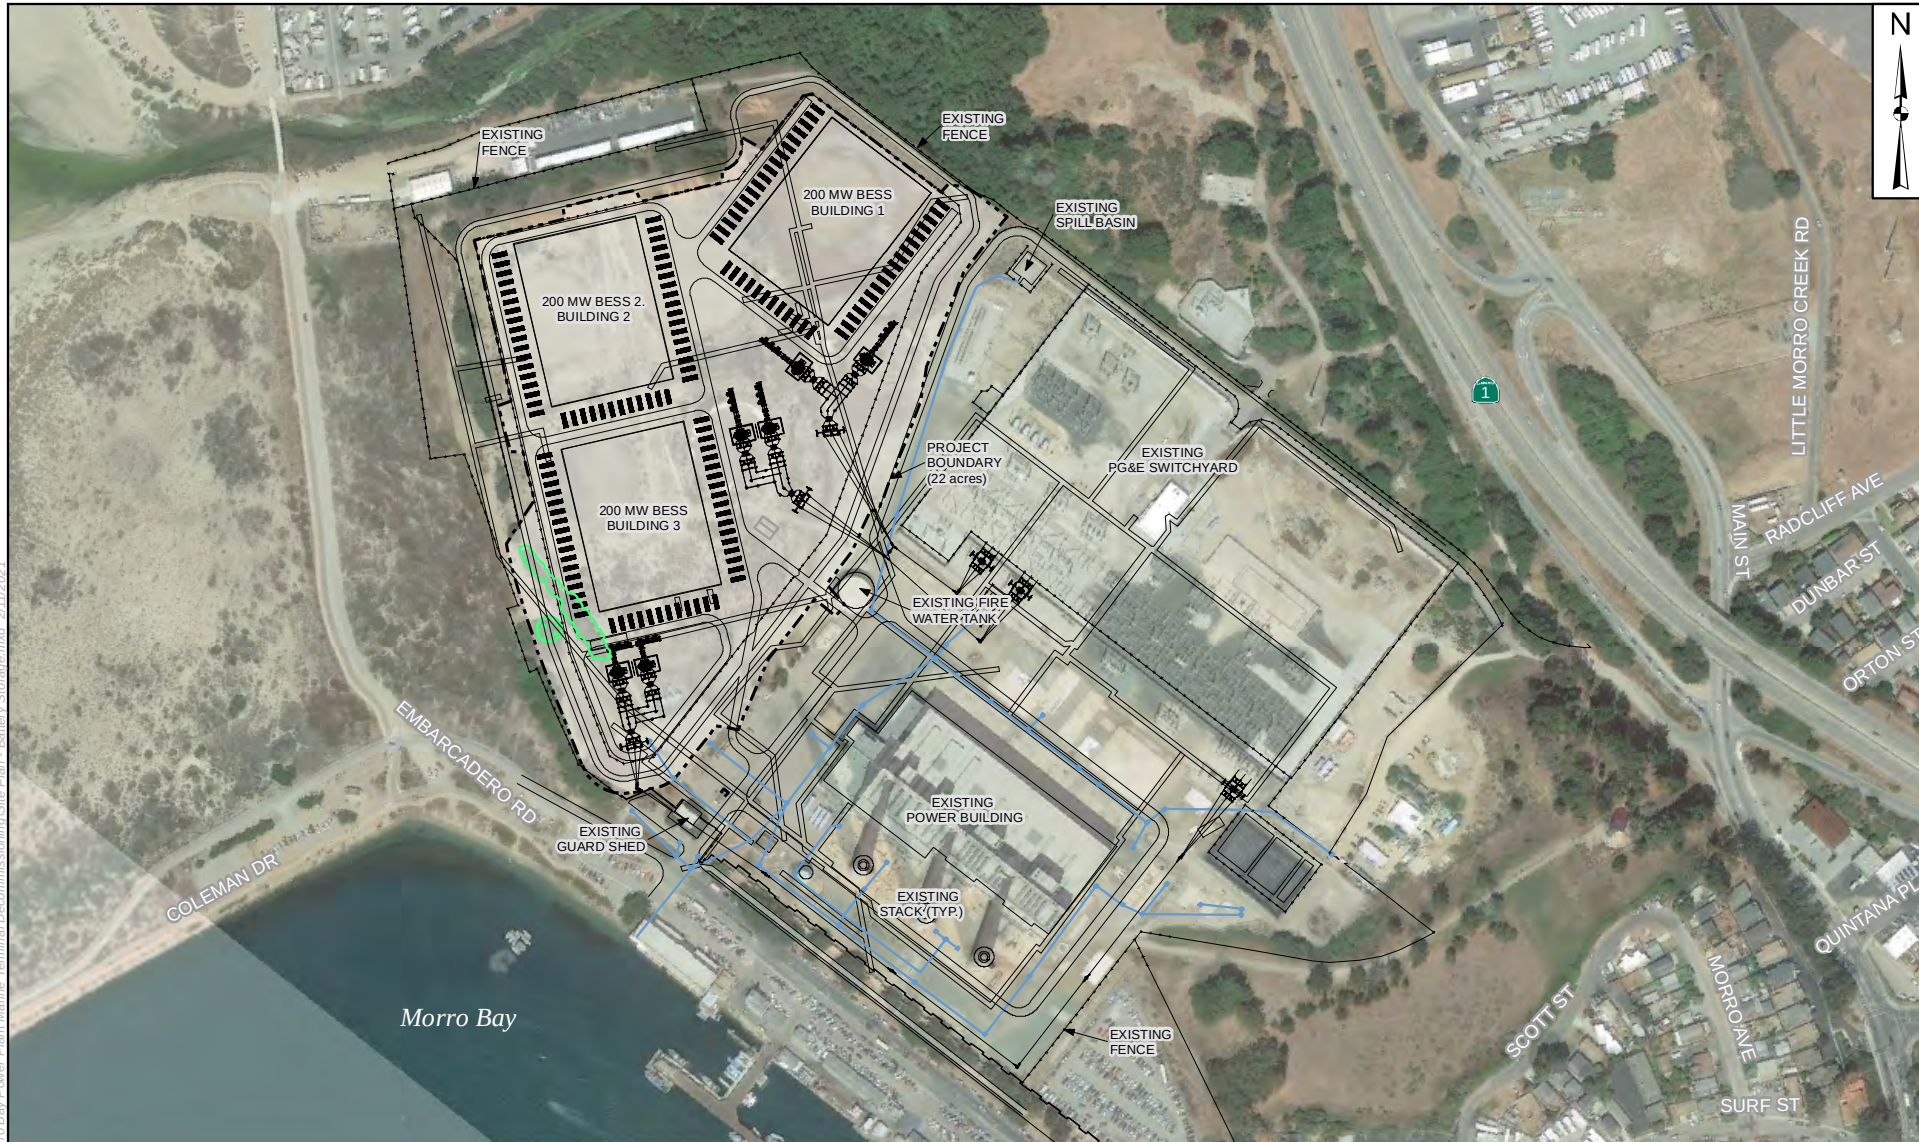
**FIGURE  
1-1**

**SITE PLAN**

Monterey cypress is a perennial evergreen tree in the Cypress Family (Cupressaceae) that is native to California and endemic to central coast of California, occurs in coastal pine forest habitats, and is a CNPS CRPR 1B.2 species. This species is widely planted and has been naturalized outside its native range (University of California, 2020). In the wild, this species is limited to two small populations, near Monterey and Carmel, California (Calflora, 2020, CNPS, 2020b). As observed during the field survey, there were several stands (shown on Figure 4-1 as Ornamental vegetation) and individual trees that appeared to be planted as landscape trees within the BSA. All trees were healthy and averaged in height from approximately ten to 20 feet tall. It is expected that six Monterey cypress will be removed as part of Project activities and is labeled on Figure 1-1. Refer to Section 5.0 for information on replacement trees plantings.

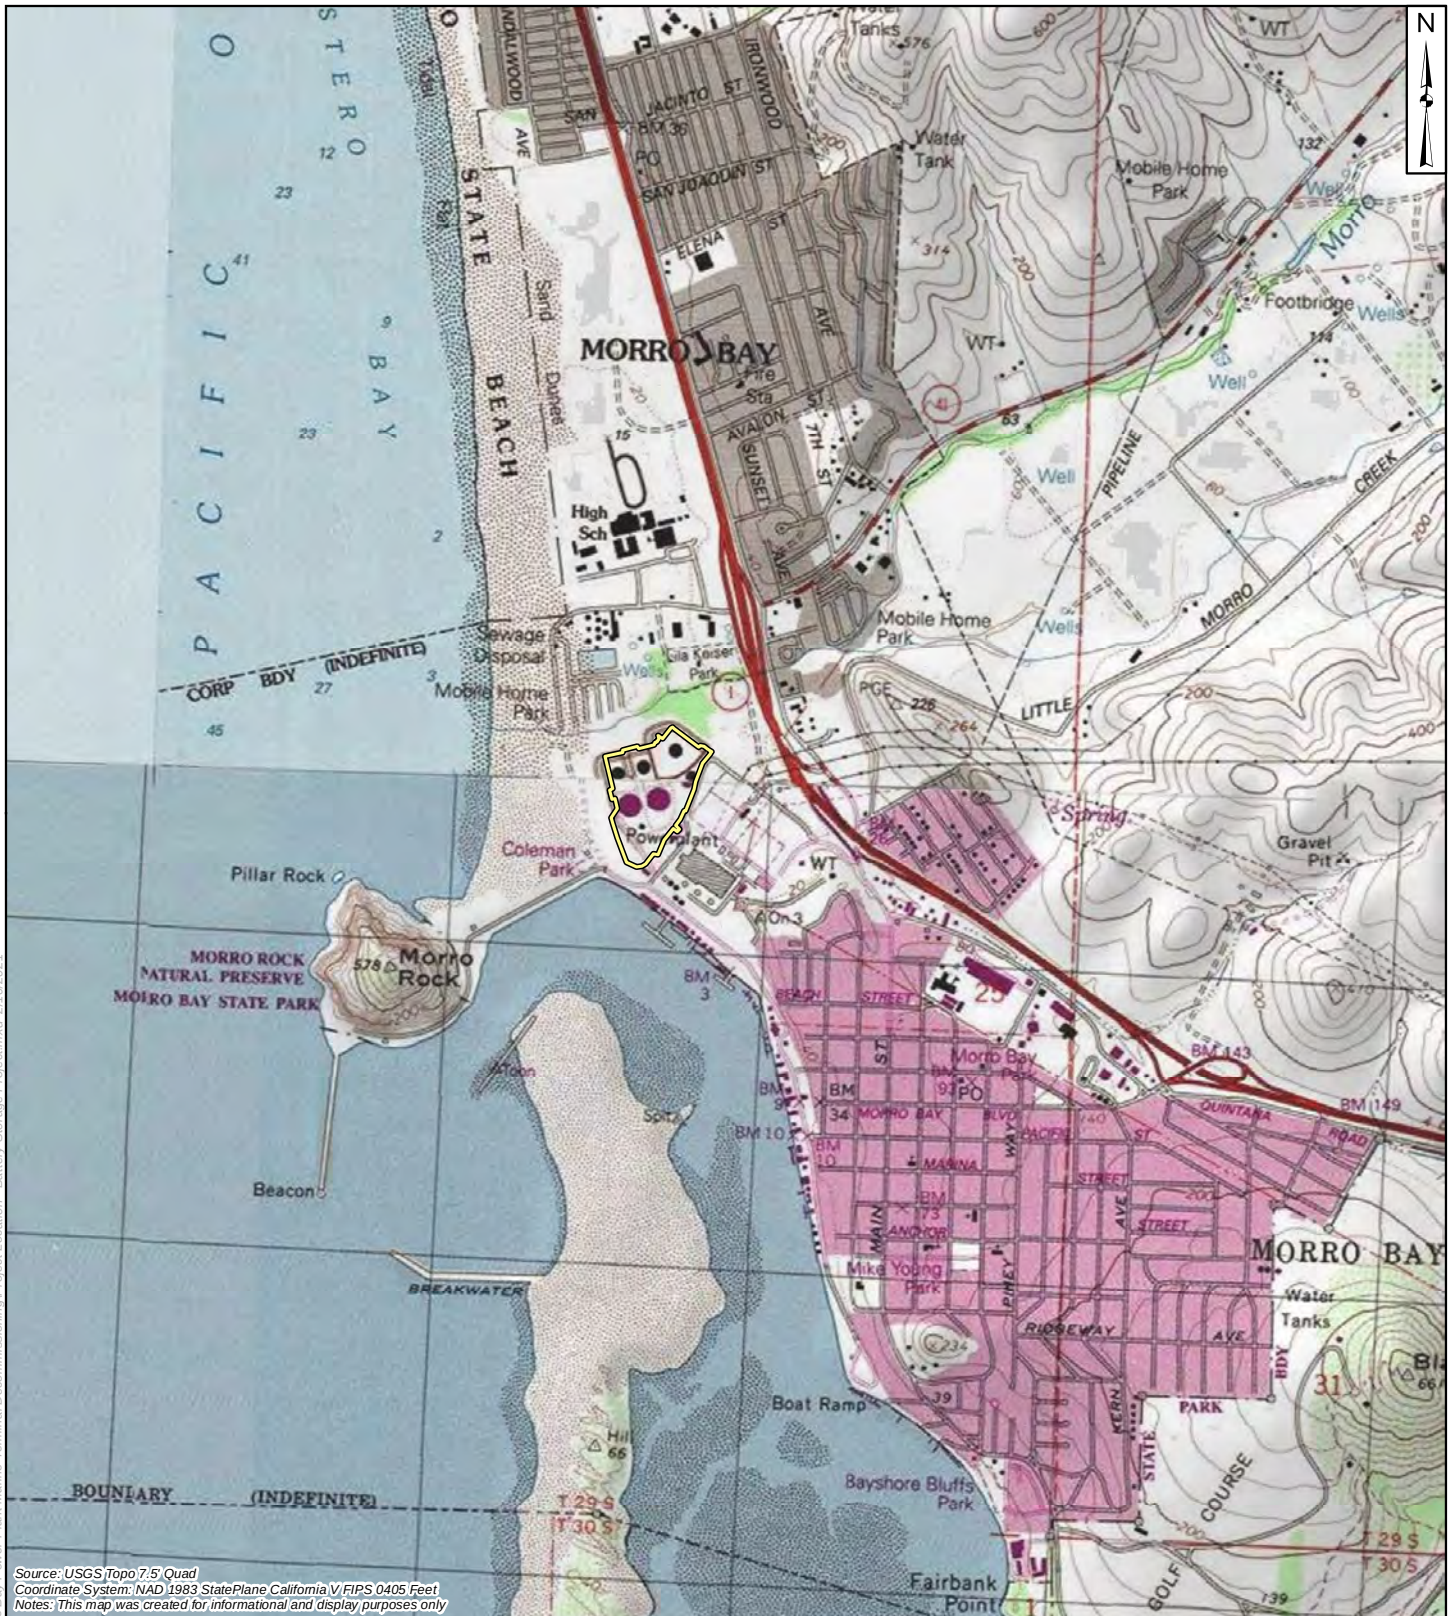
The BESS will be located northwest of the existing power plant building and west of the existing PG&E switchyard fence. Figure 1-1 Site Plan presents the location of the Project site within the MBPP property boundary. Six Monterey cypress trees and vegetation within the former tank farm will be removed as part of the Project.

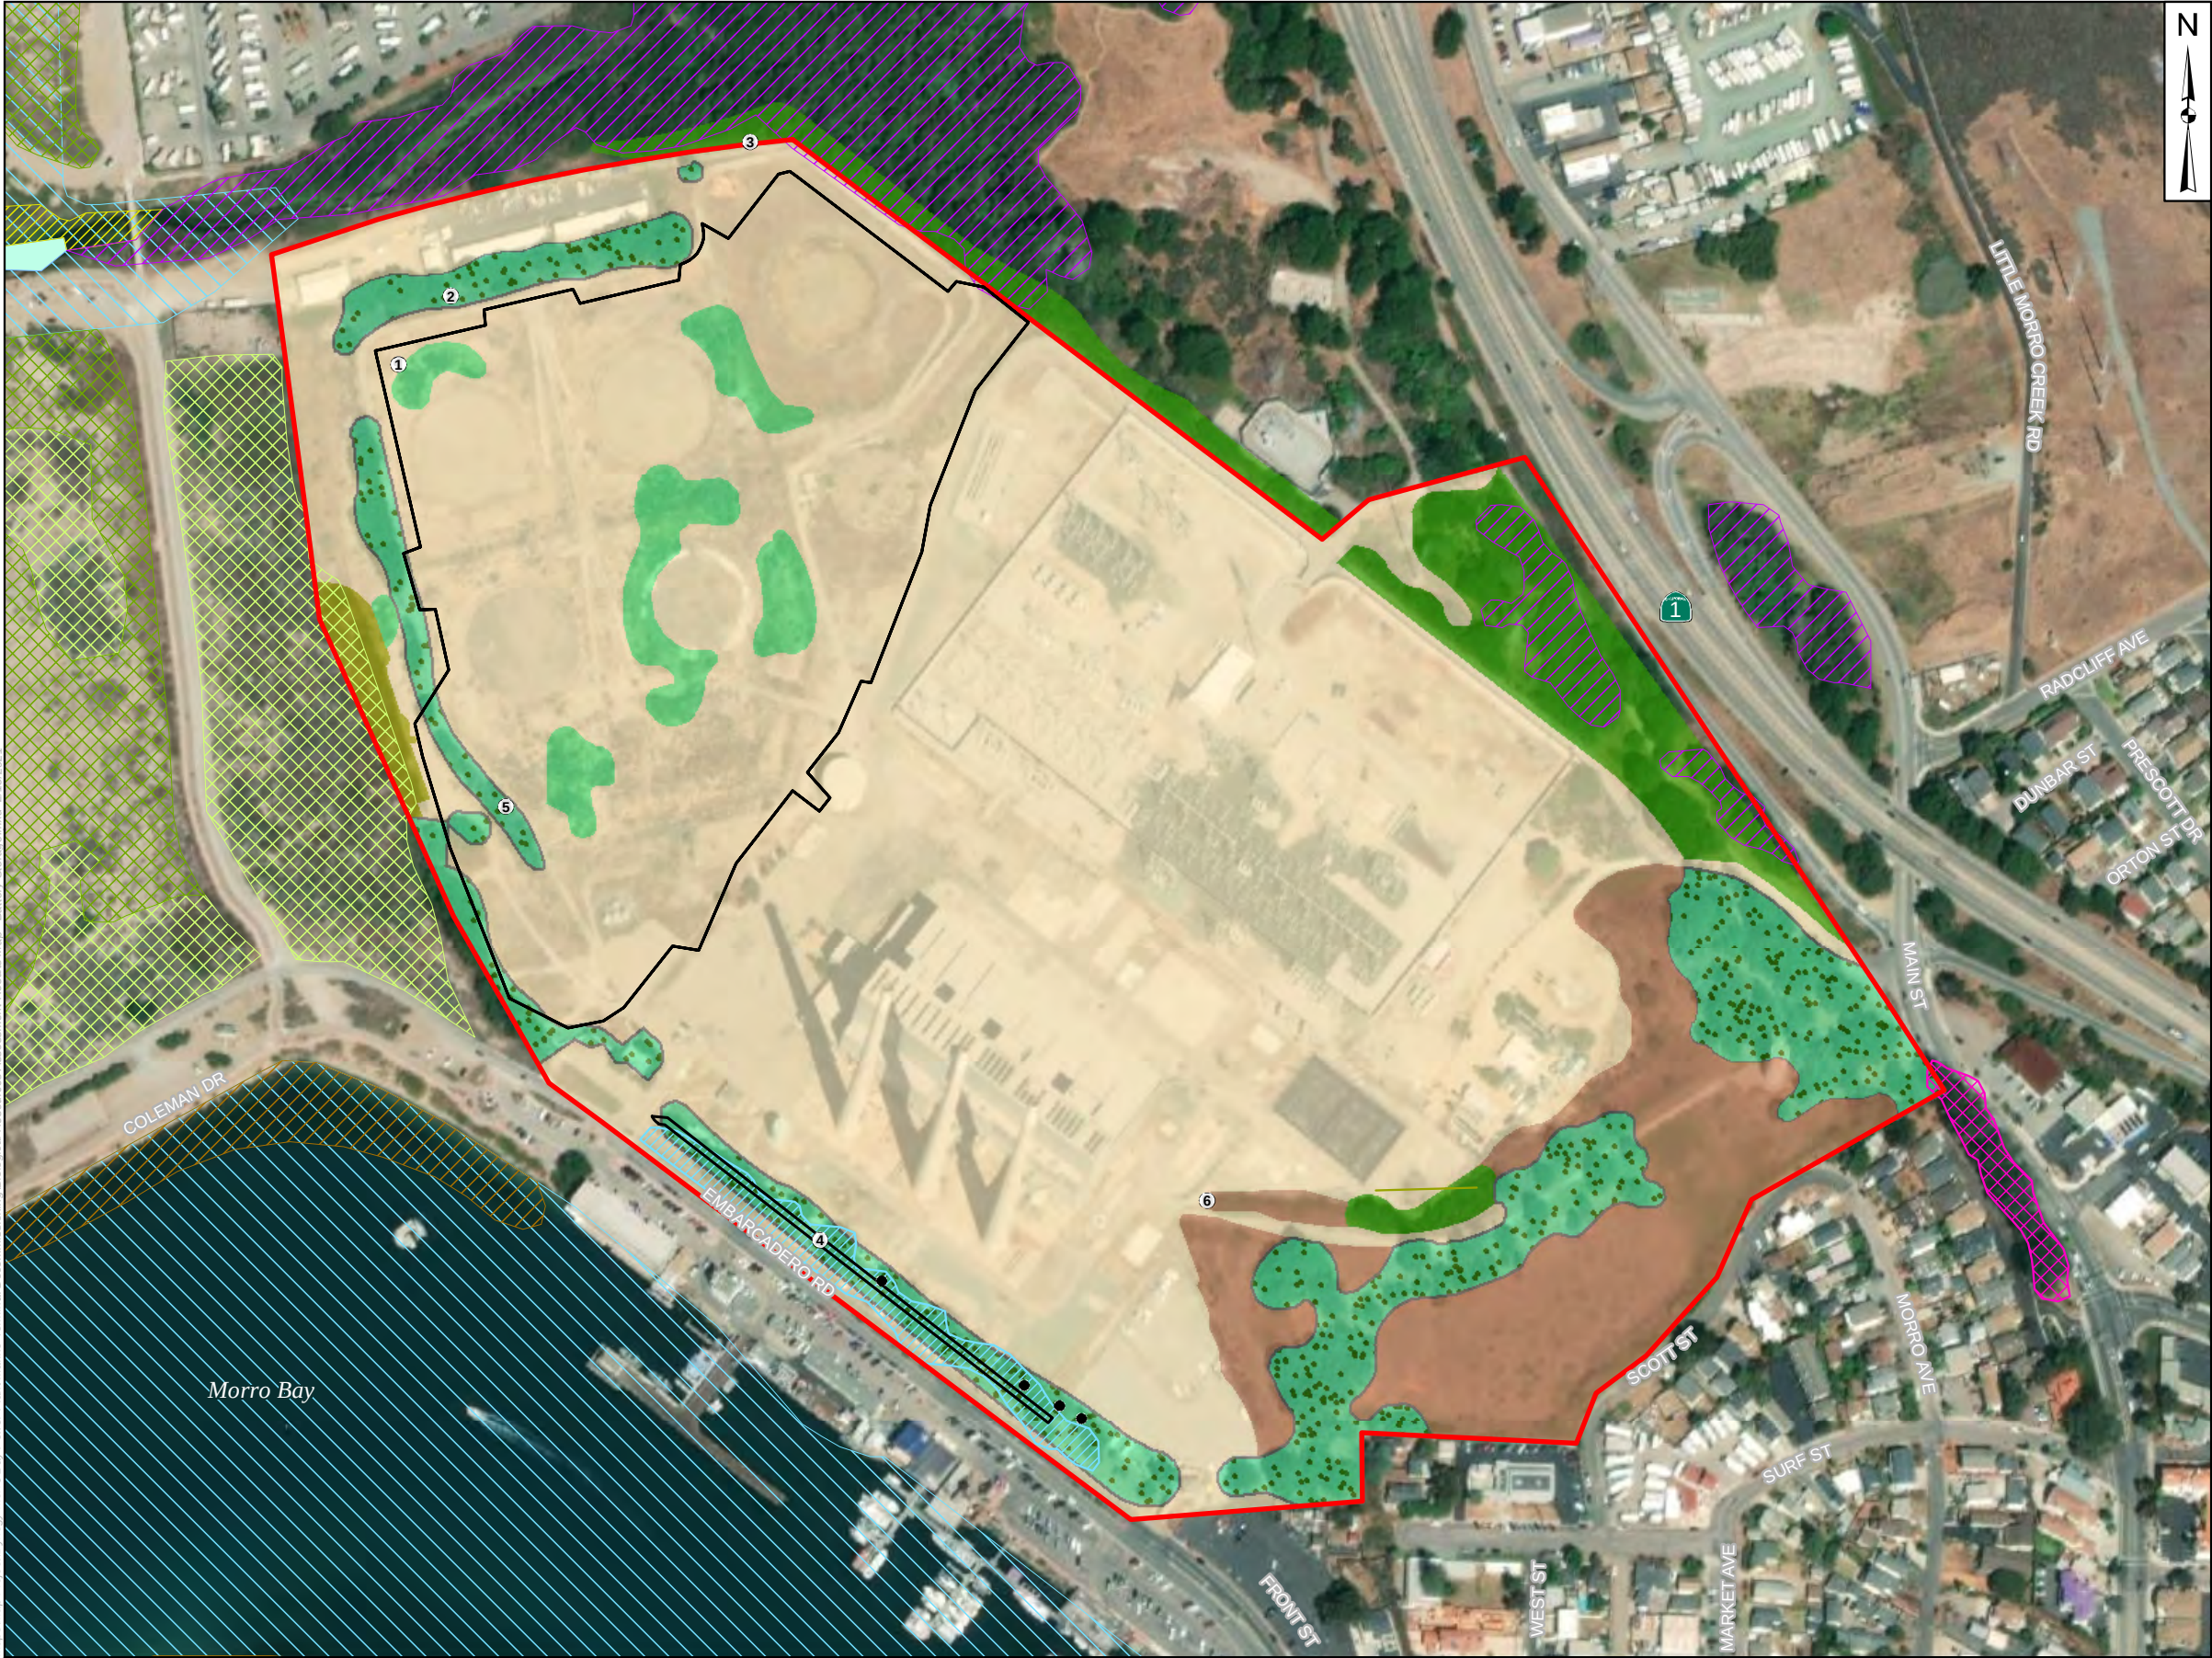
**LEGEND:**

- VRAP Location
- Inactive Nest Location
- Project Site
- Biological Survey Area (BSA)

- Backdune / Dune Scrub
- Foredune
- Freshwater Emergent Wetland
- Monarch Overwintering Site
- Outer Limit of SLR-Related Hazard Zones
- Rivers & Streams (Stream Mouth)
- Rookeries
- Shallow Bay / Mudflat / and Eelgrass Potential Habitat
- Willow Woodland and Scrubland

- Arroyo Willow Thicket
- Ruderal/Developed
- Iceplant Mat
- Mixed Dune
- Ornamental
- Silver Bush Lupine Scrub

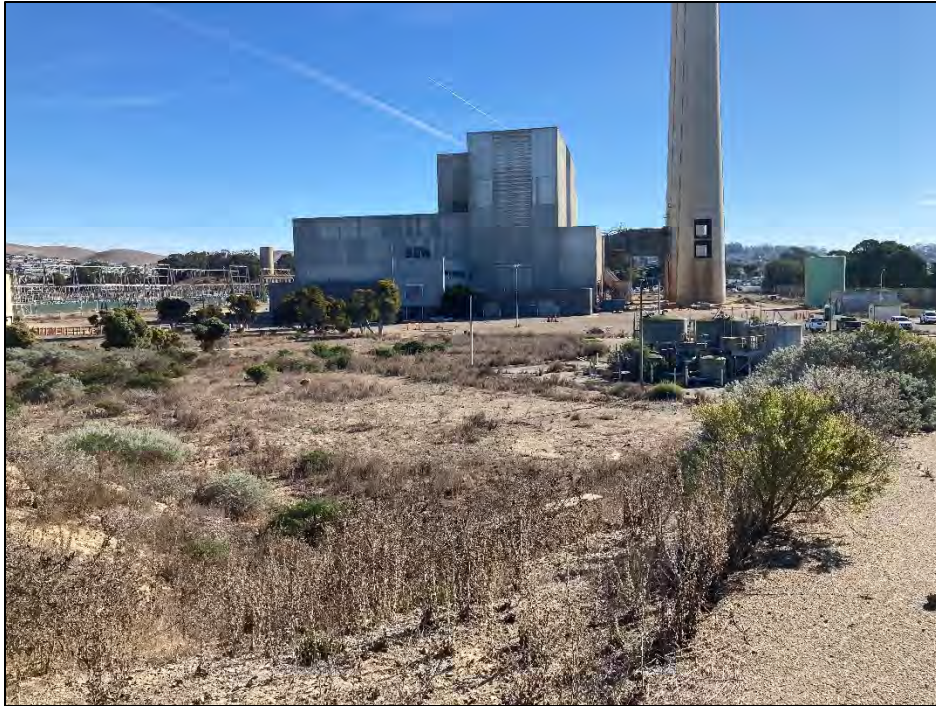
Photograph 1. Representative view of the Project Site conditions (aspect: southeast; December 16, 2020).

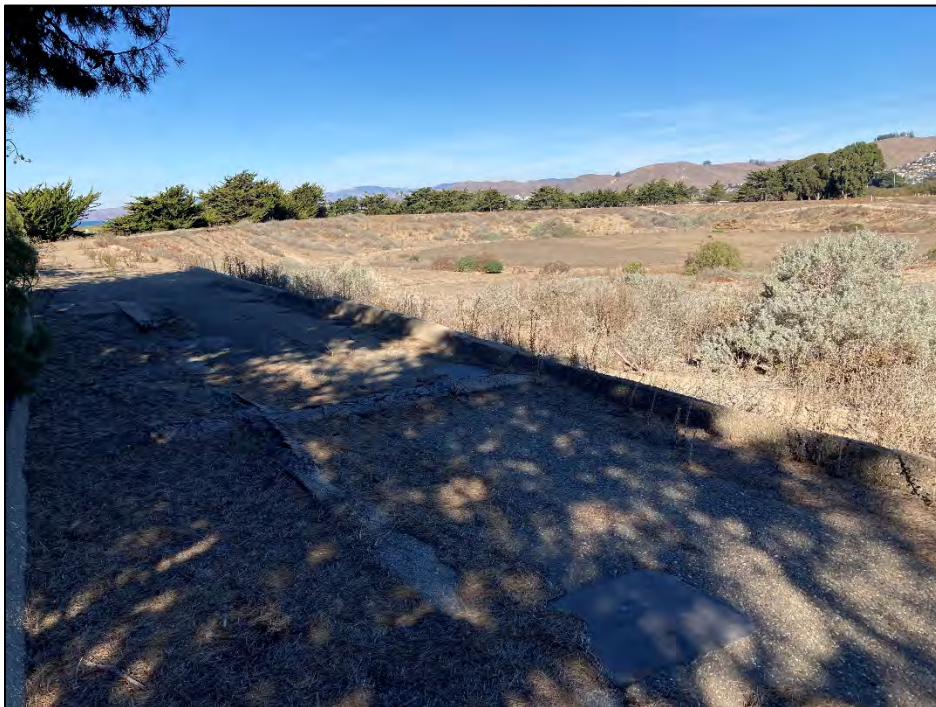
Photograph 2. Monterey pine and Monterey cypress adjacent to paved access roads and abandoned tank footprints (aspect: north; December 16, 2020).

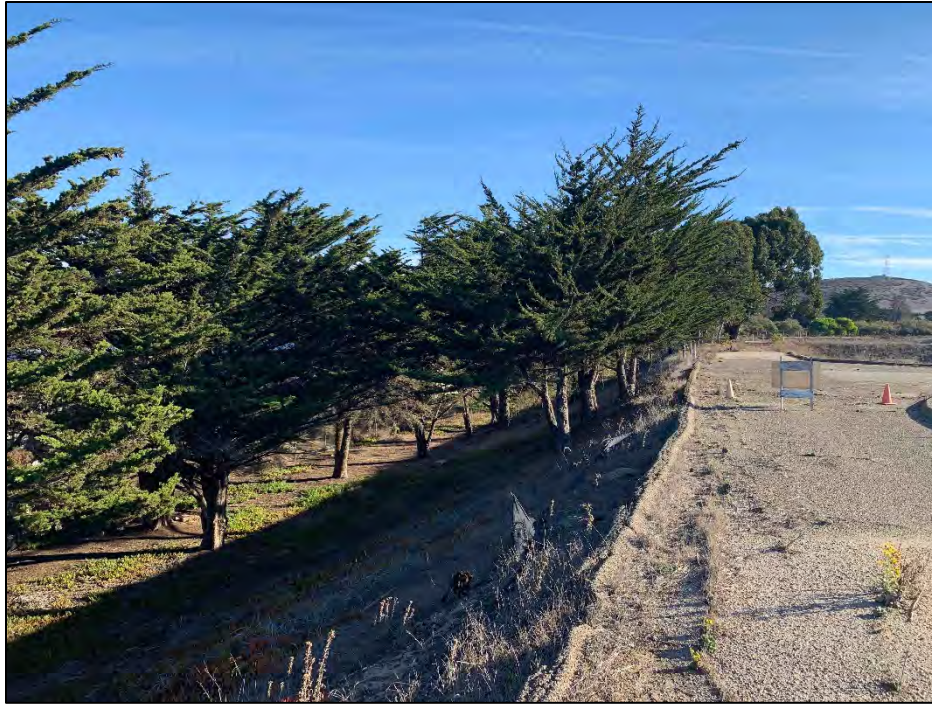
Photograph 3. Monterey cypress and paved access road in northern portion of the Project site (aspect: northeast; December 16, 2020).

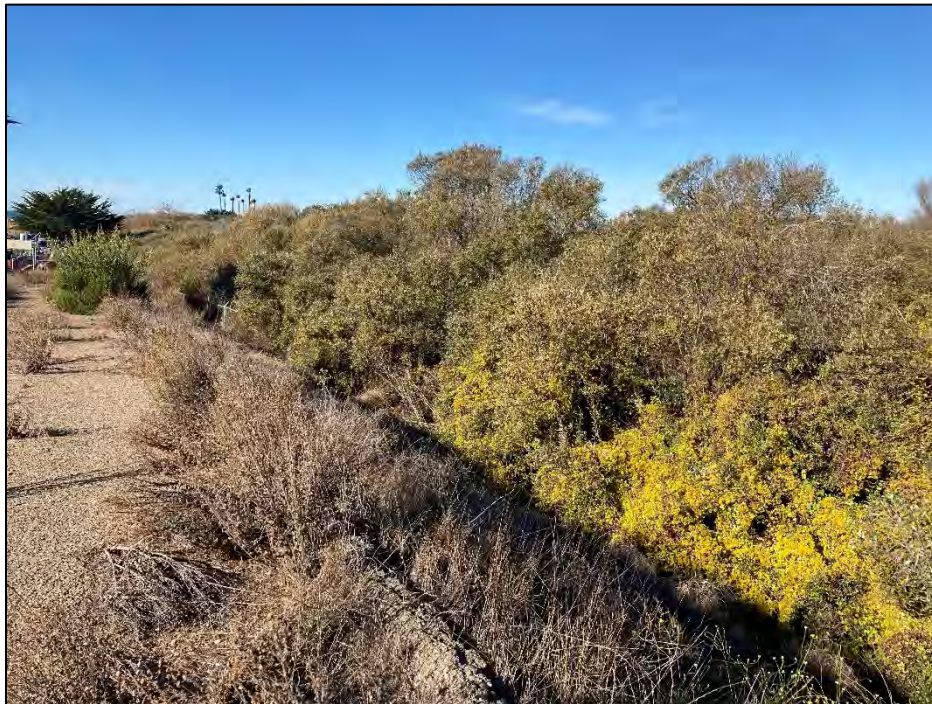
Photograph 4. Morro Creek with Arroyo willow thicket vegetation along the northern boundary of the Project site (aspect: northwest; December 16, 2020).

Arroyo willow thickets (*Salix lasiolepis* Shrubland Alliance) occurs along stream banks and benches, slope seeps, and stringers along drainages and is characterized by presence of arroyo willow as dominant or co-dominant within the shrub or tree canopy; canopy is open to continuous and the herbaceous layer is variable (Sawyer et al., 2009). As observed during the field survey, this alliance occurred along Morro Creek and Willow Camp Creek in the north and northeastern portion of the BSA. The quantitative vegetation assessment (Appendix D: data sheet MBPP003) identified native and non-native tree, shrub, and herbaceous species with arroyo willow as the dominant species. Component and intermittent species observed includes blackberry (*Rubus ursinus*), poison oak (*Toxicodendron diversilobum*), and Monterey cypress (*Hesperocyparis macrocarpa*). Arroyo willow thicket associated with riparian habitat is designated as ESHA by the City of Morro Bay.

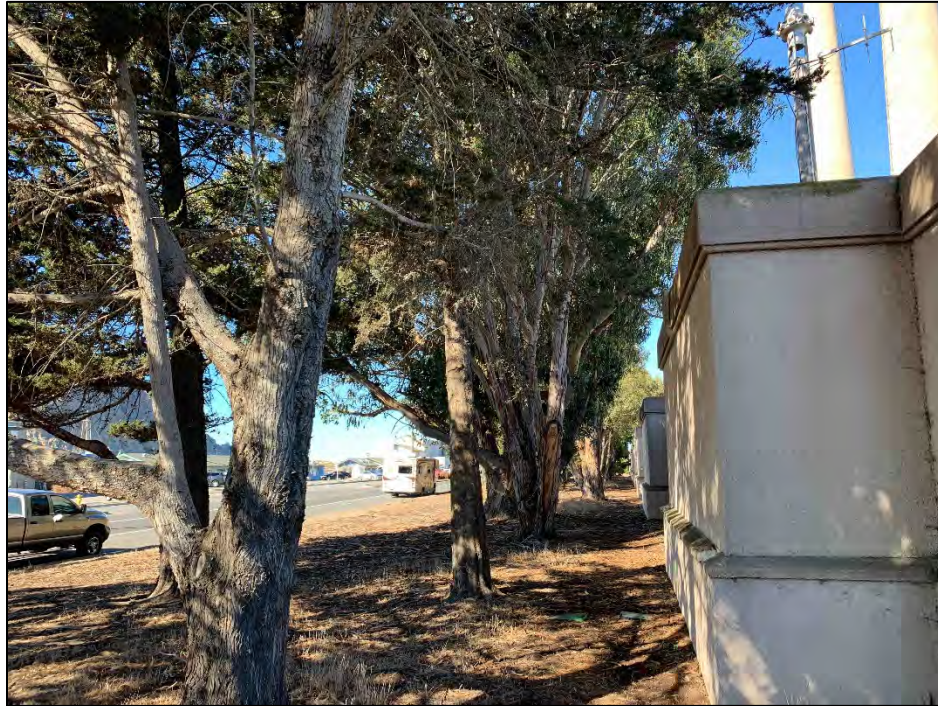
Photograph 5. Eucalyptus and Monterey cypress along Embarcadero Road and Project site boundary (aspect: northwest; December 16, 2020).

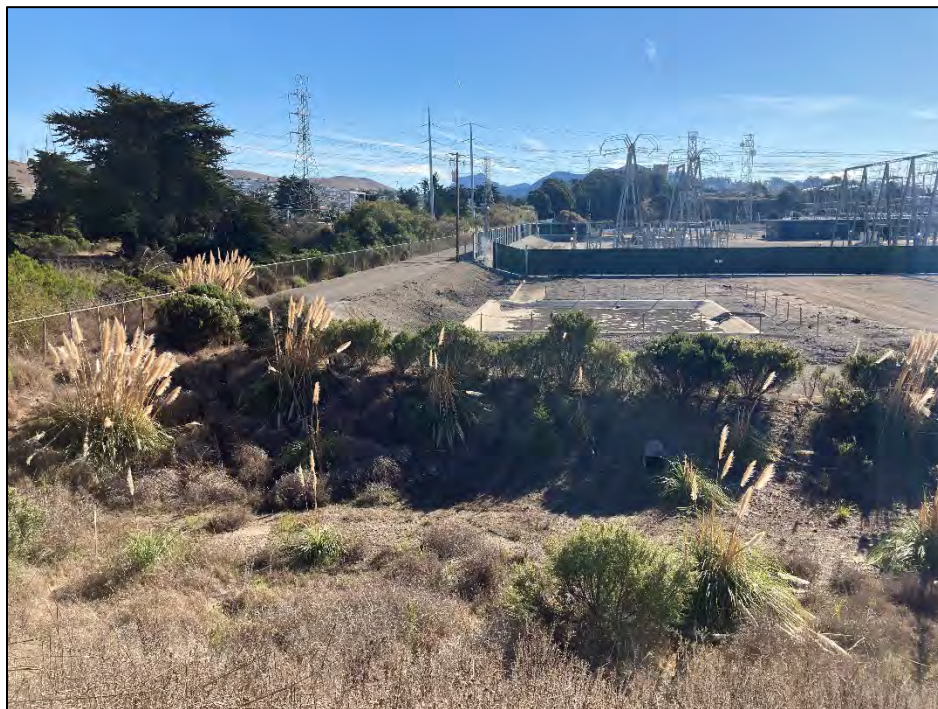
Photograph 6. Representative Ruderal vegetation and Developed areas within the Project site (aspect: southeast; December 16, 2020).

Within this Report, Ruderal/Developed habitat is a term used to describe those areas that have been disturbed by past land-use practices, recent ground disturbance or are currently developed. Ruderal/Developed habitat includes office facilities, paved and unpaved roads, industrial and commercial structures, and areas of vegetation along these features and within abandoned facilities. As observed during the December 2020 field survey, this vegetation type consisted primarily of remnant annual grasses, pampas grass (*Cortaderia jubata*), telegraph weed, ice plant, coyote brush, and scattered volunteer eucalyptus. Developed areas within the Ruderal/Developed habitat type generally do not support vegetative cover due to the presence of impervious surfaces.

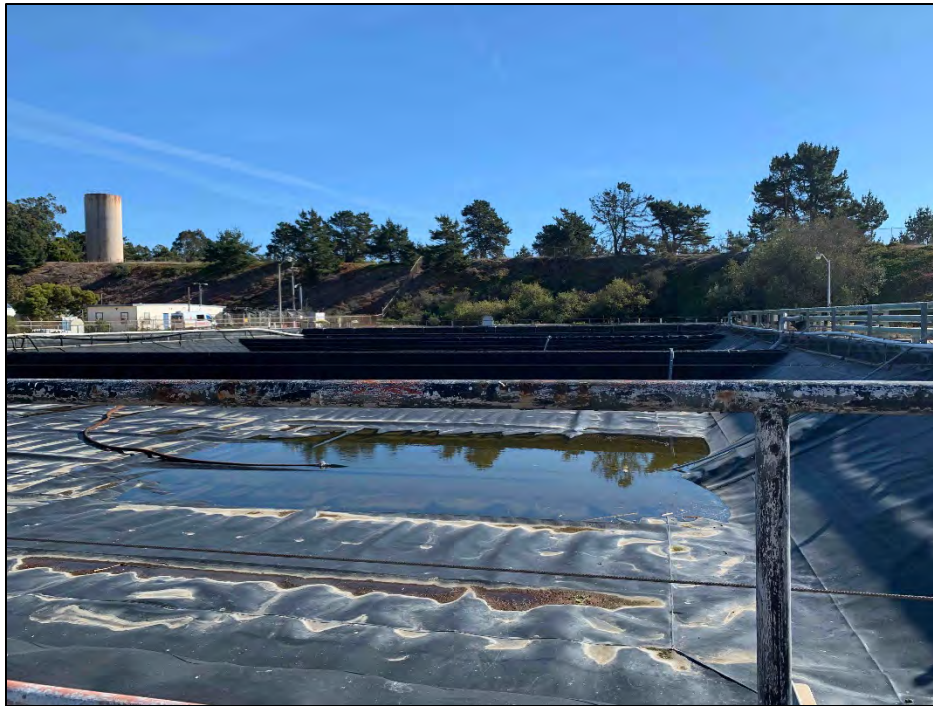
Photograph 7. Current MBPP infrastructure, ponded water visible (aspect: southeast; December 16, 2020).

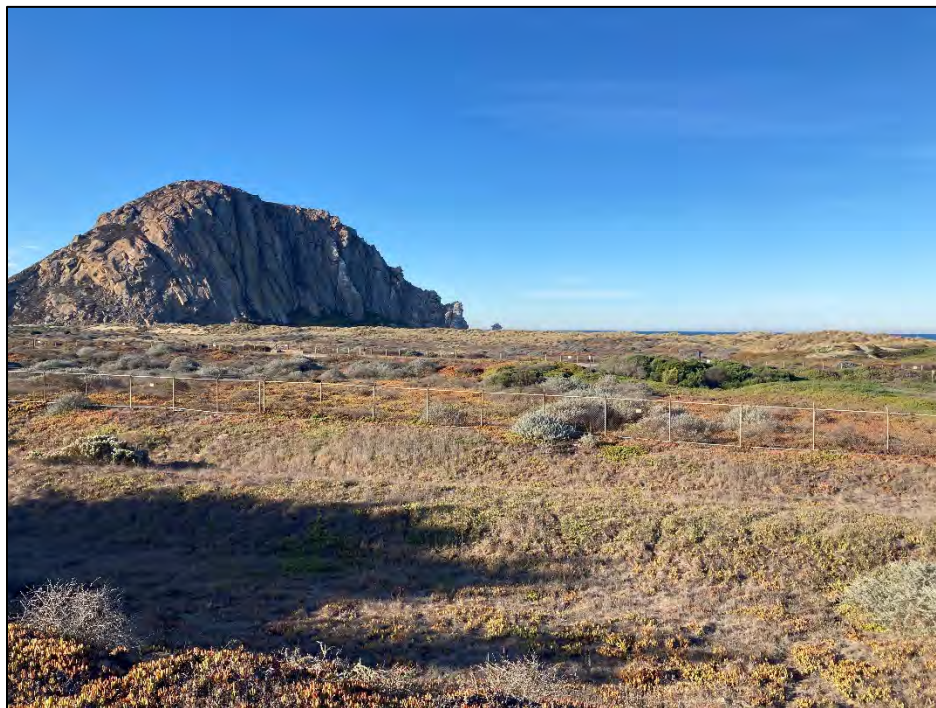
Photograph 8. Ruderal vegetation within the Project site (foreground) with Mixed dune outside of an existing fence and outside of Project site (aspect: west; December 16, 2020).

A distinct stand of vegetation comprised of an assemblage of upland coastal species was observed along the northwestern boundary of the BSA. This area has been the focus of past restoration efforts, and existing vegetation varies in degree of establishment. Past studies completed in this location designated this assemblage of vegetation as Mixed dune (Padre, 2015a). As observed during the December 2020 field survey, the composition of species within the Mixed dune vegetation species was similar to previously assessed conditions, and consisted of ice plant, beach bur (*Ambrosia chamissonis*), coyote brush, and remnant annual grasses (Appendix A – Site Photographs, Photo 8). This alliance (referred to as Central Dune Scrub) is considered sensitive by the CDFW and is designated as ESHA (referred to as Back Dune/Dune Scrub) by the City of Morro Bay. Impacts to Mixed dune may be considered significant under CEQA.

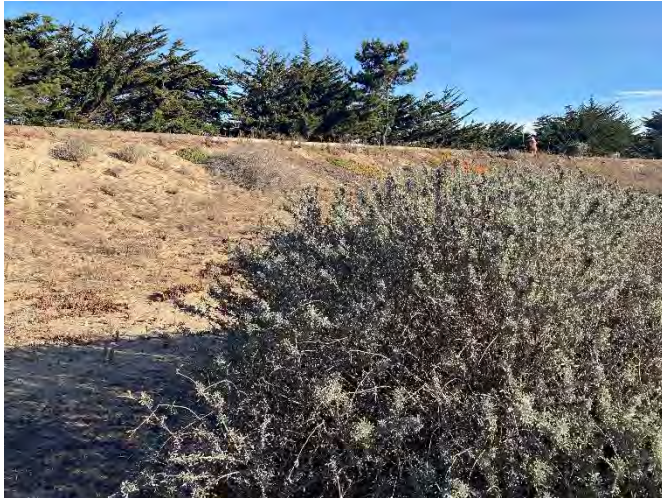
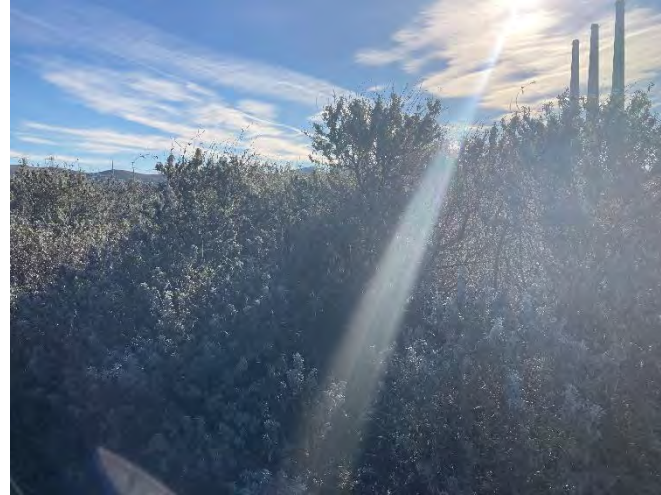
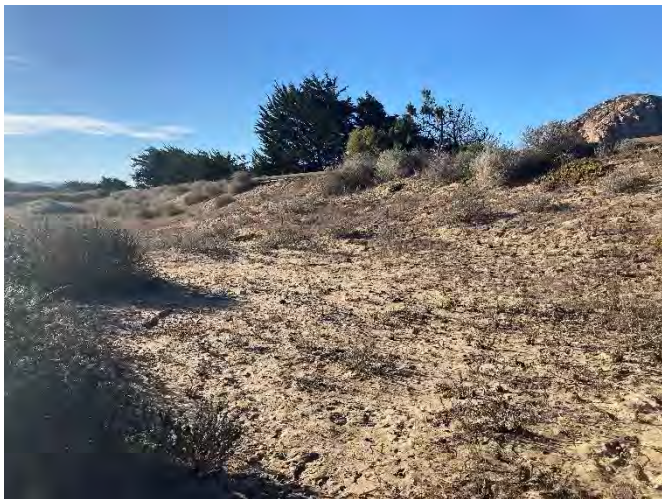
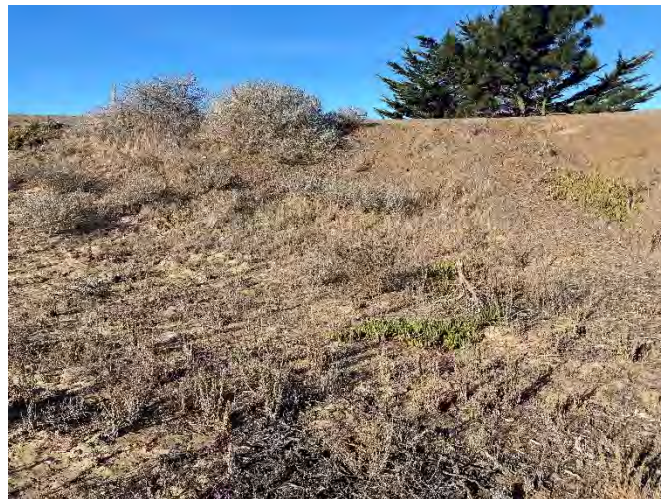
Project: 1902-1172 Biological Resources Assessment; MBPP BESS Project  
Vegetation Rapid Assessment Attachment  
Stand/Plot ID: **MBPP001**

Classification: Silver bush lupine scrub (MCV2)

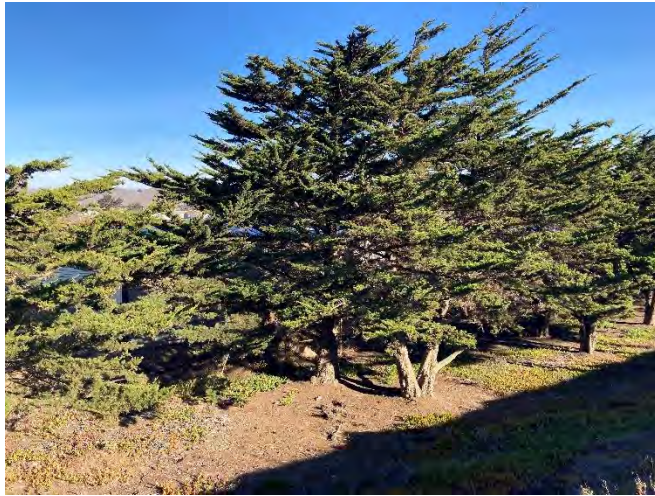
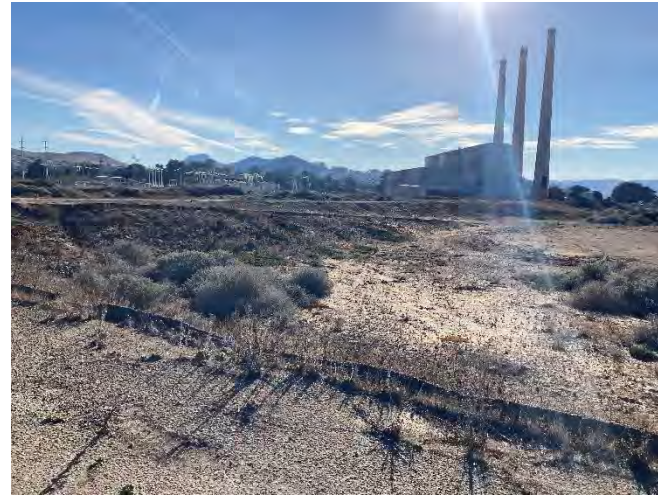
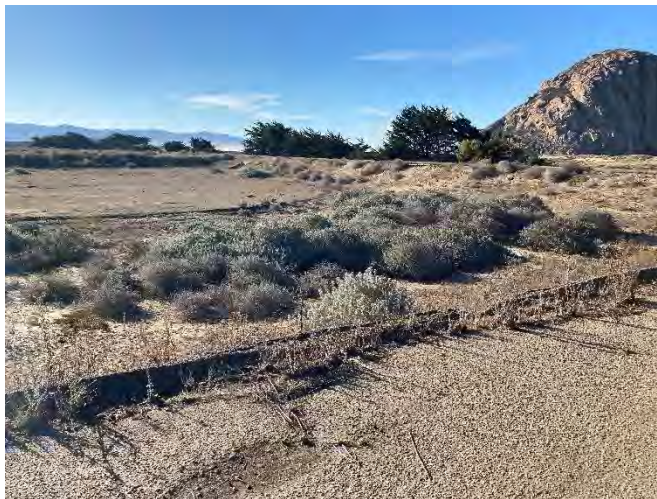
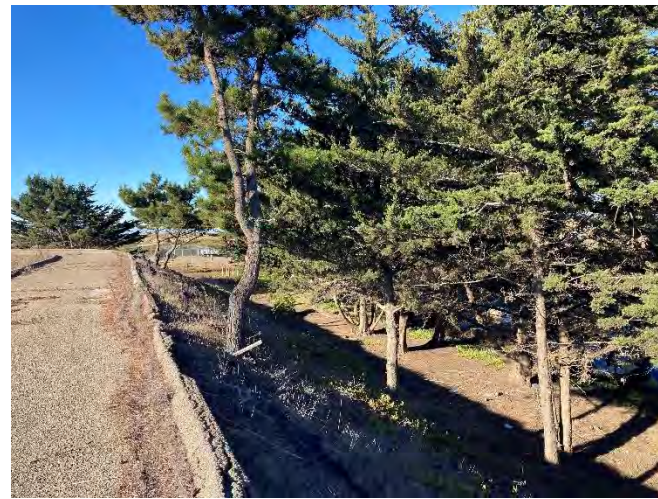
Project: 1902-1172 Biological Resources Assessment; MBPP BESS Project  
Vegetation Rapid Assessment Attachment  
Stand/Plot ID: **MBPP002**

Classification: Monterey cypress stand (Site-Specific; Ornamental)

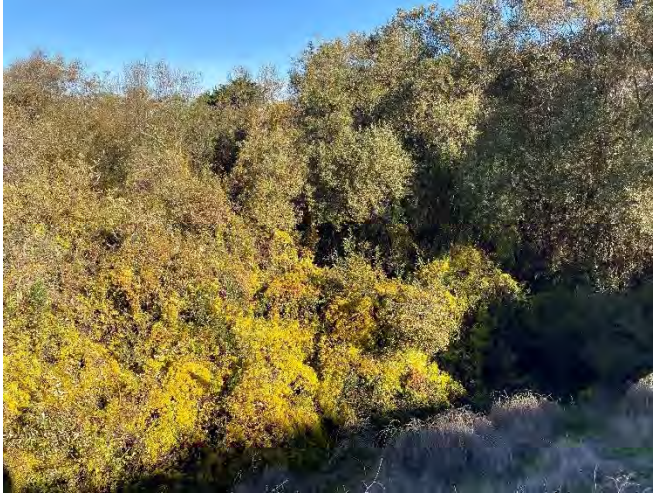
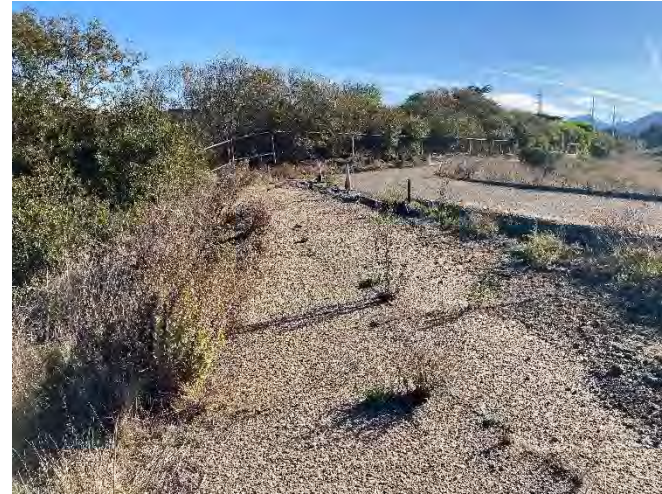
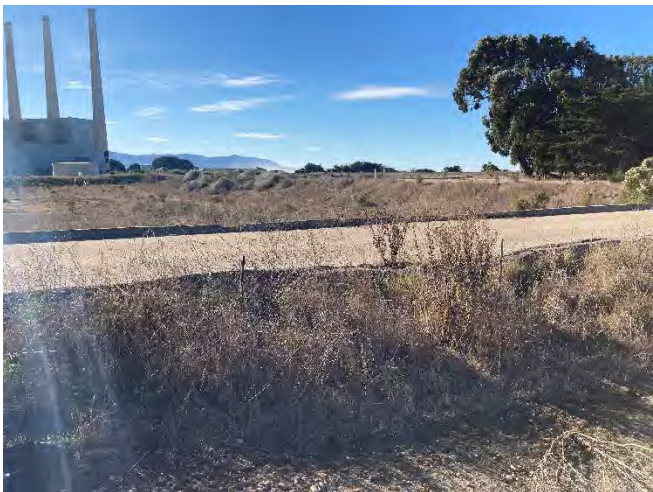
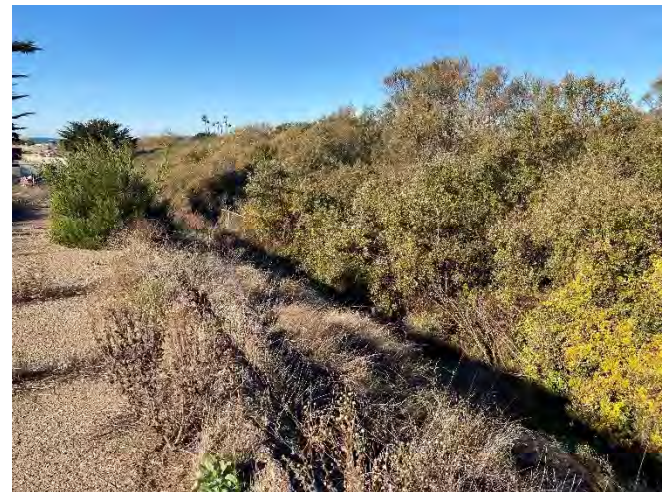
Project: 1902-1172 Biological Resources Assessment; MBPP BESS Project  
Vegetation Rapid Assessment Attachment  
Stand/Plot ID: **MBPP003**

Classification: Arroyo willow thickets (MCV2)

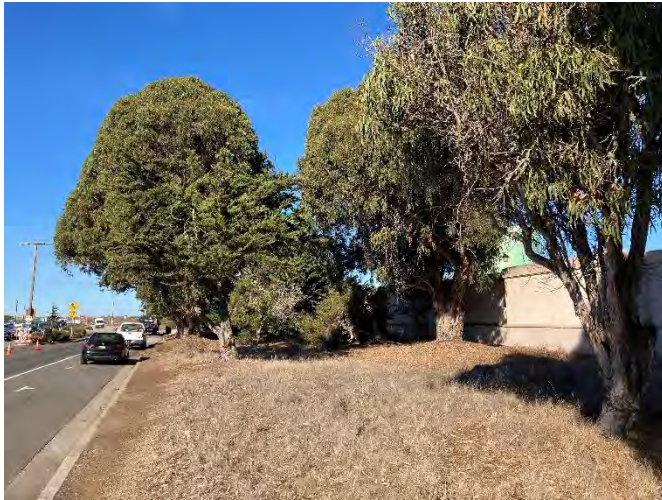
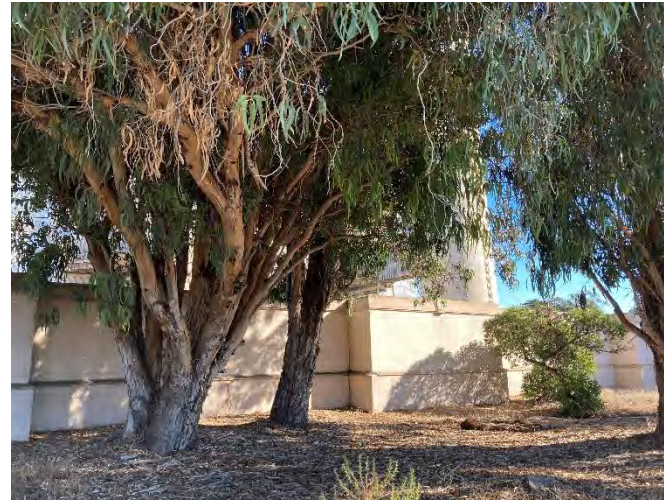
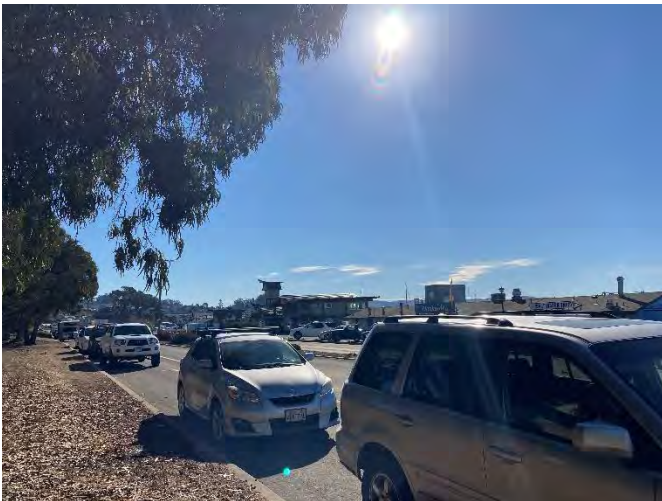
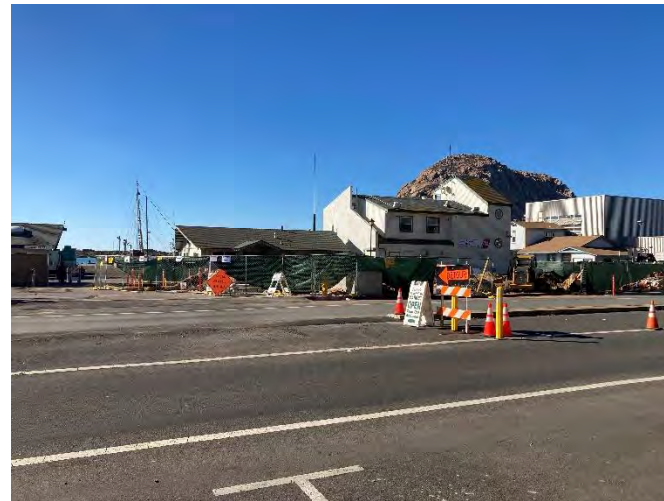
Project: 1902-1172 Biological Resources Assessment; MBPP BESS Project  
Vegetation Rapid Assessment Attachment  
Stand/Plot ID: **MBPP004**

Classification: Eucalyptus groves (Site-Specific; Ornamental)

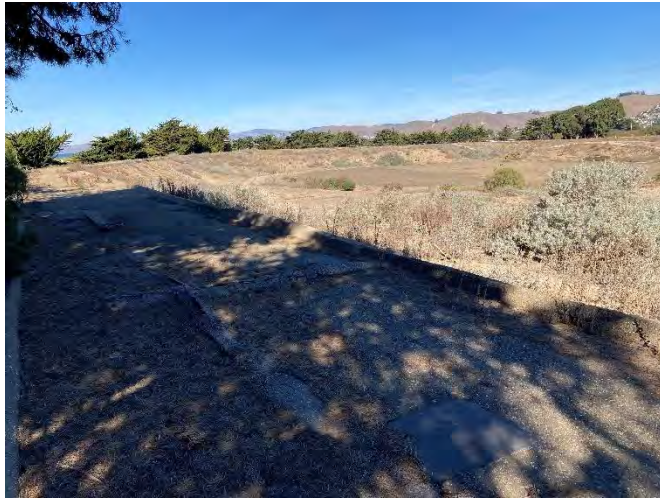
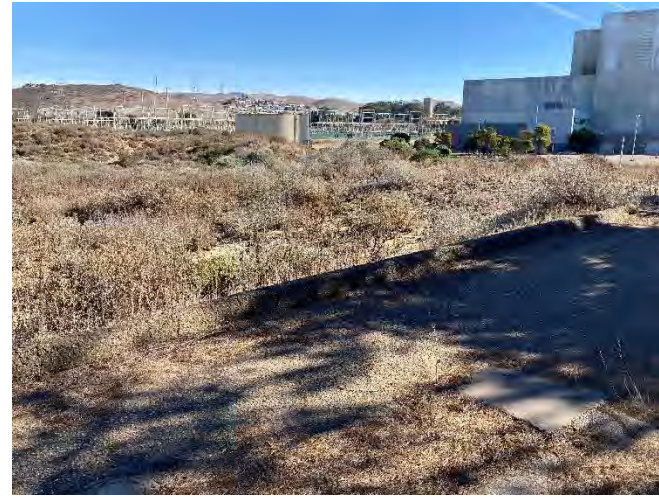
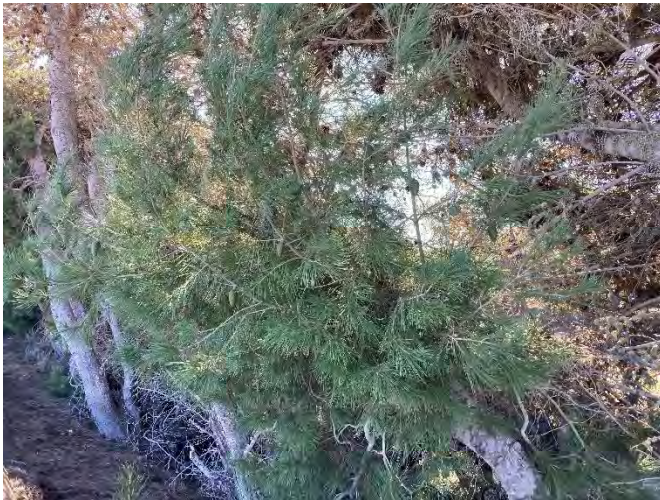
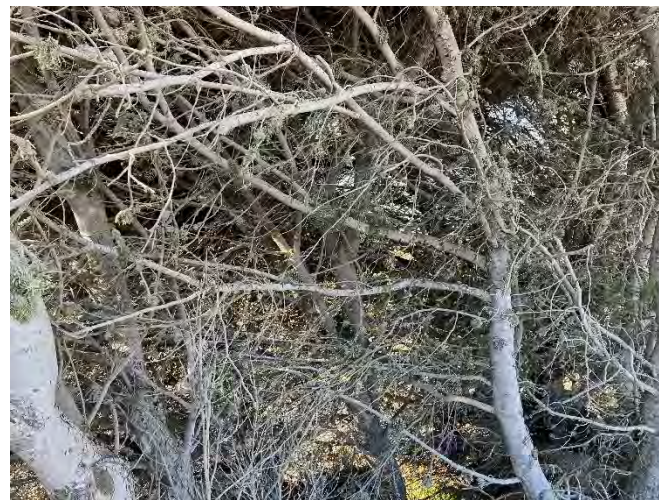
Project: 1902-1172 Biological Resources Assessment; MBPP BESS Project  
Vegetation Rapid Assessment Attachment  
Stand/Plot ID: **MBPP005**

Classification: Monterey pine stand (Site-Specific; Ornamental)
