# **BIOLOGICAL RESOURCE ASSESSMENT REPORT**

## **MORRO BAY POWER COMPANY, LLC BATTERY ENERGY STORAGE SYSTEM CITY OF MORRO BAY, CALIFORNIA**

**Project No. 1902-1172**

**FEBRUARY 2021**

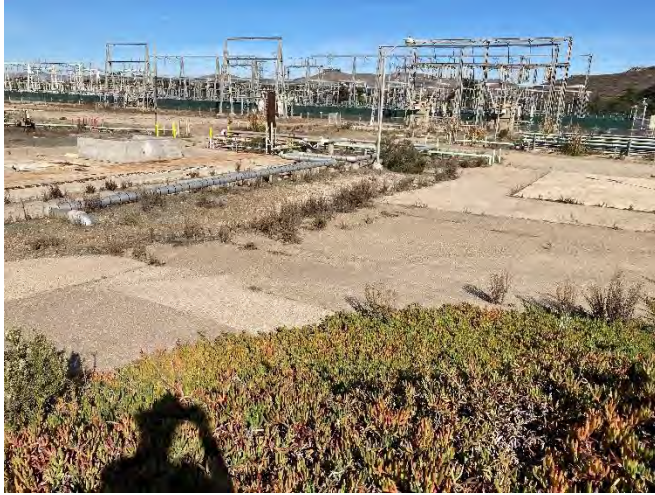
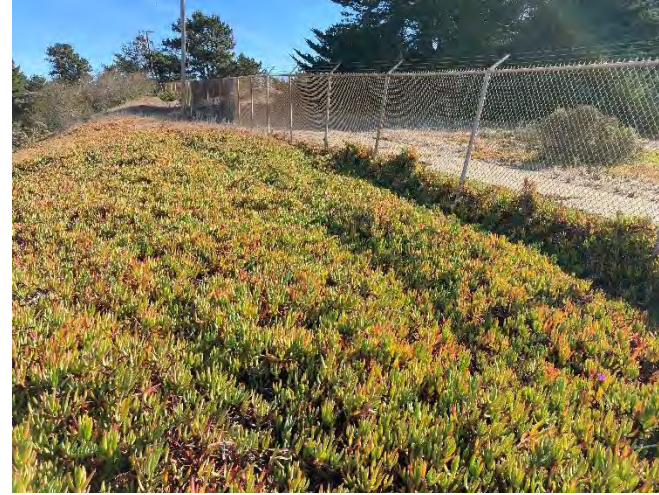
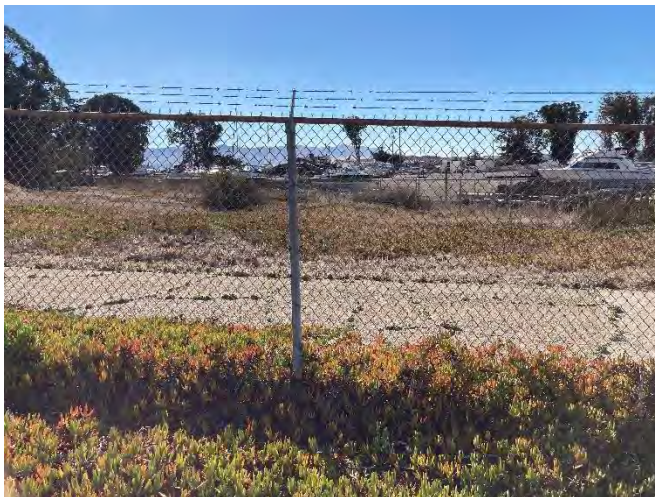
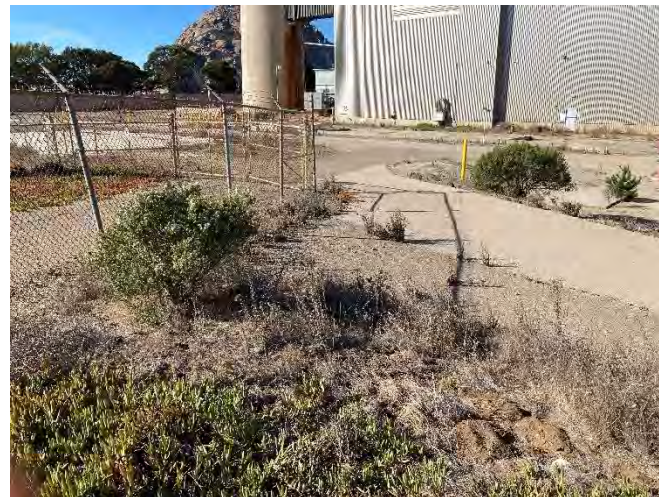
Project: 1902-1172 Biological Resources Assessment; MBPP BESS Project  
Vegetation Rapid Assessment Attachment  
Stand/Plot ID: **MBPP006**

Classification: Ice plant mats (MCV2)
