**SITE ASSESSMENT REPORT
and
REQUEST FOR SITE CLOSURE**

Former Estero Bay Defense Fuel Supply Point
3300 Panorama Drive
Morro Bay, California

Site I.D. No. T10000014042

March 31, 2022

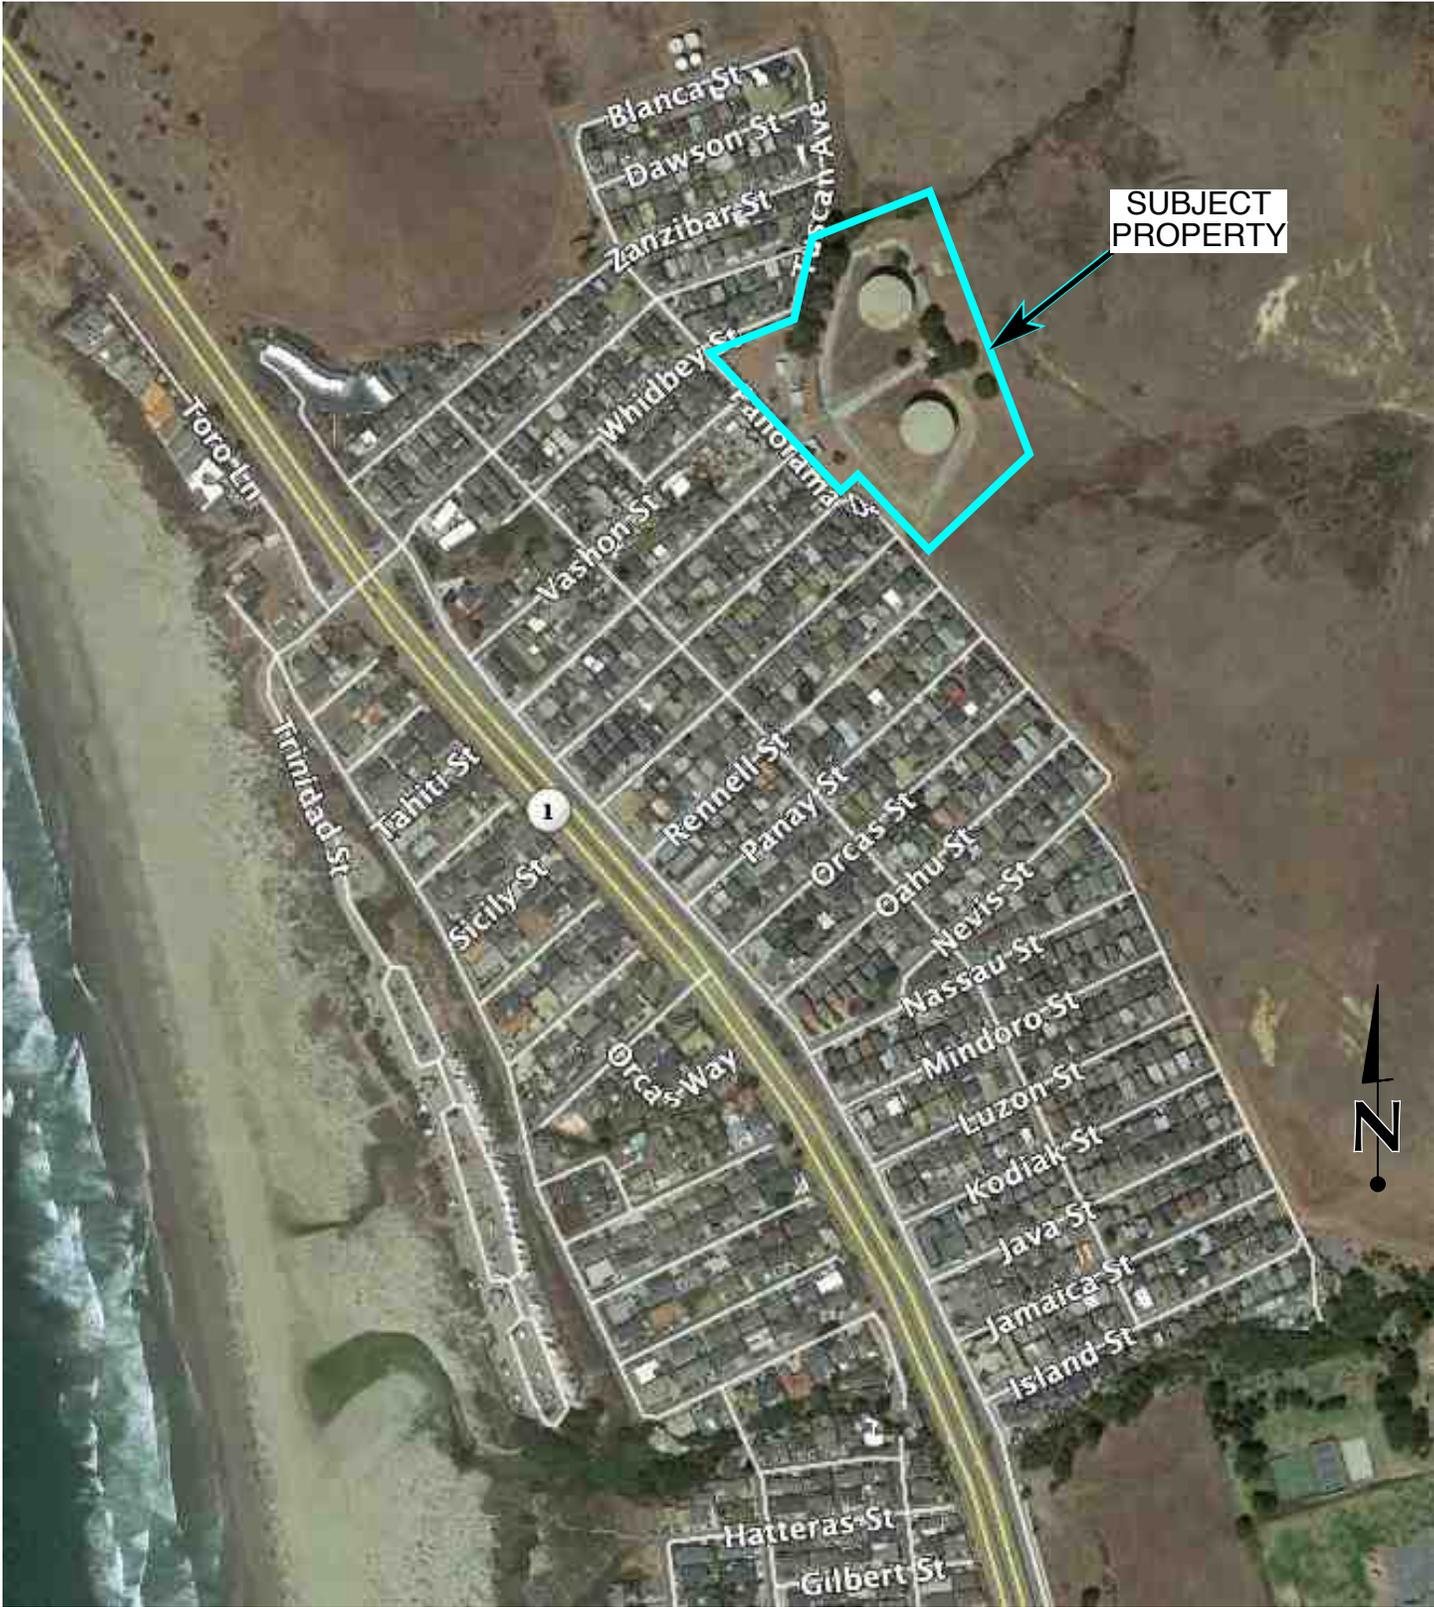
Figure 3: Lead Sampling Map

The tanks, piping, and buildings at the site were potential sources for lead contamination in surface soil due to deterioration of lead paint. Lead is present in surface soil throughout the site, but the areas of highest lead concentration are around the tank pad areas.

Lead concentrations in the surface soil slightly exceeded the California screening level for residential soil in 5 of the 48 samples. The maximum concentration of lead found was 230 ppm. The average lead concentration on the site is below the California DTSC residential screening level and below the federal EPA residential soil screening level for play areas. The elevated lead concentrations in the surface soil are due to the lead based paint historically present on the AGT, piping system, and support buildings. Lead concentrations in surface soil are summarized in **Table 6**.

Surface soils in the flat areas of the site (the tank impoundments and the areas around the buildings on the west side of the site) contain low-level lead impacts from lead-based paint on the AGT system and buildings. Although average lead concentrations are below the DTSC screening level, surface soil lead concentrations should be as low as feasibly attainable. We recommend that the Soil Management Plan for grading include a plan for moving the surface soil (to a depth of 6-12 inches) from these areas to locations where it will be beneath roadways, building slabs or other hardscape. Lead testing of surface soil in the exposed yard areas of residential lots, school sites, parks, and playgrounds is recommended after final grading.

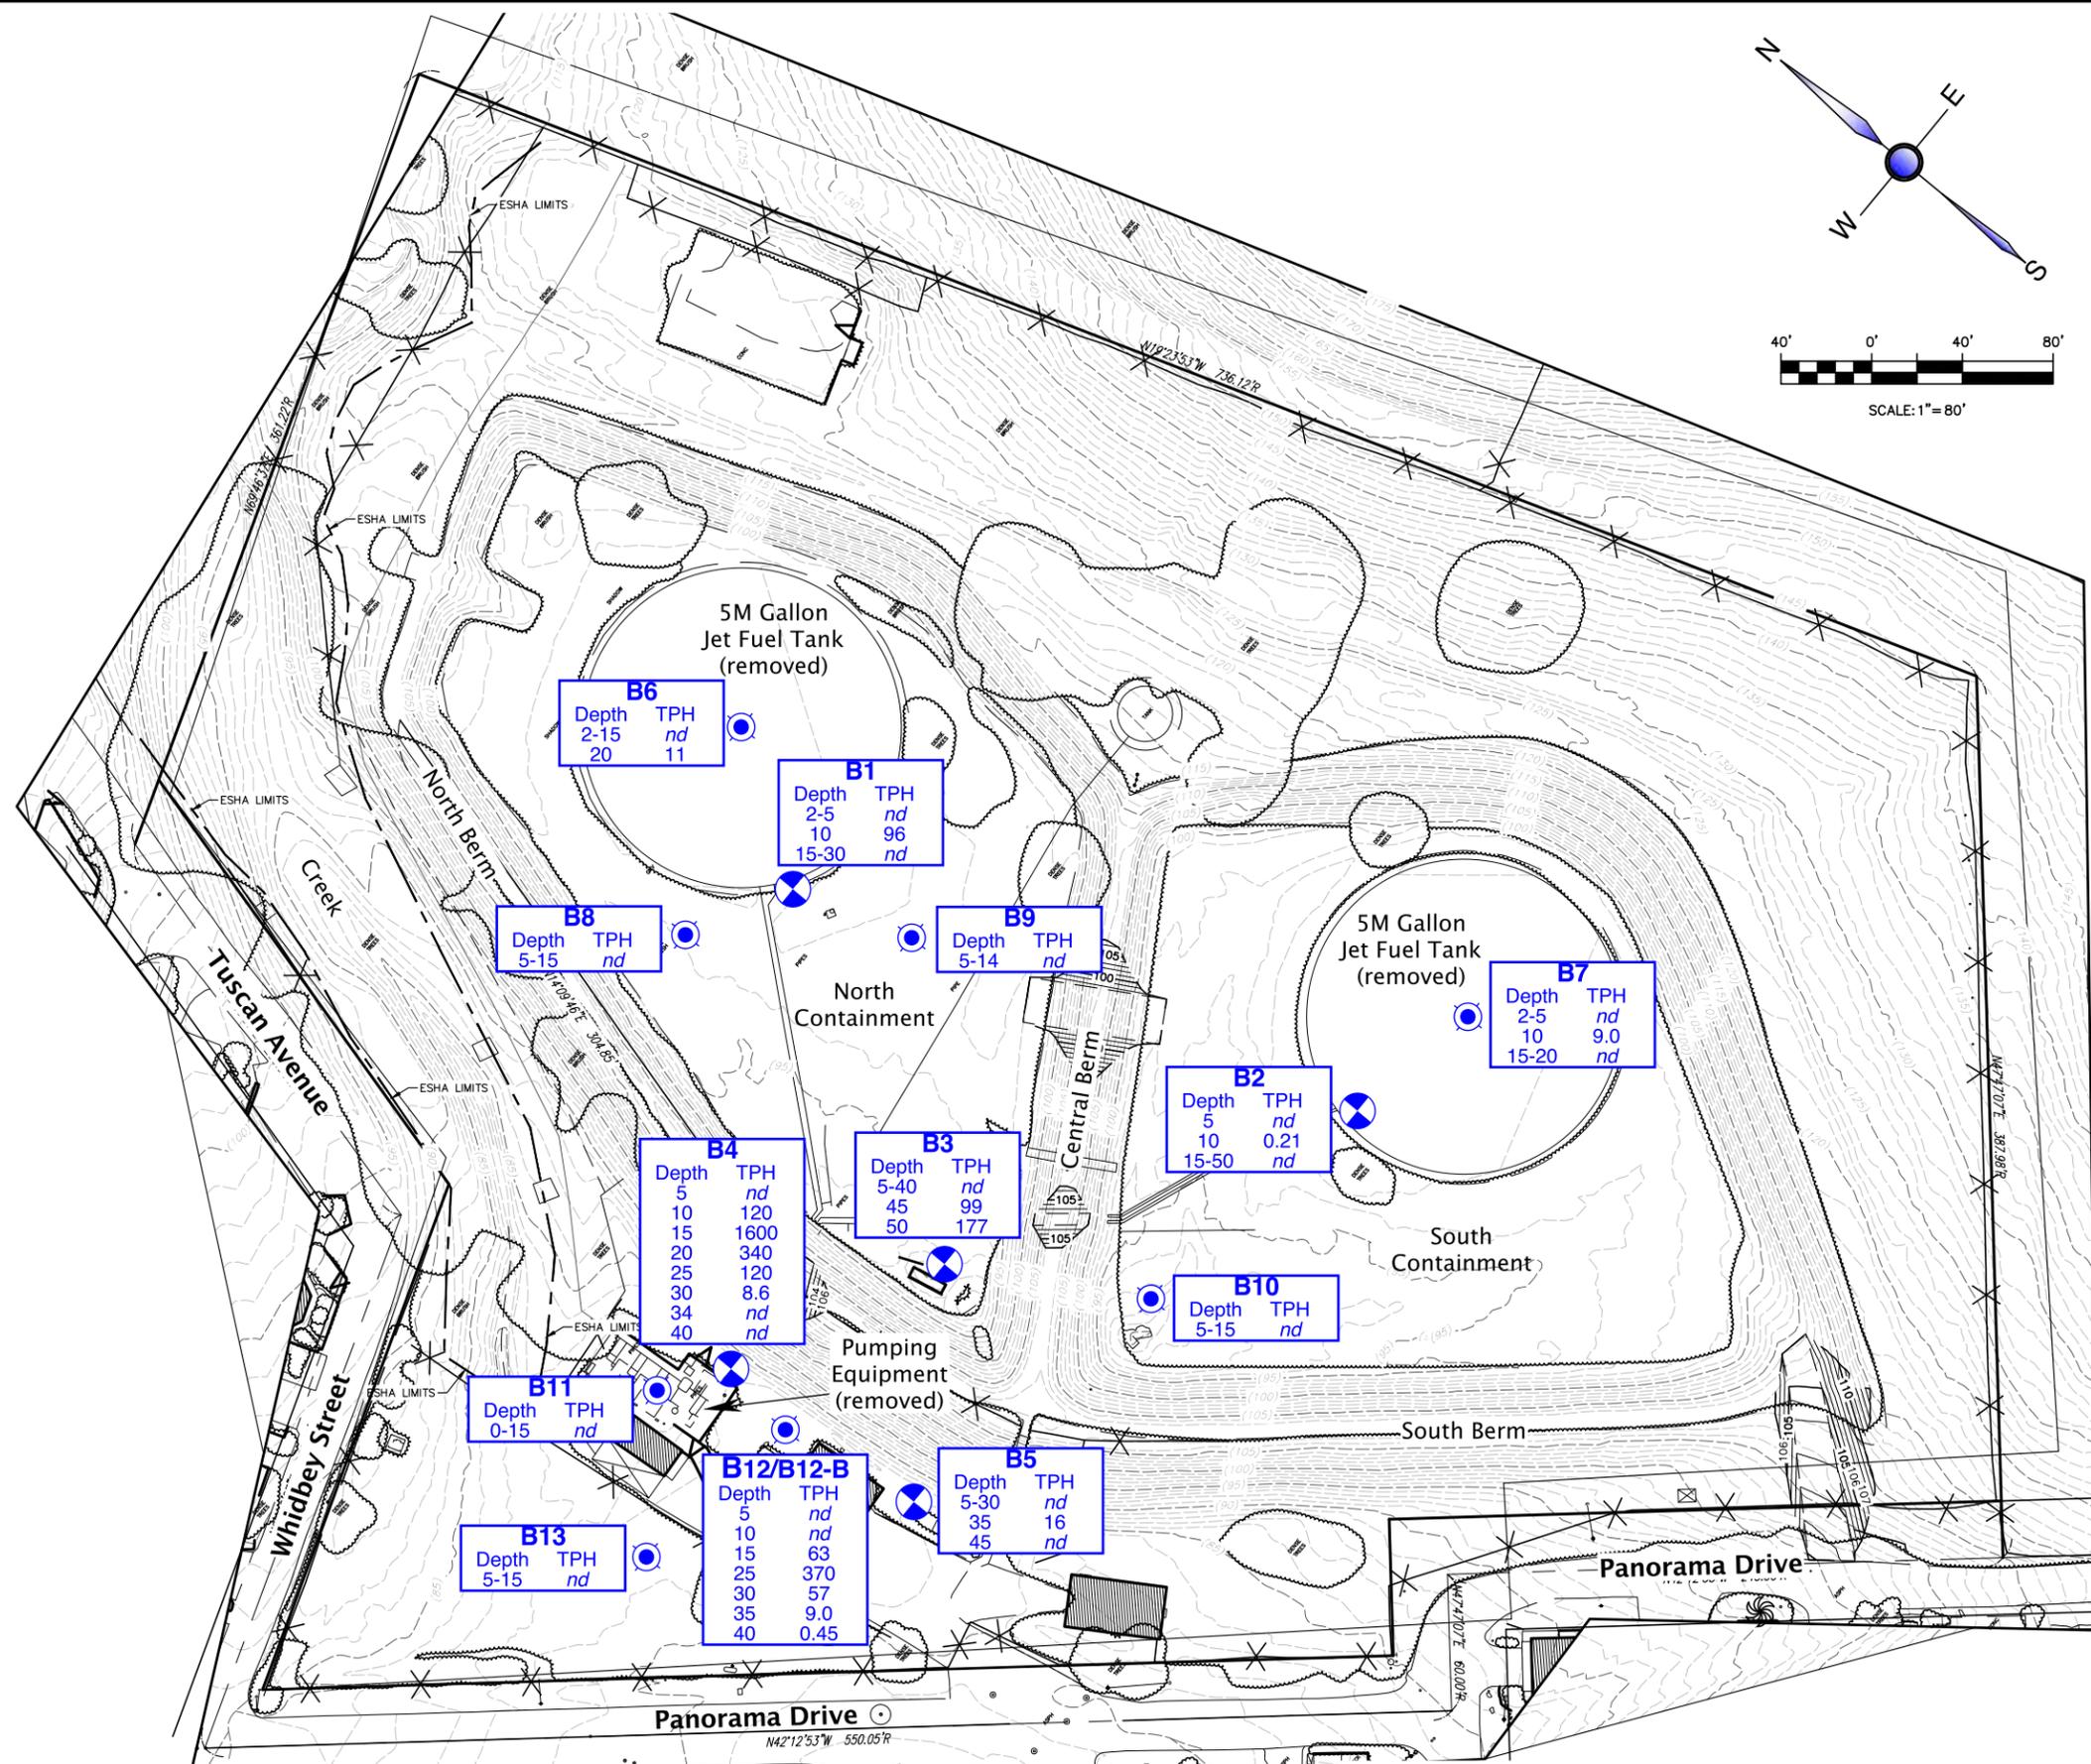
Figure
1

Subsurface soil sampling was conducted on November 23-25, 2020. Six hollow-stem-auger (HSA) borings and eight direct-push (DP) borings were drilled and sampled. Borings were located to re-assess previously discovered areas of petroleum impacts and assess potential release locations not previously investigated. Borings B1, B2, B6, B7, B8, and B9 were located to assess possible releases from the tanks and piping within the tank containment areas. Boring B3 was located to assess the north stormwater sump and wastewater clarifier. Boring B10 was located to assess the south stormwater sump. Boring B4 was located to assess the jet fuel piping manifold sump. Boring B11 was located to assess the pumping equipment containment. Borings B5 and B12/12B were located to assess a drainage swale leading from the pumping equipment area. Boring B13 was located to assess the jet fuel intake pipeline.

The borings were logged by the undersigned Professional Geologist. The boring logs are attached in **Appendix I**. The boring locations are shown on **Figure 1: Soil Boring Location Map**.

B5	
Depth	TPH
5-30	nd
35	16
45	nd

B13	
Depth	TPH
5-15	nd

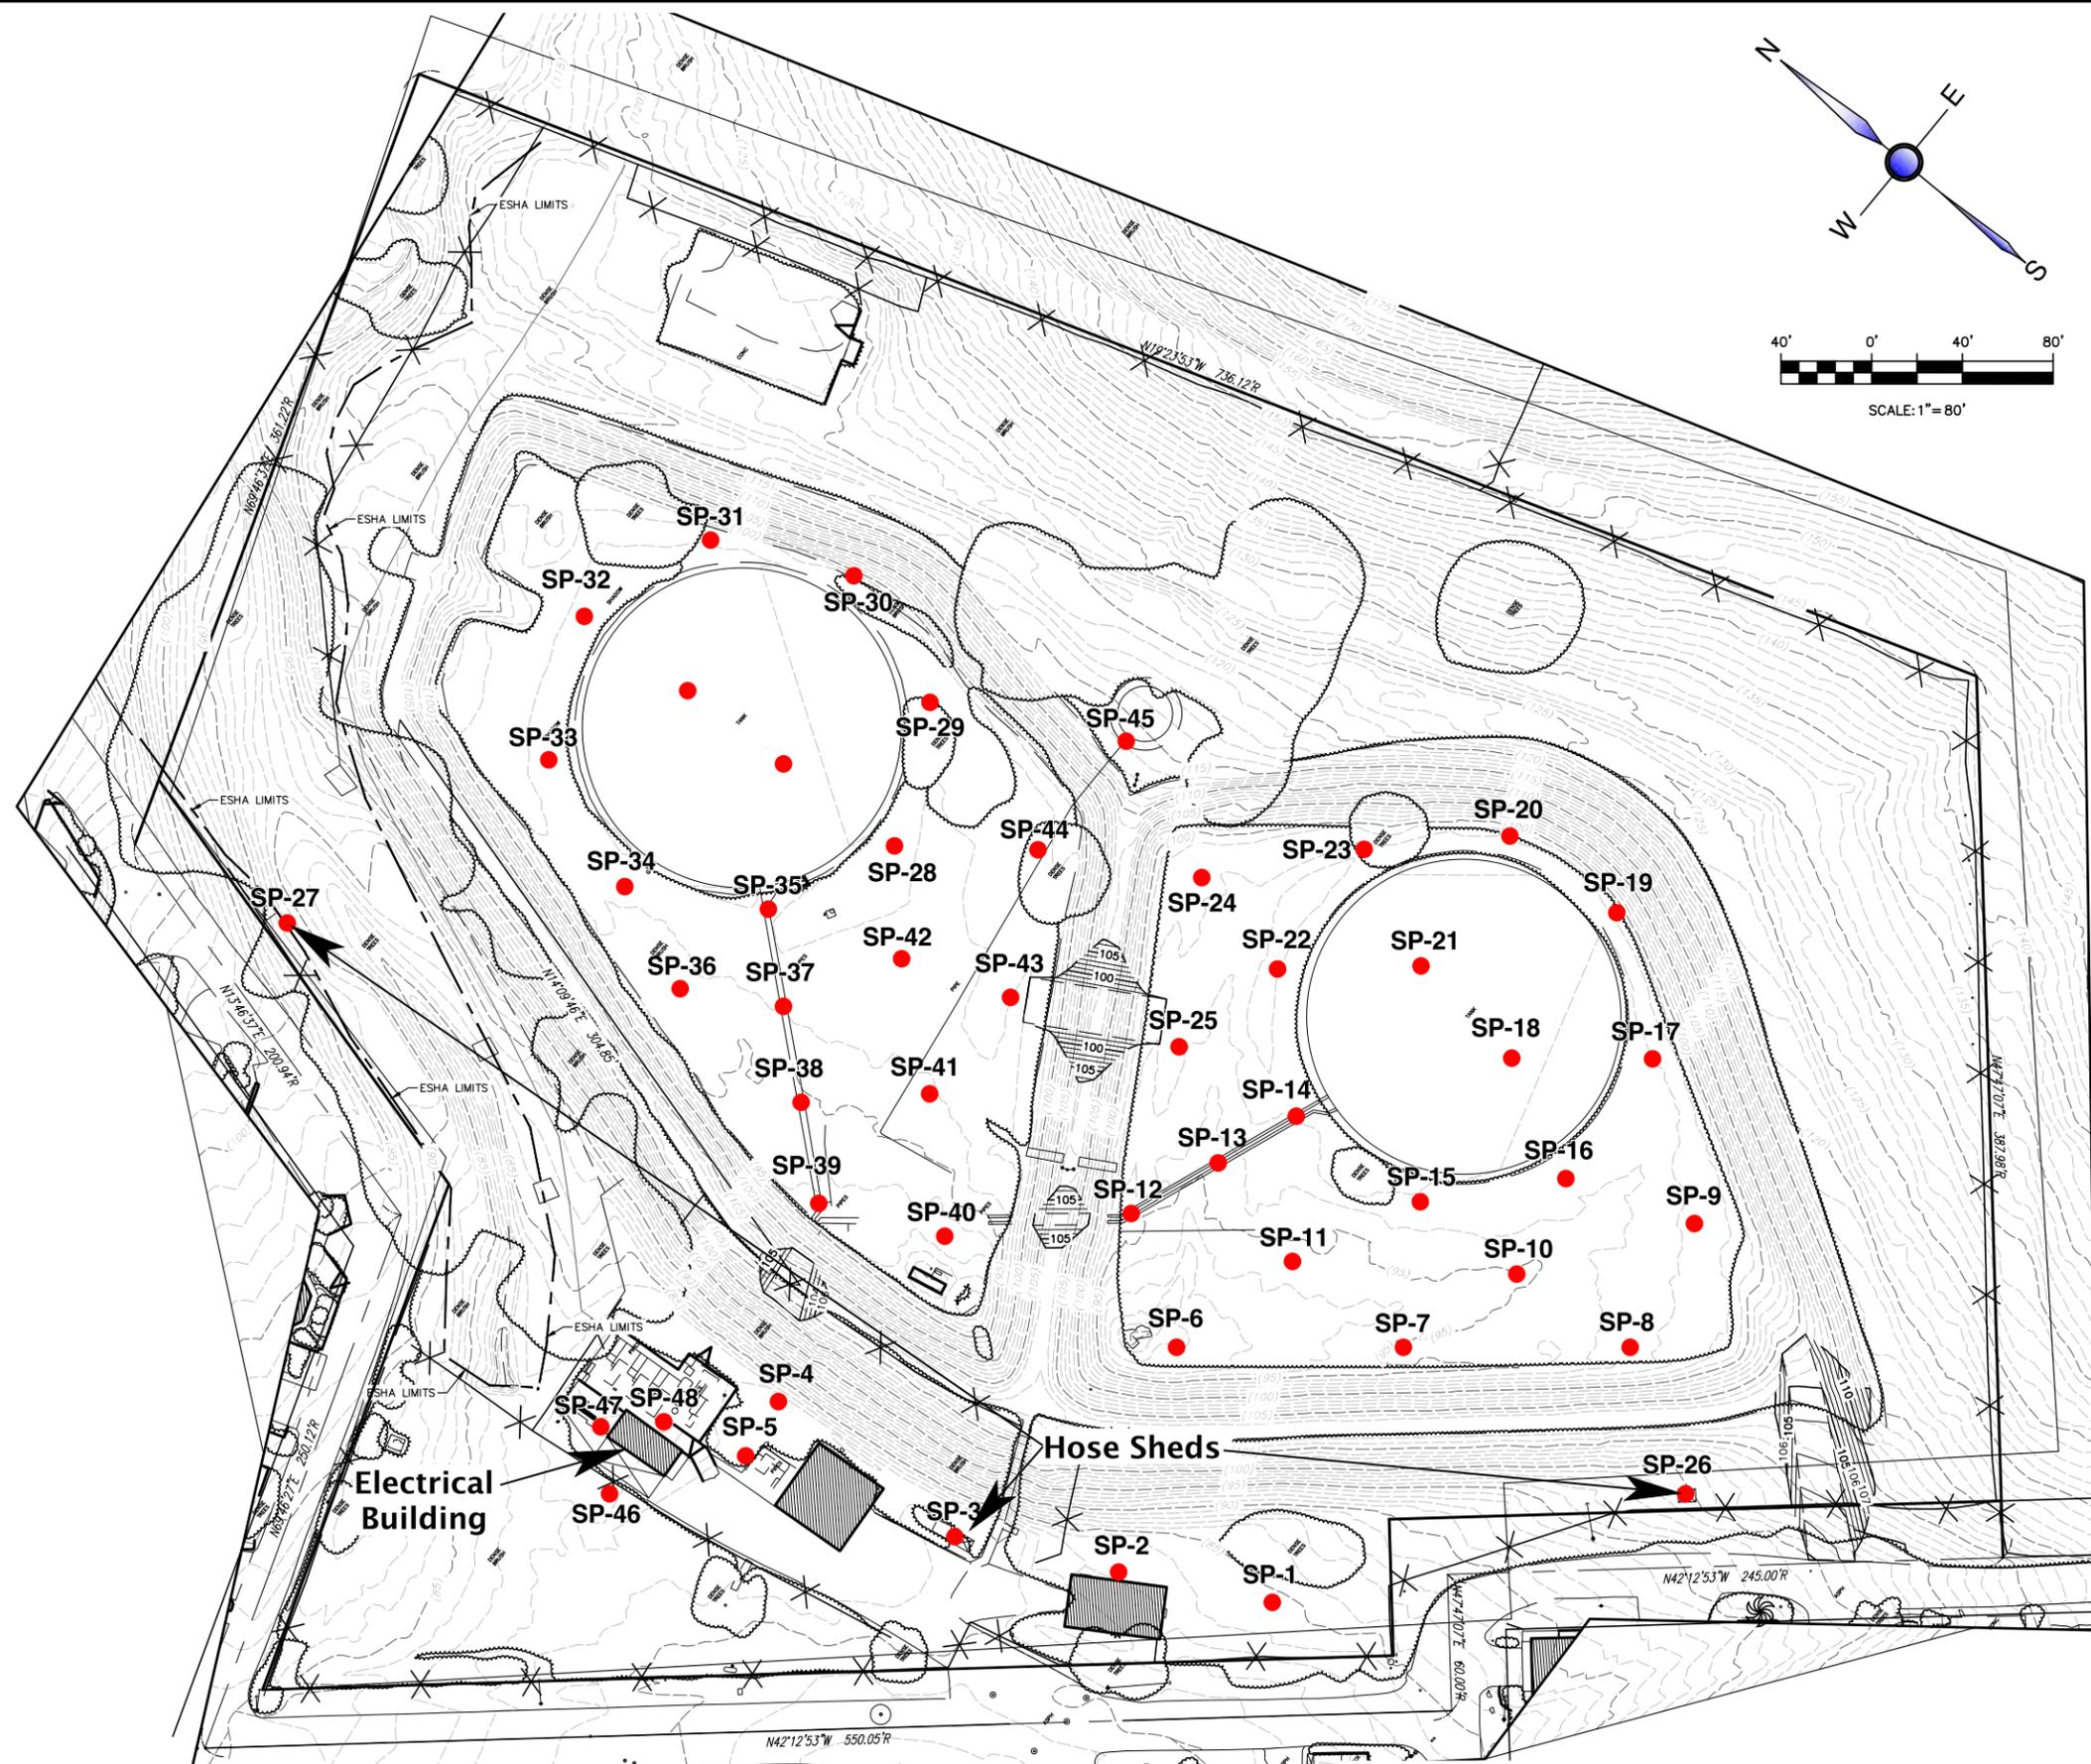
- Location of composite surface soil samples
