# ARBORIST REPORT

## 3300 PANORAMA

Location:  
3300 Panorama Drive  
Morro Bay, CA 93442

Revised:  
June 5, 2023

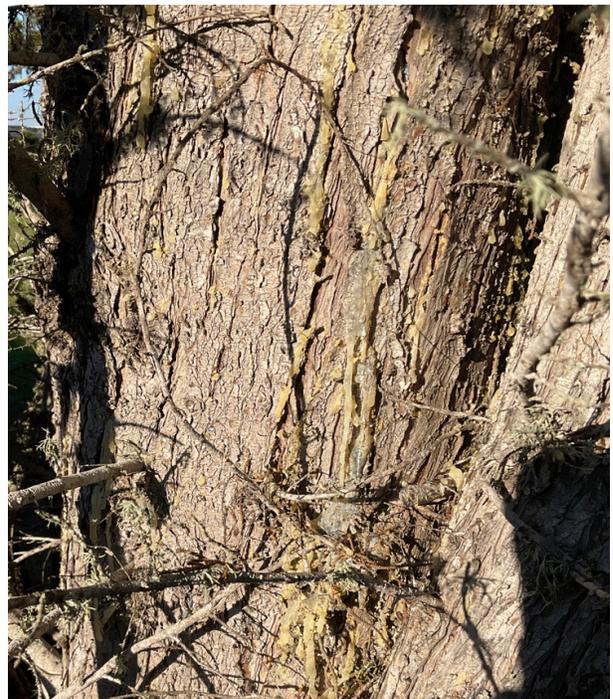
Photo of sap flows from tree 814, typical of most Monterey cypress onsite. Trees exude sap to trap and remove boring insects from the cambium.
