## INFILTRATION TESTING REPORT – Revision #1

**PROJECT NUMBER:**  
SL09618-6

**PROJECT NAME:**  
3300 Panorama Drive  
APN: 065-038-001  
Morro Bay, California

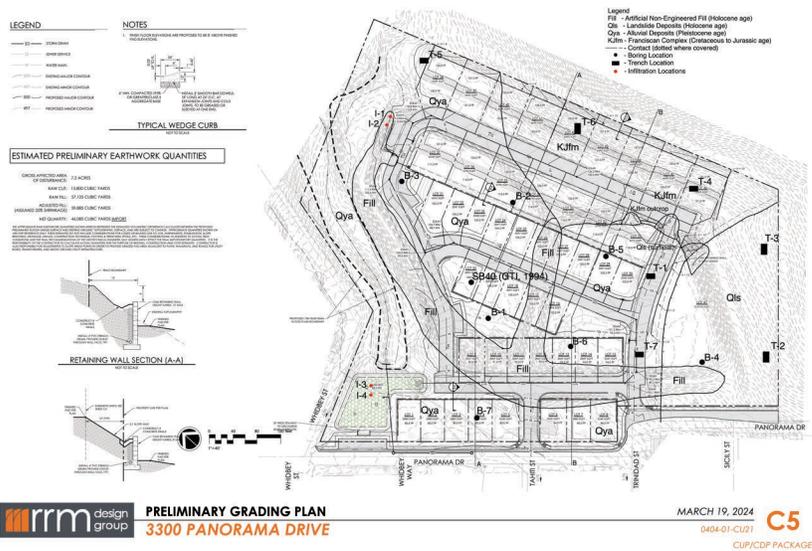
Figure 2: Infiltration Test Locations

Four, six-inch diameter infiltration test borings were drilled on January 28, 2022 to a maximum depth of 8 feet below ground surface (bgs) at the approximate locations indicated on Figure 2: Infiltration Test Locations. Three-inch diameter perforated PVC pipe was placed in the infiltration test borings and annular space was filled with clean pea gravel. Groundwater and/or impermeable strata were not encountered in any of the infiltration test borings.

Date	Test Location	Depth (ft)	Infiltration Rate (inches/hour)
February 23, 2022	I-1	8	0.12
	I-2	8	0.12
	I-3	8	0.60
	I-4	8	0.72

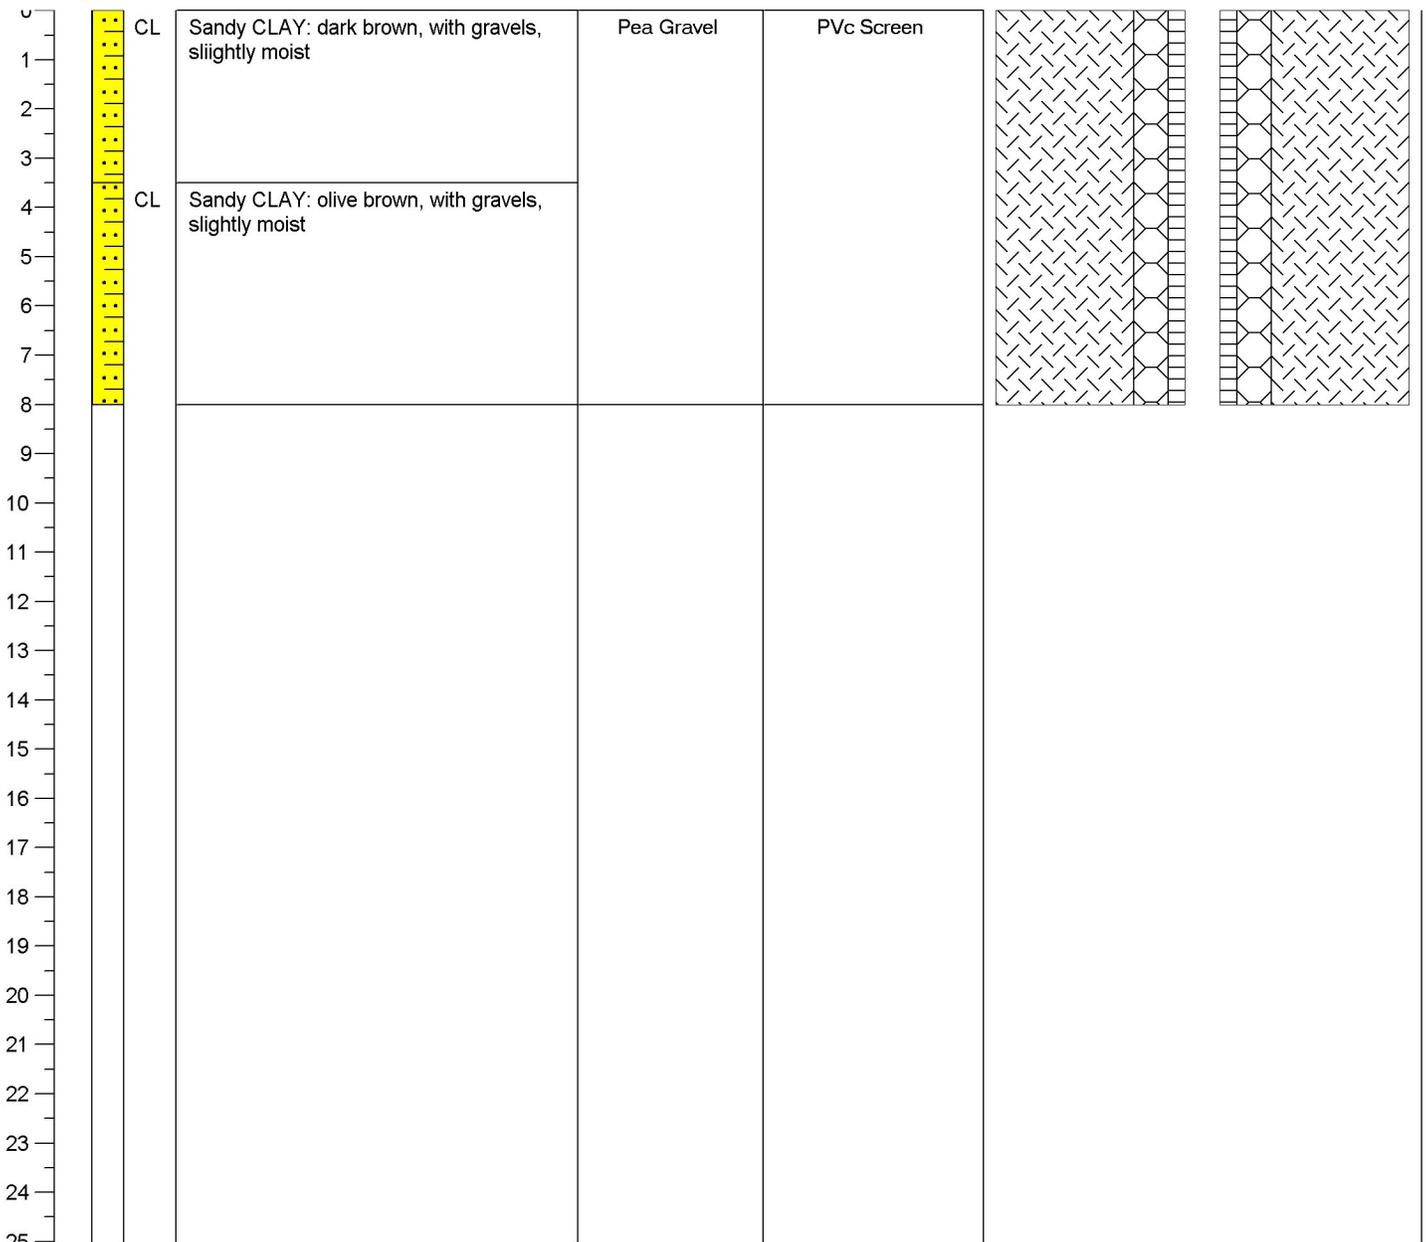
**BORING NO. I-1**  
**JOB NO. SL09618-4**

PROJECT: **3300 Panorama Dr**  
 DRILLING LOCATION: **See Figure 2, Site Plan**  
 DATE DRILLED: **January 28, 2022**  
 LOGGED BY: **D. Wordeman**

DRILL RIG: **CME 55**  
 HOLE DIAMETER: **8 Inches**  
 SAMPLING METHOD: **N/A**  
 APPROX. ELEVATION: **Not Recorded**

Depth of Groundwater: **Not Encountered** Boring Terminated At: **8 Feet**

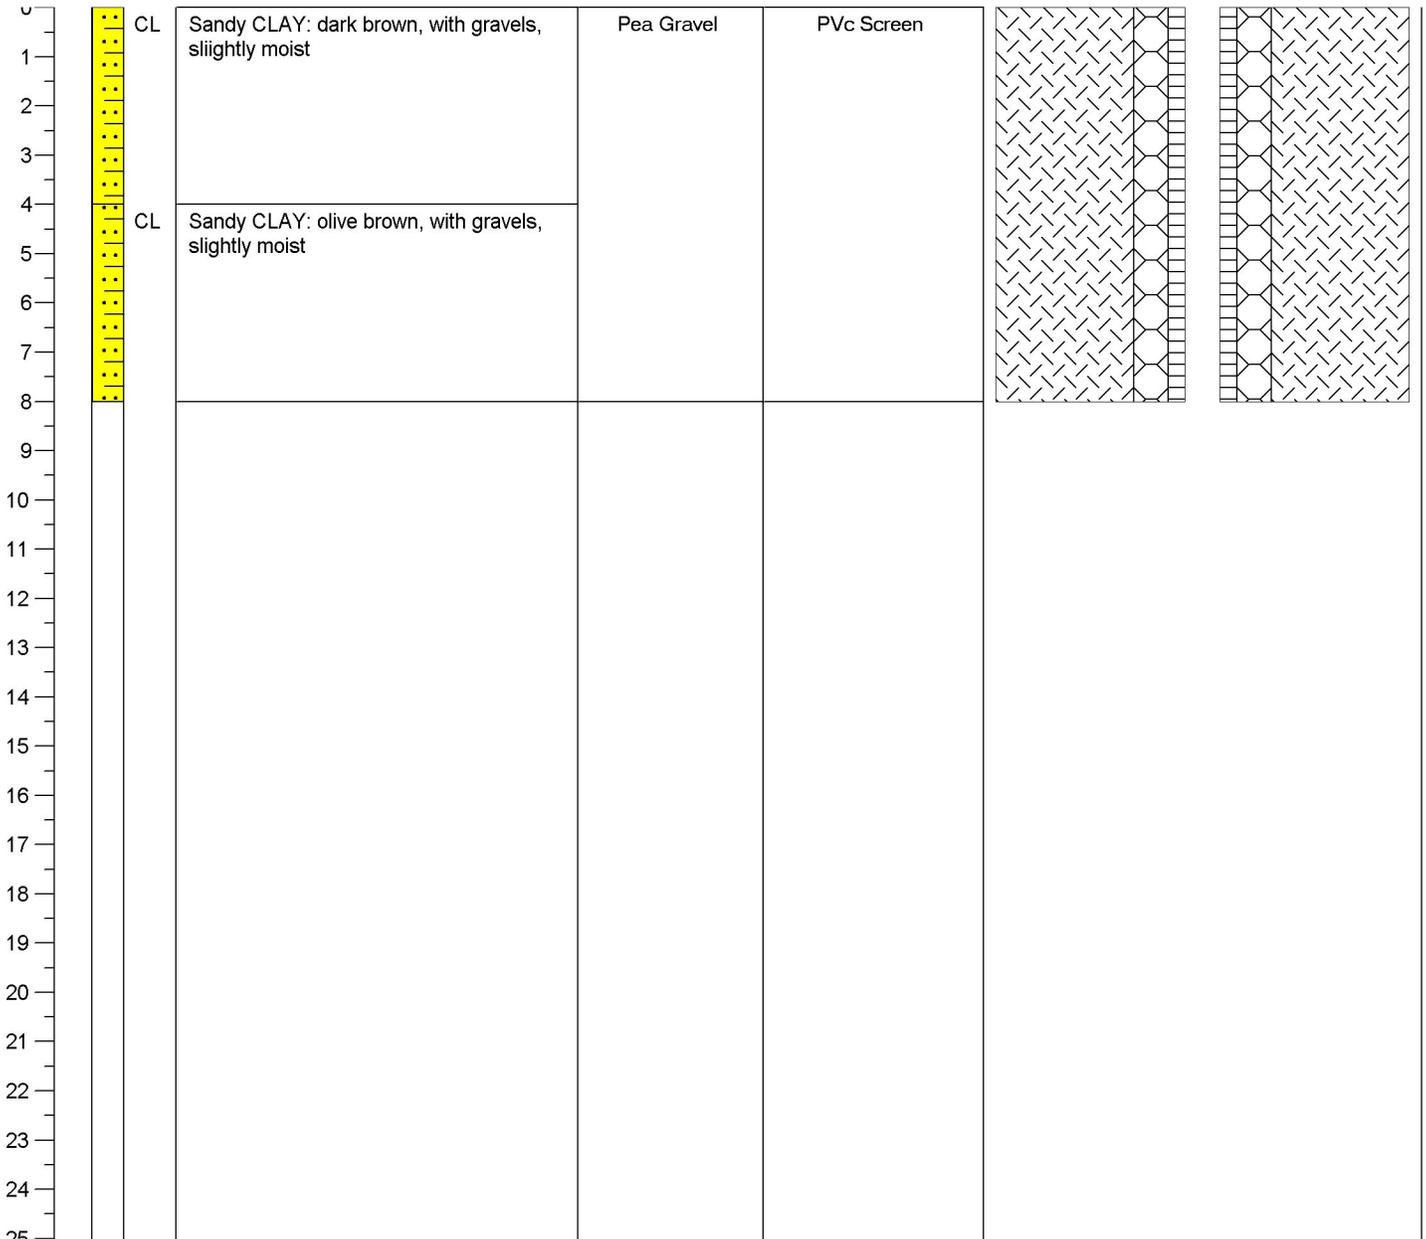
# INFILTRATION LOG

PROJECT: **3300 Panorama Dr**  
 DRILLING LOCATION: **See Figure 2, Site Plan**  
 DATE DRILLED: **January 28, 2022**  
 LOGGED BY: **D. Wordeman**

Depth of Groundwater: **Not Encountered** Boring Terminated At: **8 Feet**

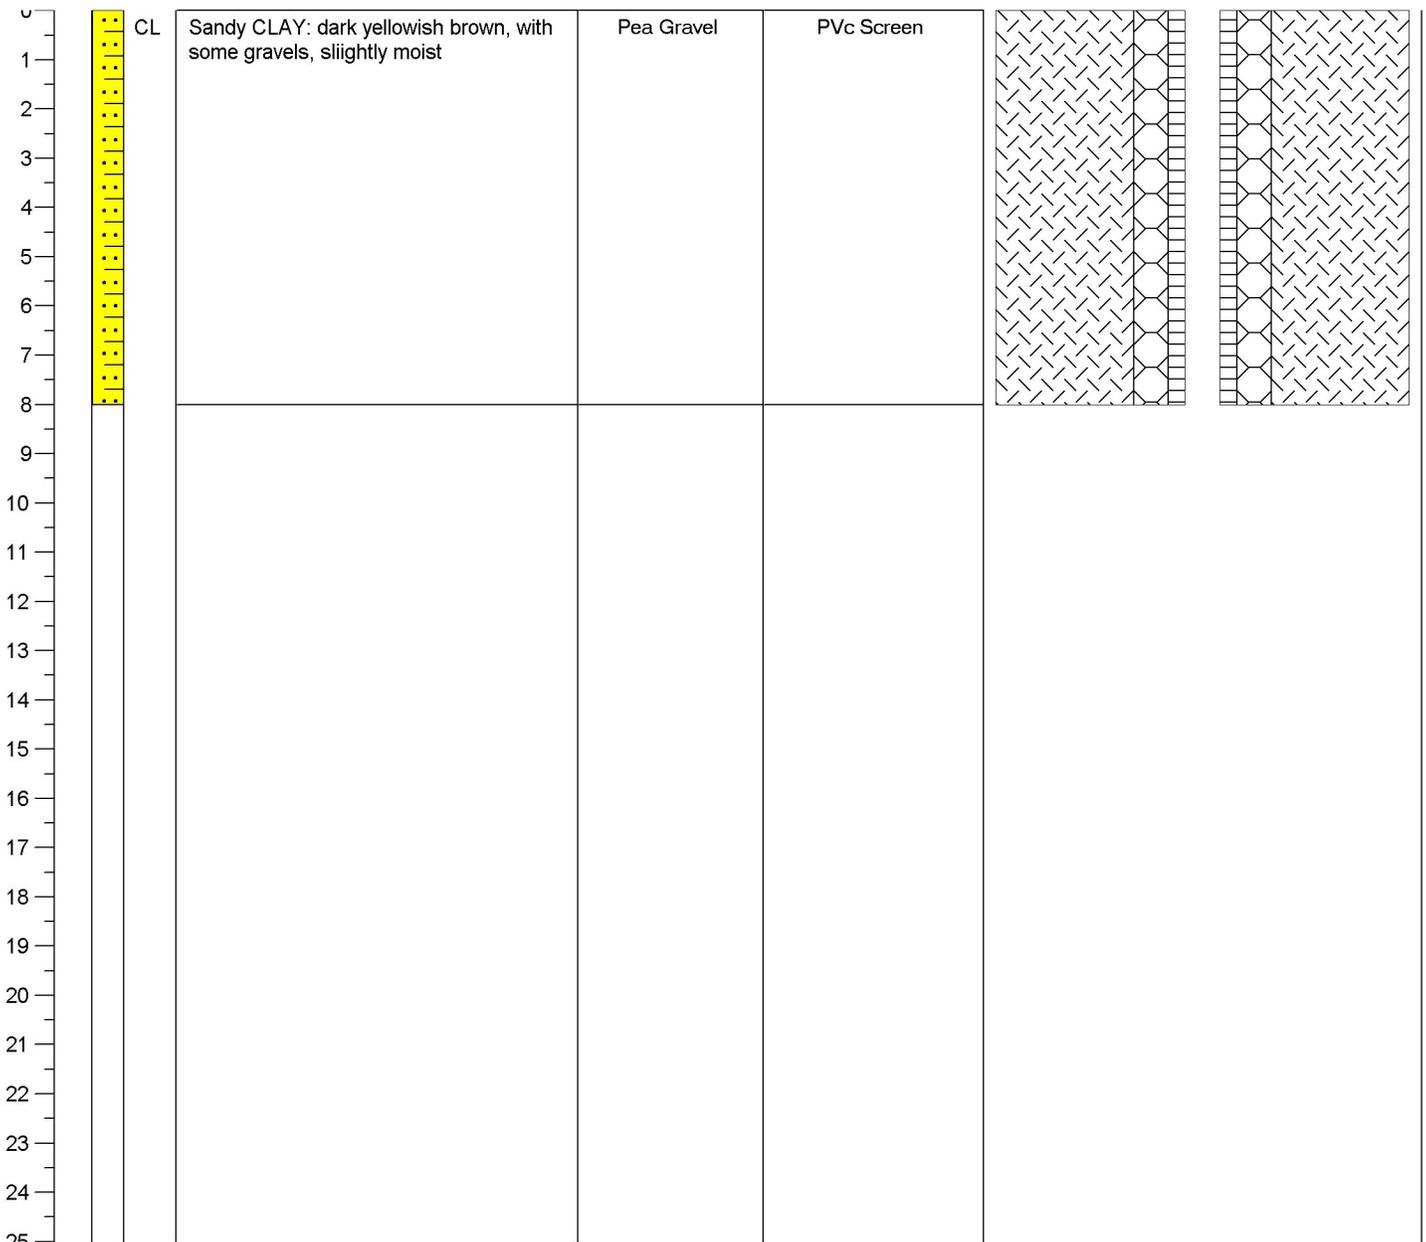
# INFILTRATION LOG

PROJECT: **3300 Panorama Dr**  
 DRILLING LOCATION: **See Figure 2, Site Plan**  
 DATE DRILLED: **January 28, 2022**  
 LOGGED BY: **D. Wordeman**
