3300 Panorama Drive
APN: 065-038-001
Morro Bay, California

1.0 INTRODUCTION

This report presents the results of the geologic investigation for the proposed residential development to be located at 3300 Panorama Drive, APN: 065-038-001, Morro Bay, California. See Figure 1: Area Location Map for the general location of the project area, (USGS, 2021). The purpose of this update is to include revisions of the proposed project size and scope.

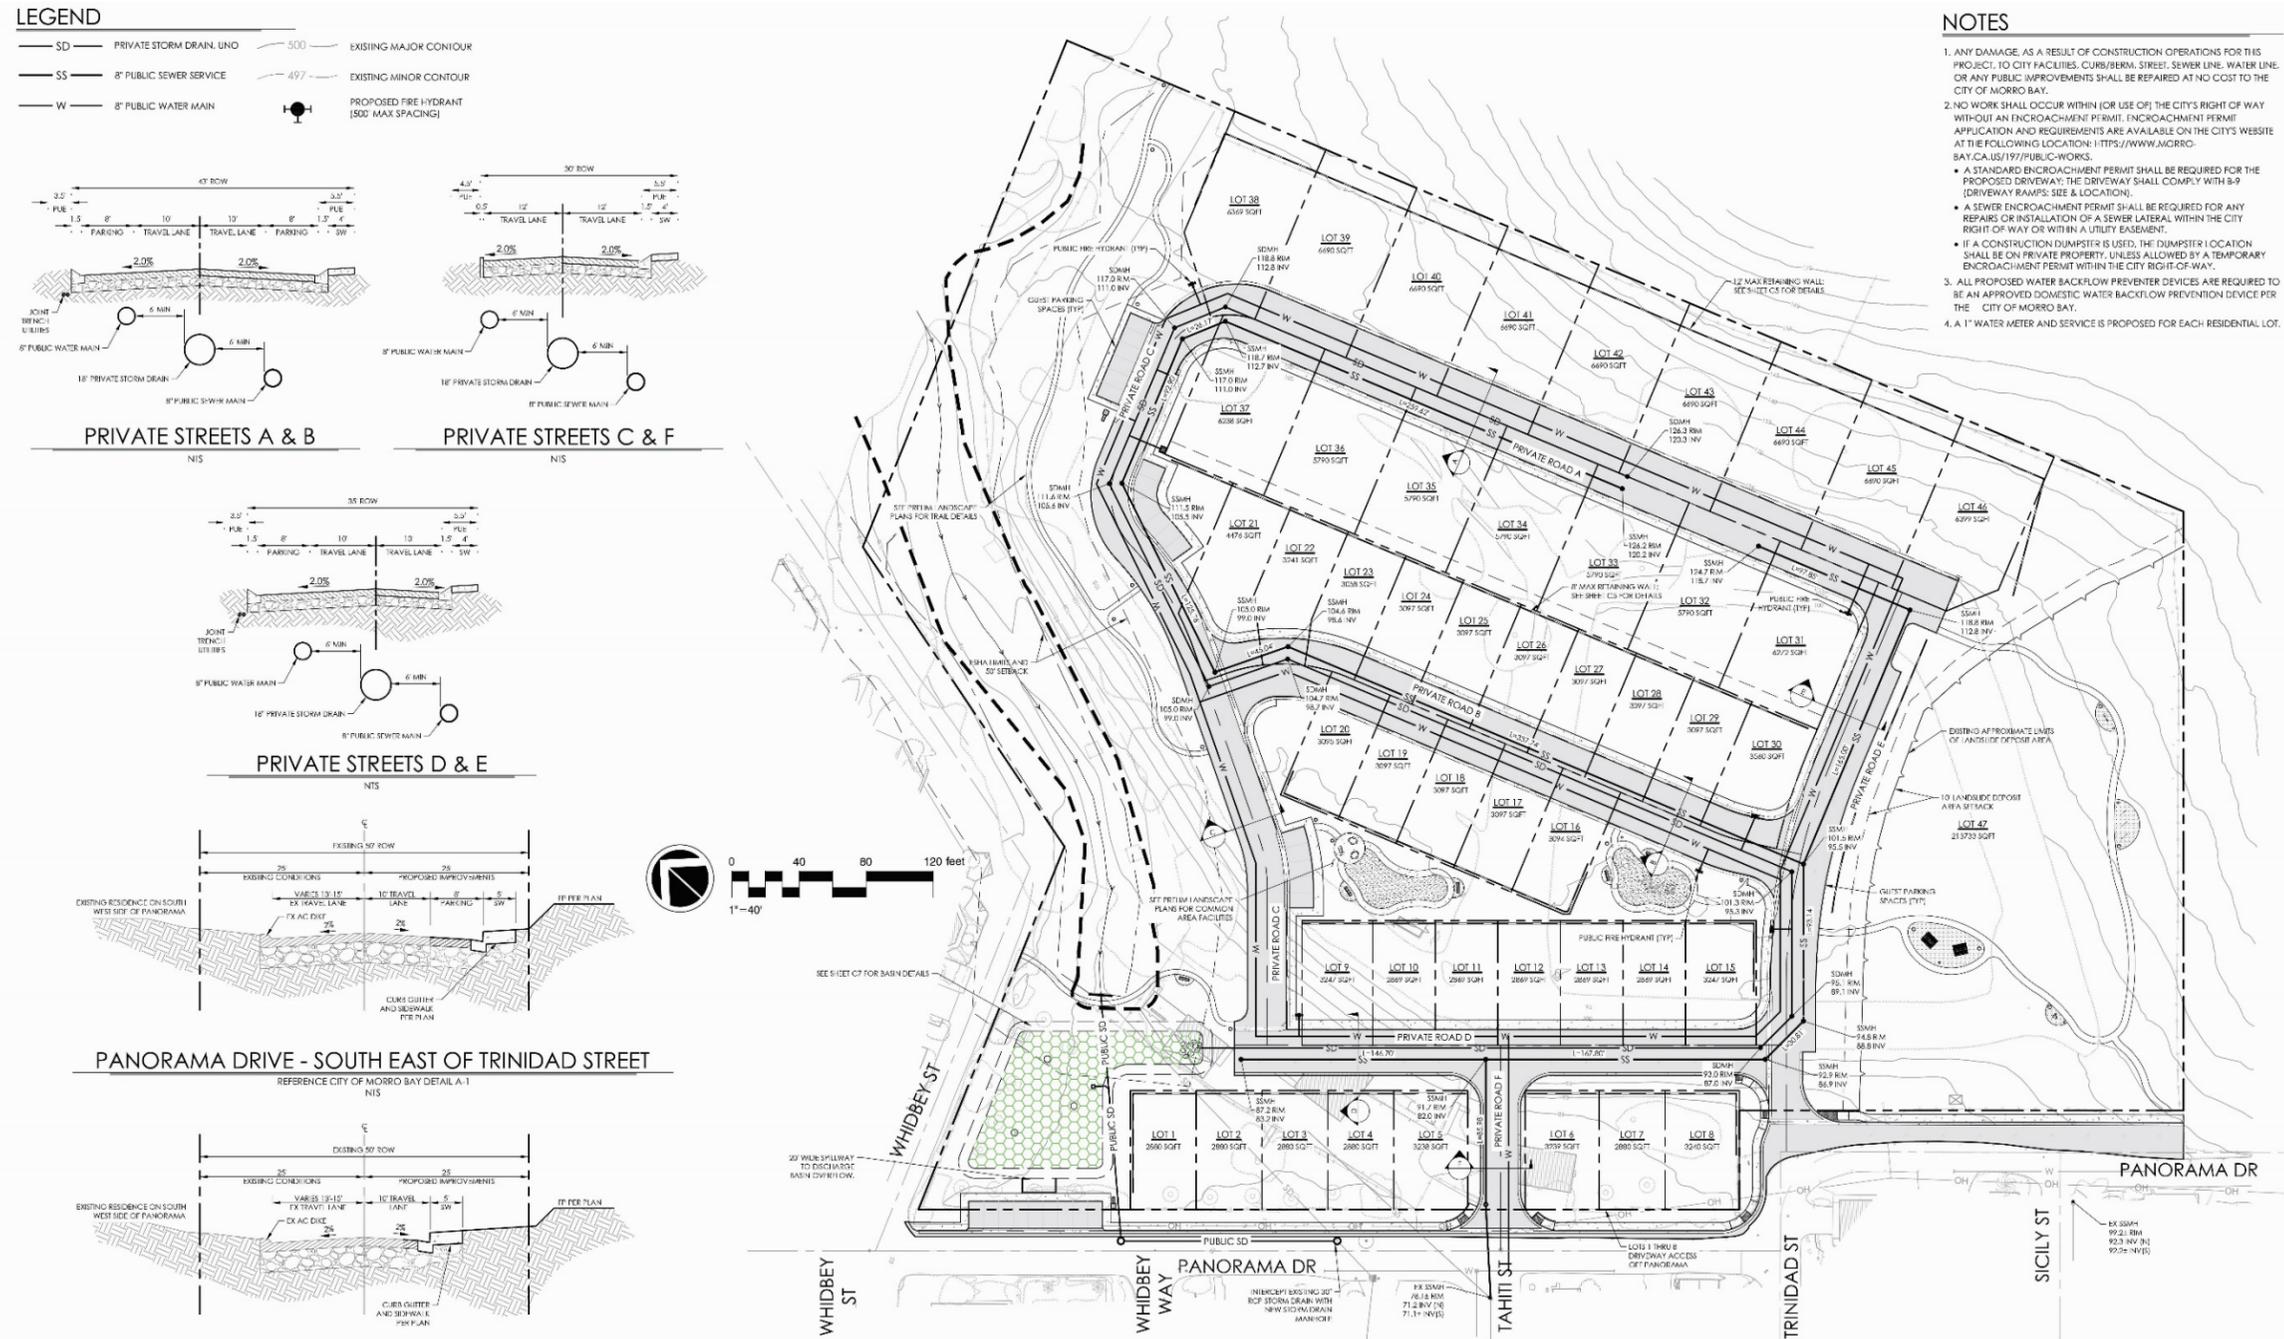
Figure 2: Preliminary Site Plan (RRM Design Group, 2024)

PRELIMINARY CIVIL SITE PLAN
3300 PANORAMA DRIVE

The Site is covered with seasonal grasses and assorted pine trees. Site drainage follows the topography to the west toward an existing drainage gully and south towards Panorama Drive. See Figure 2: Site Plan, provided by RRM Design Group, for the proposed development limits.

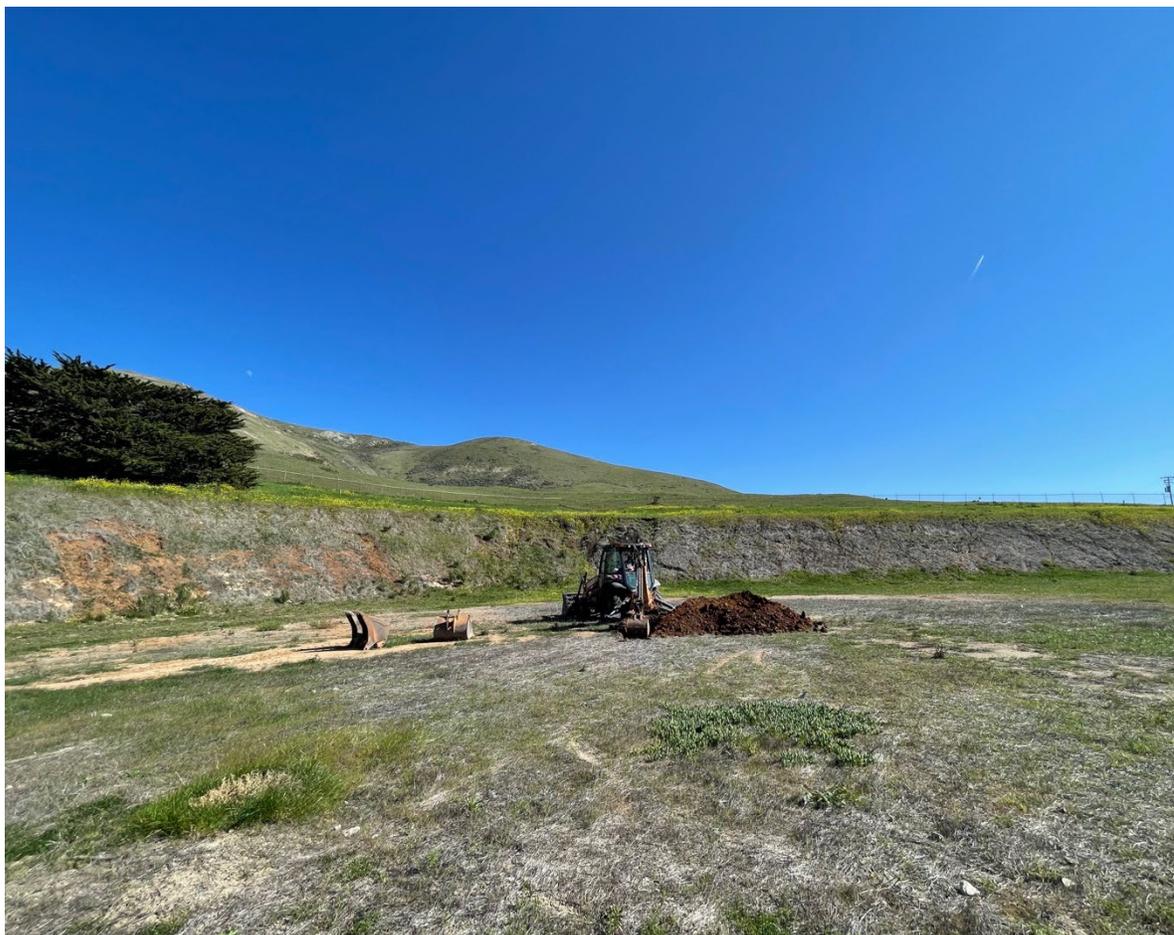
Figure 6: Photograph of the Site with the head scarp on the hills in the background (looking east)

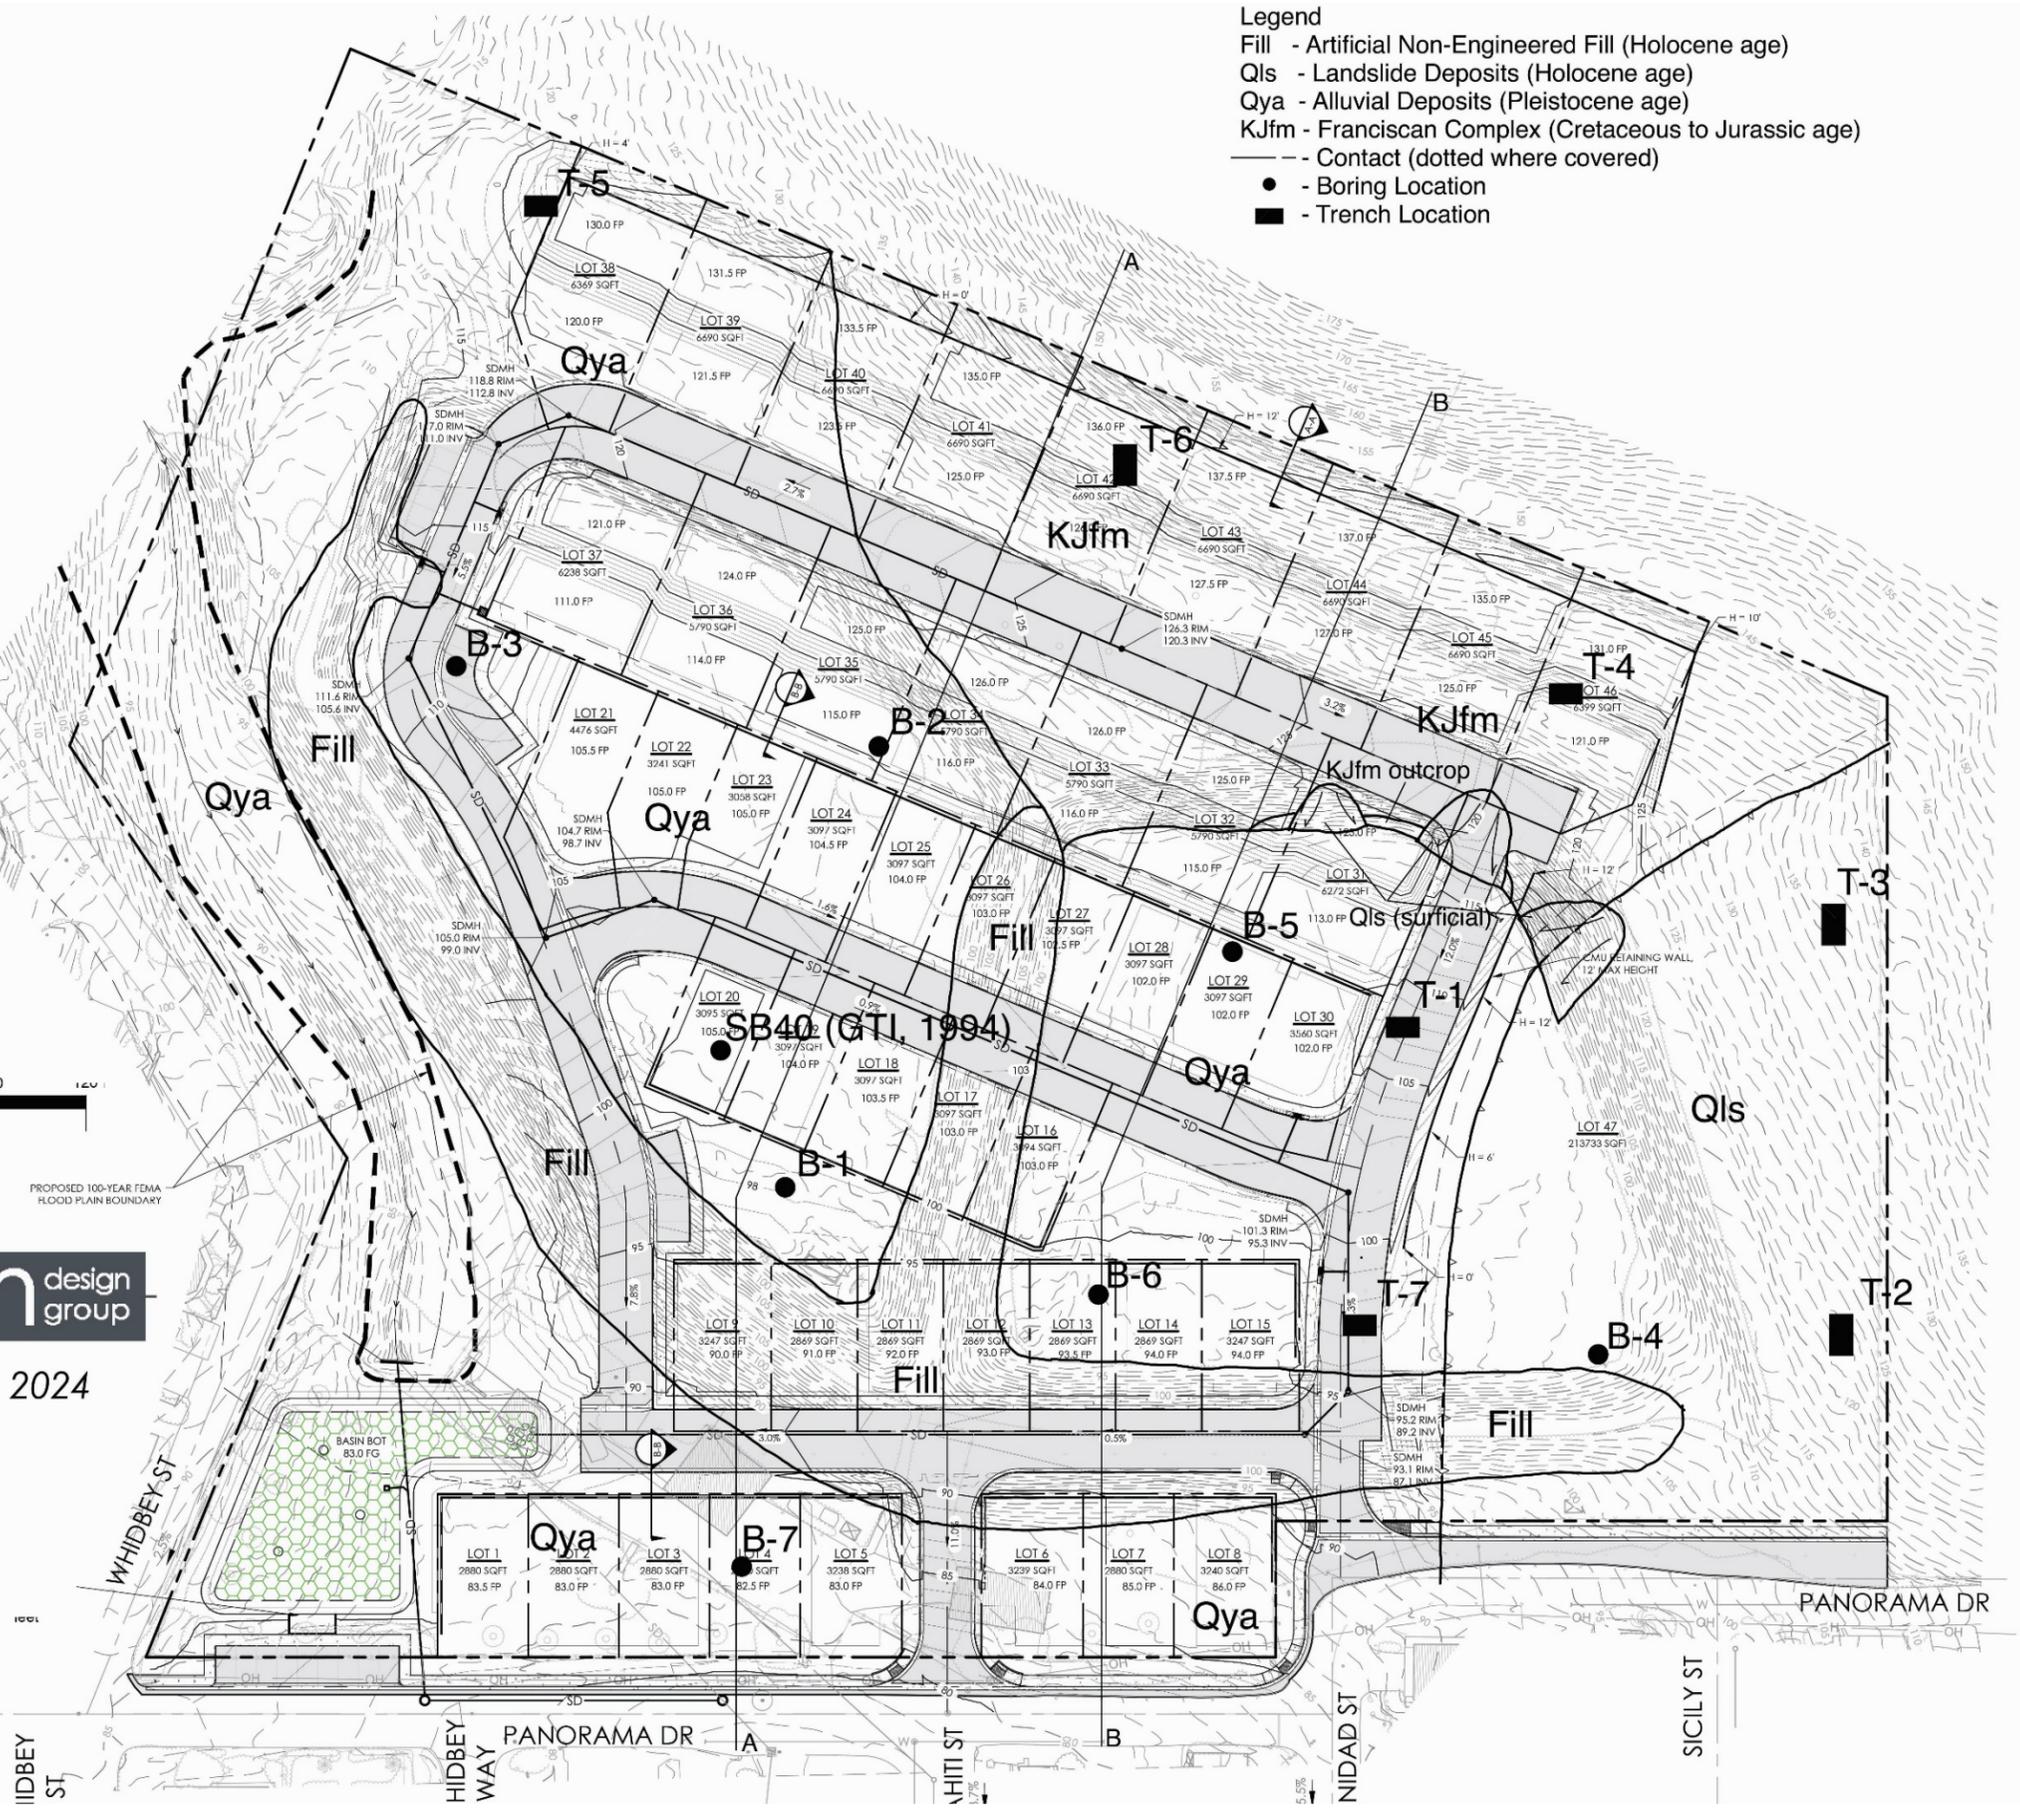
PLATE
1A
PROJECT
SL09618-6

SITE ENGINEERING GEOLOGY MAP
3300 PANORAMA DRIVE, APN:065-038-001
MORRO BAY, CALIFORNIA

Locally, the site is located within landslide deposits, alluvium or colluvium overlying Franciscan Complex units as depicted on Plate 1A, Site Engineering Geology Map. Hall and Prior, 1975, Dibblee, 2006 and Wieggers, 2016 mapped the Site as underlain by Holocene age Landslide Deposits (Qls), Holocene age Alluvial Deposits (Qal, Qa, Qya), and Cretaceous to Jurassic age Franciscan Complex (KJfme, Sp, Kfm) units. Information derived from subsurface exploration was used to classify subsurface soil and formational units and to supplement geologic mapping.

Alluvial Deposits were encountered throughout the majority of the western and southern portion of the Site. The Alluvial Deposits at the site consists of grayish brown clayey sand to dark yellowish brown to dark brown sandy clay with gravel observed in a slightly moist to moist and stiff to very stiff condition. Alluvial Deposits were observed within borings B-1 through B-3 and B-5 through B-7 to various depths of 24 feet in boring B-2 to 57 feet in boring B-6. Previous boring SB40 encountered alluvial deposits to a maximum depth of 60 feet bgs. Alluvial deposits were also encountered within trench T-5 to the termination depth of 10 feet bgs. Plate 1A depicts the extents of the Alluvial Deposits at the Site.

Landslide Deposits are mapped through the upper portion of the site. Hall and Prior, 1975, Dibblee, 2006 and Wieggers, 2016 map the site was underlain by a large landslide complex. Landslide Deposits were observed within trenches T-4 through T-6 to a depth of 6 feet below ground surface. The Landslide Deposits at the site consists of light brown to very dark grayish brown sandy clay with gravel and cobbles of Franciscan Complex observed in a dry to slightly moist and loose condition. Caliche was observed throughout. Plate 1A depicts the extents of the Landslide Deposits at the Site. An additional discussion of the landslide potential is presented in Section 4.5.

The Franciscan Complex mélangé (KJfm) is mapped on the rock ridge along the northern property boundary. Wieggers, 2016 describes the Franciscan Complex as “Chaotic mixture of fragmented, fault-bounded, metamorphosed rock masses embedded in a penetratively sheared matrix of argillite and crushed metasandstone. Penetrative deformation of the matrix postdates metamorphism of enclosed rock masses. Individual rock masses range from less than a meter to kilometers in scale and include altered mafic volcanic rocks (greenstone), chert, serpentinite, high-grade blueschist, graywacke, and conglomerate.” The Franciscan Complex was observed within trenches T-4 and T-6 underlying the colluvium. The Franciscan Complex at the site consists of metavolcanic rock, graywacke sandstone and serpentinite observed to be massive, highly fractured, moderately to severely weathered and moderately hard. Plate 1A depicts the extents of the Franciscan Complex (KJfm) at the Site.

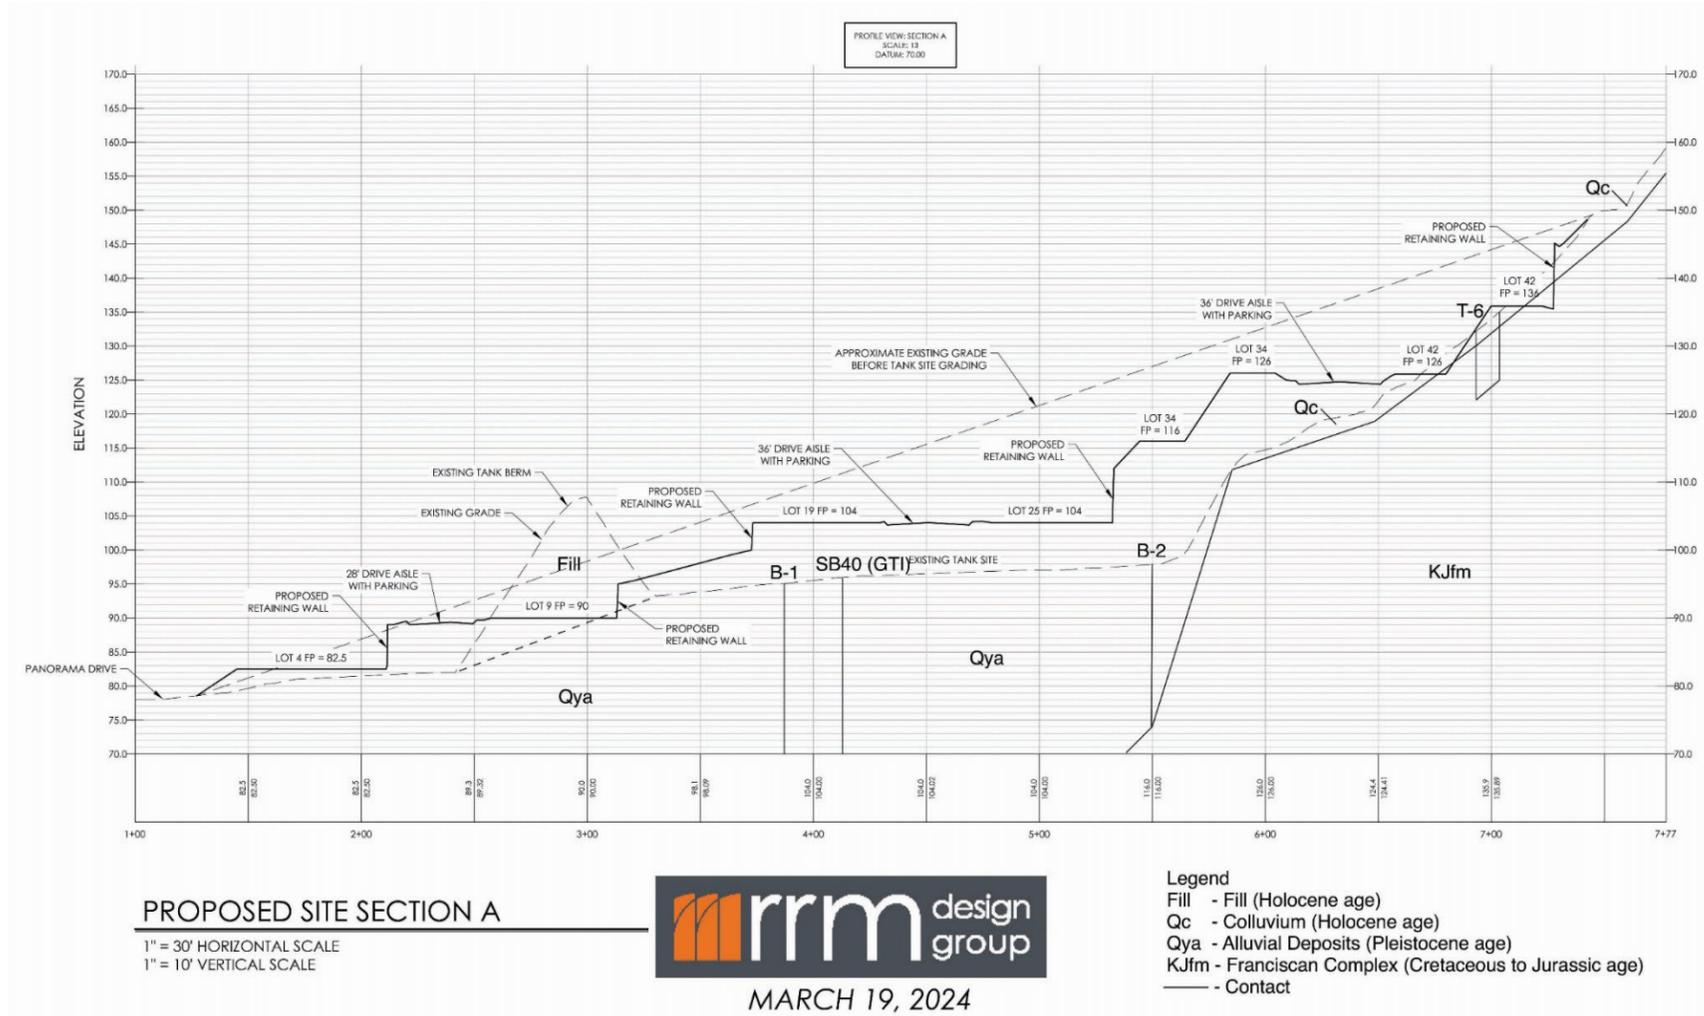
SITE CROSS SECTION A-A'
3300 PANORAMA DRIVE, APN:065-038-001
MORRO BAY, CALIFORNIA

SITE CROSS SECTION B-B'
3300 PANORAMA DRIVE, APN:065-038-001
MORRO BAY, CALIFORNIA

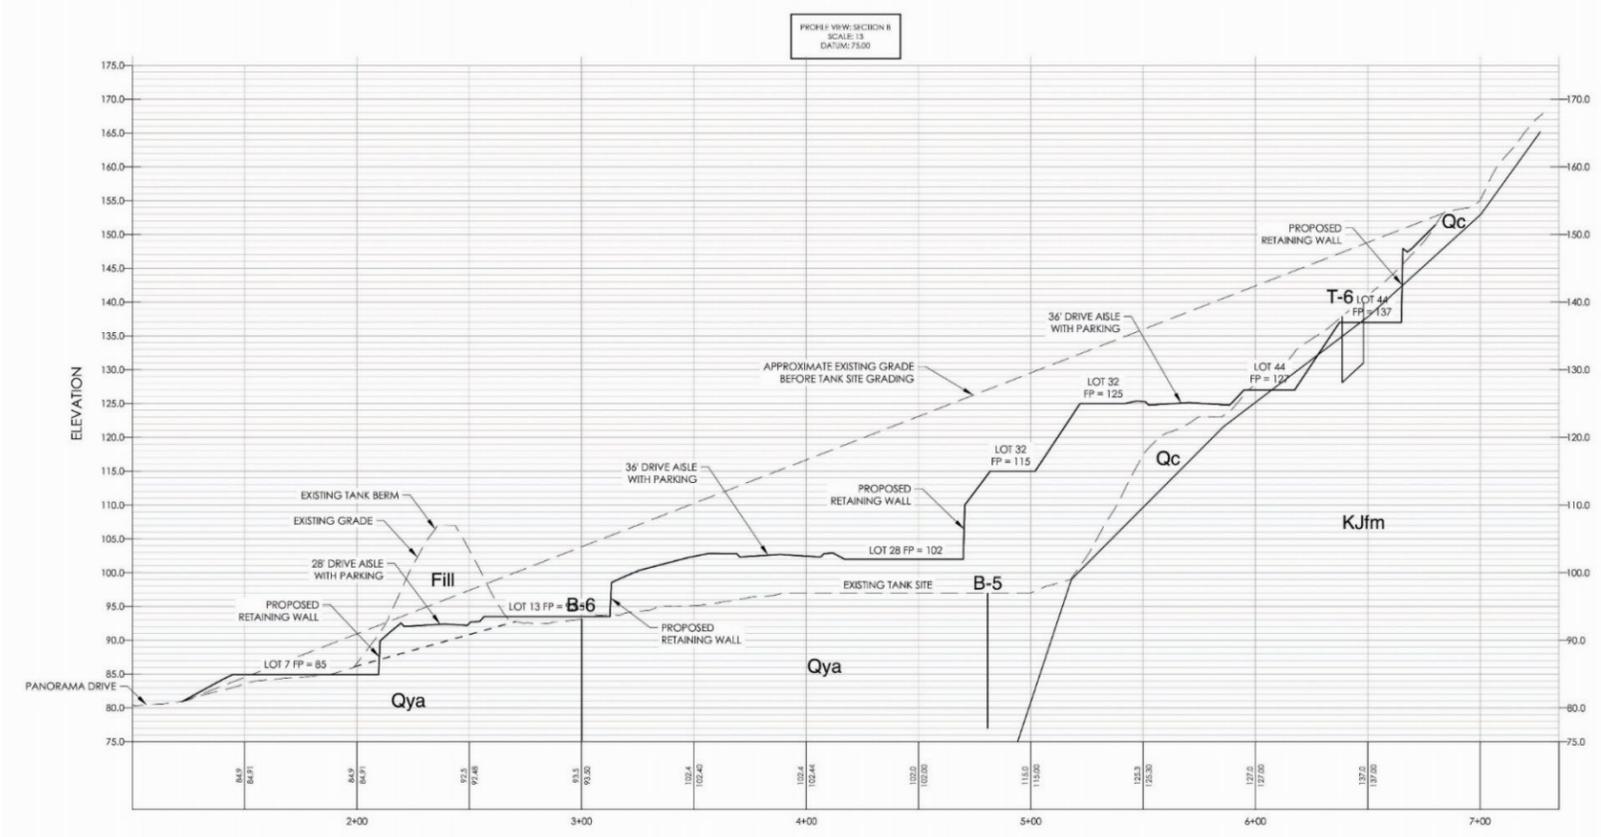
PROPOSED SITE SECTION B
1" = 30' HORIZONTAL SCALE
1" = 10' VERTICAL SCALE

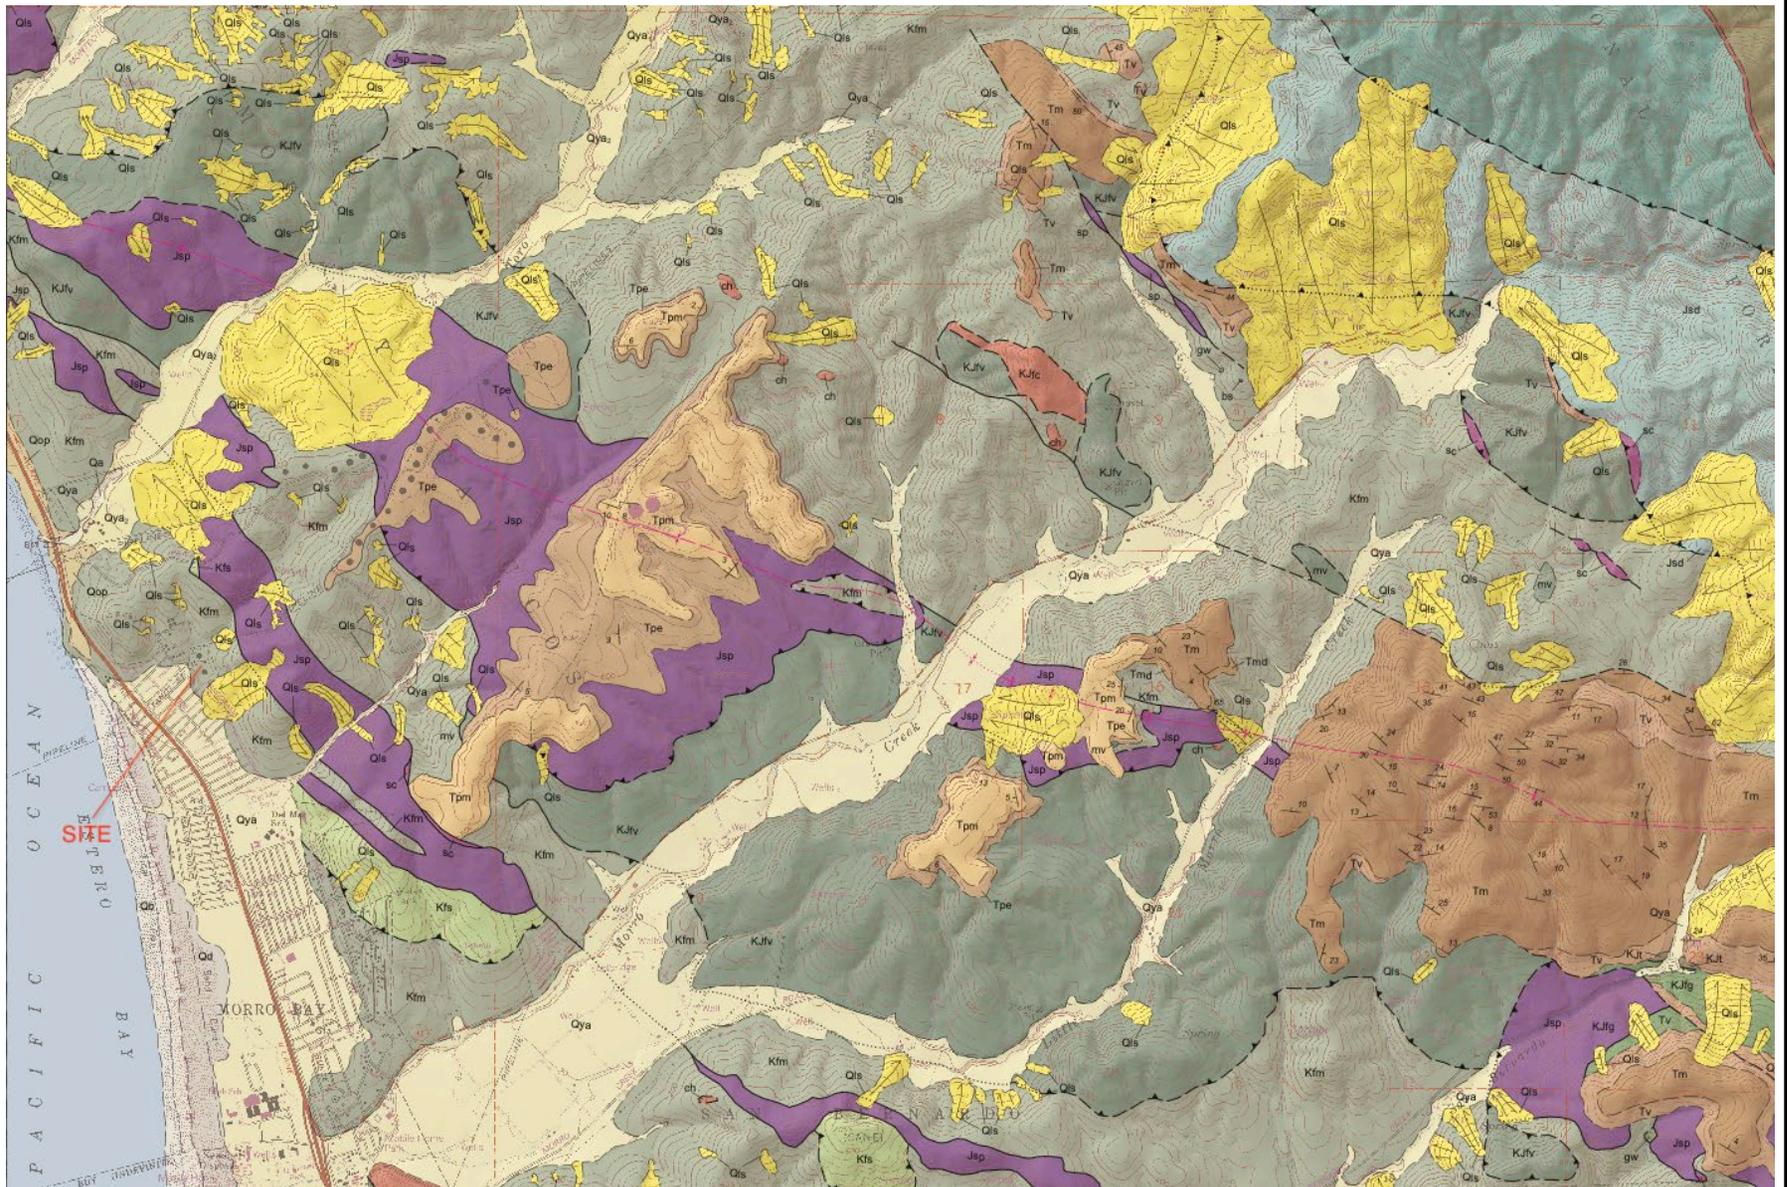
PLATE
2A
PROJECT NO.:
SL09618-5

REGIONAL GEOLOGY MAP (Wiegiers, 2016)
3300 PANORAMA DRIVE, APN: 065-038-001
MORRO BAY, CALIFORNIA

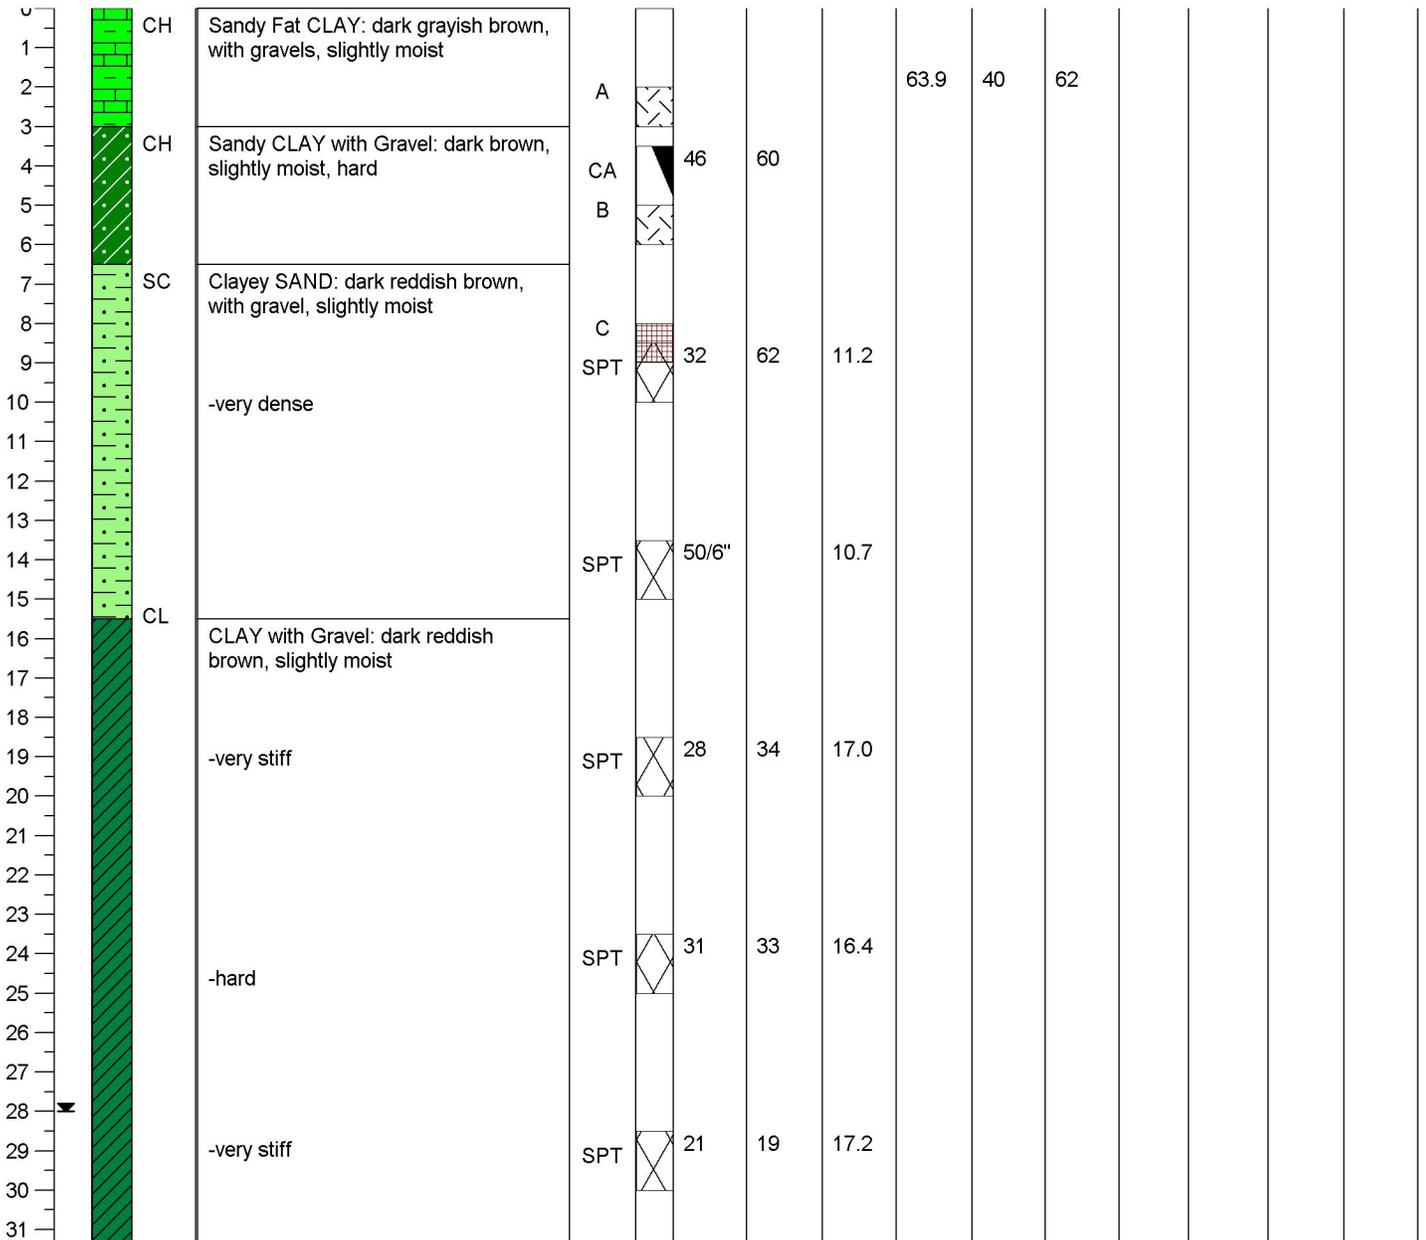
BORING NO. B-1
JOB NO. SL09618-4

PROJECT INFORMATION				DRILLING INFORMATION											
PROJECT:	3300 Panorama Dr			DRILL RIG:	CME 55										
DRILLING LOCATION:	See Figure 3: Field Investigation			HOLE DIAMETER:	8 Inches										
DATE DRILLED:	January 24, 2022			SAMPLING METHOD:	SPT and CA										
LOGGED BY:	D. Wordeman			APPROX. ELEVATION:	Not Recorded										
Depth of Groundwater:		28 Feet		Boring Terminated:		50 Feet									
						Page 2 of 2									
DEPTH	LITHOLOGY	USCS	SOIL DESCRIPTION	SAMPLE ID	SAMPLERS TYPE	N (BLOWS / FT)	(N1) 60	MOISTURE CONTENT (%)	FINES CONTENT (%)	PLASTICITY INDEX (PI)	EXPANSION INDEX (EI)	OPTIMUM WATER CONTENT (%)	MAXIMUM DRY DENSITY (pcf)	COHESION, C (psf)	FRICION ANGLE, (degrees)

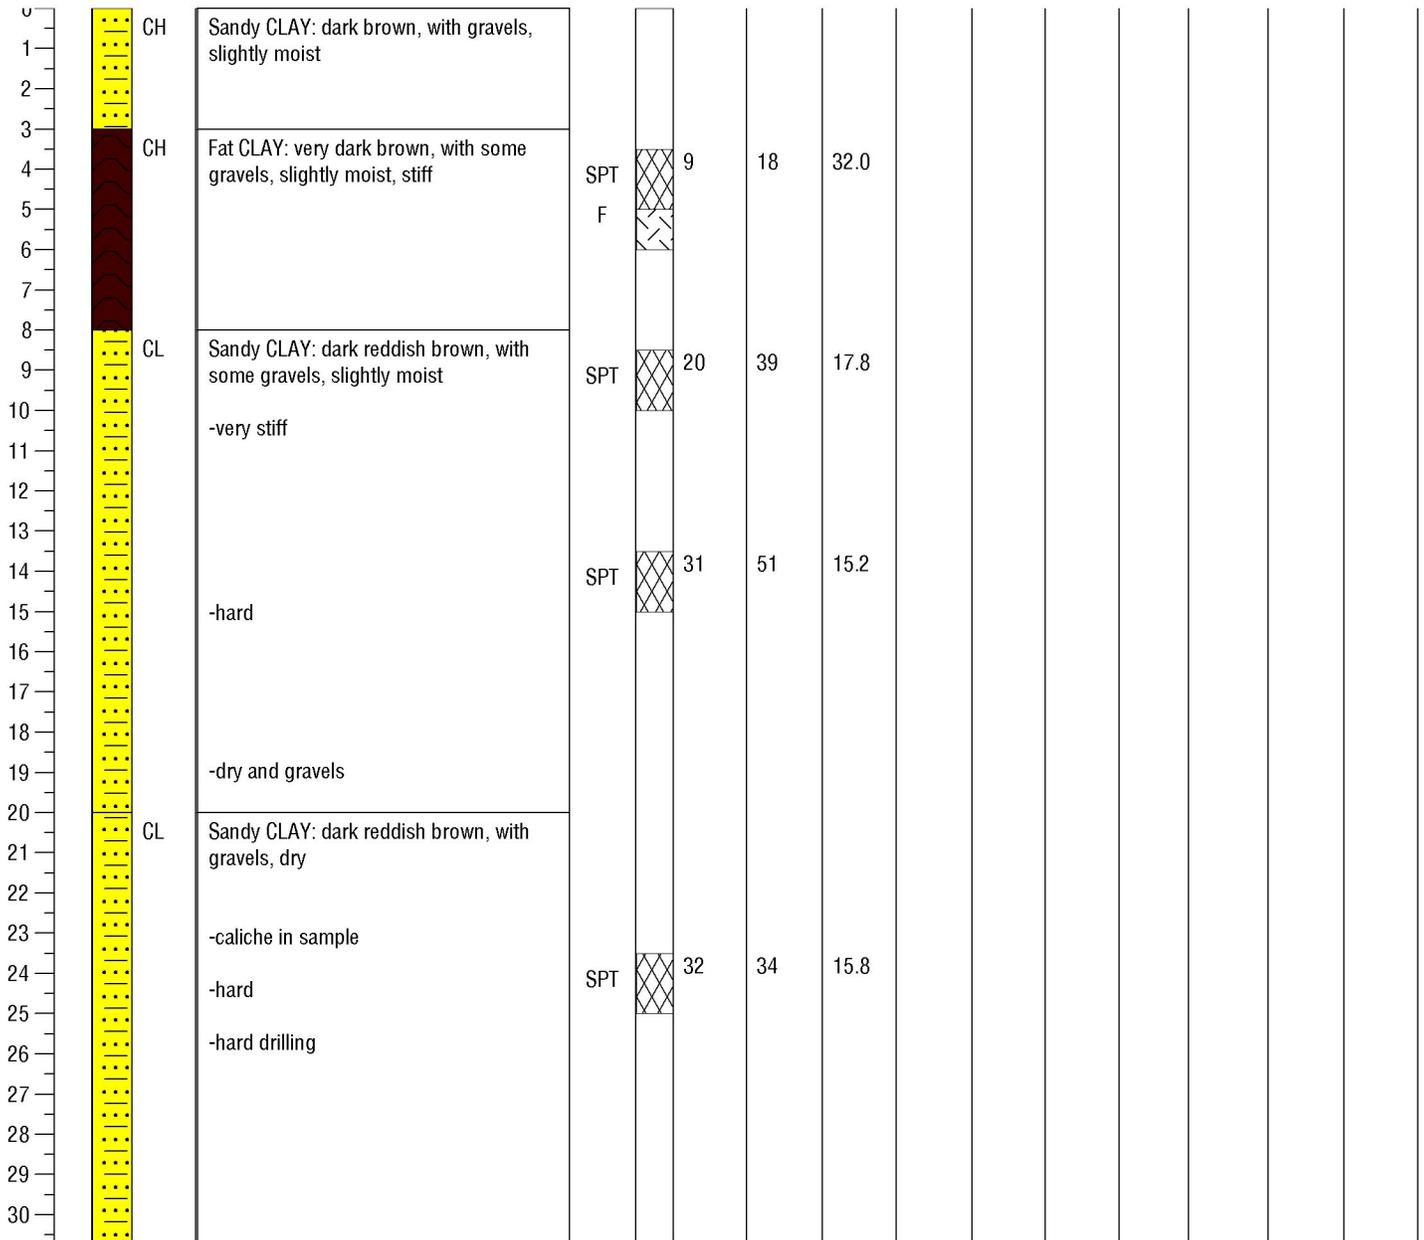
BORING NO. B-6
JOB NO. SL09618-4

PROJECT INFORMATION						DRILLING INFORMATION									
PROJECT:	3300 Panorama Dr					DRILL RIG:	CME 55								
DRILLING LOCATION:	See Figure 3: Field Investigation					HOLE DIAMETER:	8 Inches								
DATE DRILLED:	January 28, 2022					SAMPLING METHOD:	SPT								
LOGGED BY:	D. Wordeman					APPROX. ELEVATION:	Not Recorded								
Depth of Groundwater:			Not Encountered			Boring Terminated:			60 Feet			Page 1 of 2			
DEPTH	LITHOLOGY	USCS	SOIL DESCRIPTION	SAMPLE ID	SAMPLERS TYPE	N (B.LOWS / FT)	(N1) 60	MOISTURE CONTENT (%)	FINES CONTENT (%)	PLASTICITY INDEX (PI)	EXPANSION INDEX (EI)	OPTIMUM WATER CONTENT (%)	MAXIMUM DRY DENSITY (pcf)	COHESION, C (psf)	FRICION ANGLE, (degrees)

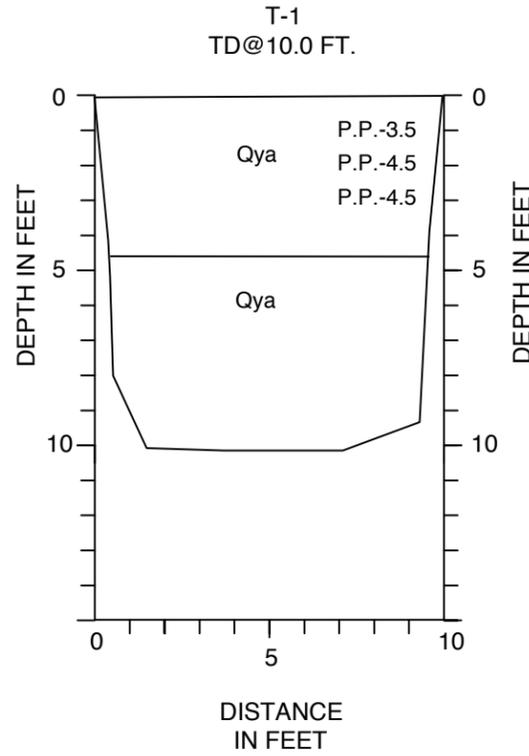
ALLUVIAL DEPOSITS (Qya)
Light brown CLAY, highly sheared,
caliche, moist

ALLUVIAL DEPOSITS (Qya)
Reddish brown sandy CLAYEY,
slightly moist

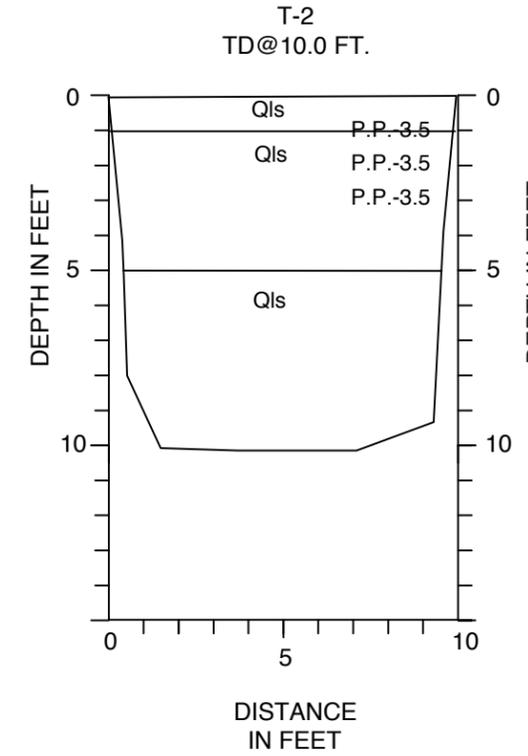
LANDSLIDE DEPOSITS (Qls)
Light brown sandy CLAY, loose, dry

LANDSLIDE DEPOSITS (Qls)
Very dark grayish brown sandy CLAY,
slightly moist, loose, cobbles at base

LANDSLIDE DEPOSITS (Qls)
Light brown sandy CLAY with gravels,
dry to slightly moist, caliche,
moderately sheared

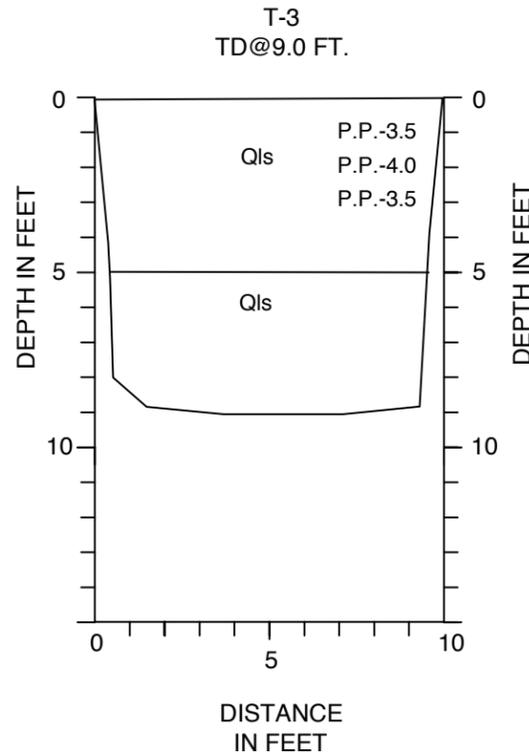
LANDSLIDE DEPOSITS (Qls)
Very dark grayish brown sandy CLAY,
slightly moist, caliche from 3-5'

LANDSLIDE DEPOSITS (Qls)
Light brown sandy CLAY with gravel,
dry to slightly moist, caliche

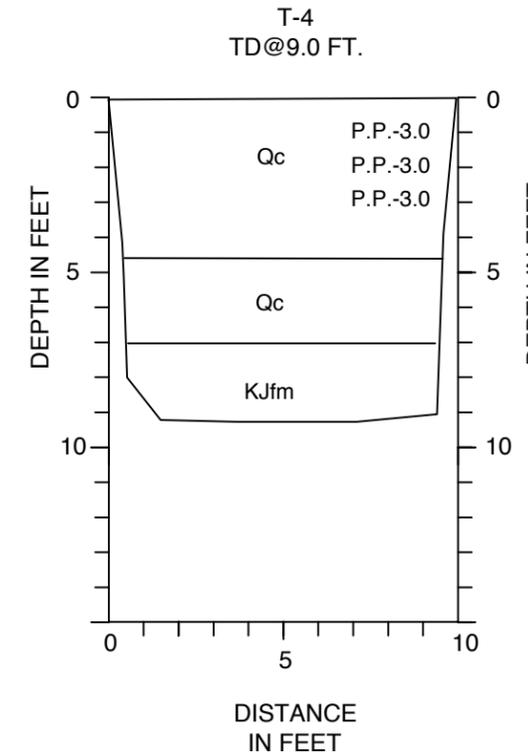
COLLUVIUM (Qc)
Dark reddish brown CLAY, slightly
moist

COLLUVIUM (Qc)
Light yellowish brown fat CLAY,
slightly moist

FRANCISCAN COMPLEX (KJfm)
White to light grayish brown
metavolcanic, severely to moderately
weathered, dry, caliche, moderately
hard

Colluvial Deposits were observed overlying the Franciscan Complex upslope of the tank pads in the northern portion of the site (in the area mapped as KJfm on Plate 1A although the colluvium is not depicted on the map). Colluvial Deposits were observed within trench T-4 and T-6 to a depth of 3 to 5 feet below ground surface. The Colluvial Deposits at the site consists of dark reddish brown sandy clay observed in a slightly moist condition.

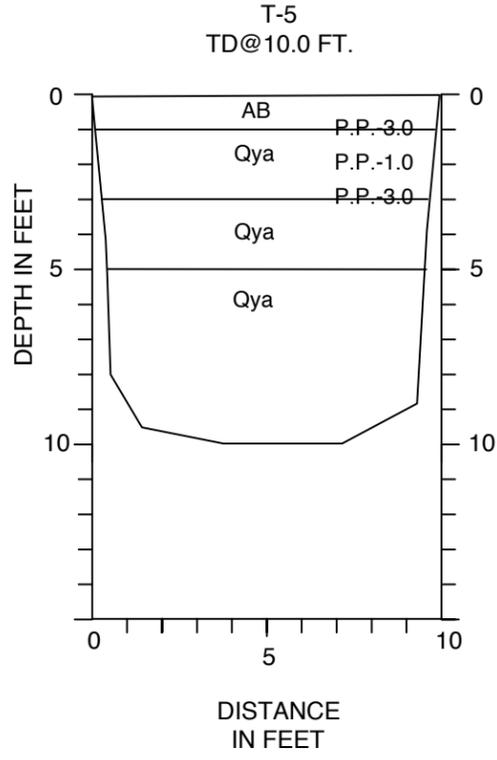
White aggregate base
 ALLUVIAL DEPOSITS (Qya)
 Reddish brown sandy CLAY, slightly moist
 ALLUVIAL DEPOSITS (Qya)
 Light brown fat CLAY, slightly moist
 ALLUVIAL DEPOSITS (Qya)
 Light olive brown to dark brown sandy CLAY, dry to slightly moist, firm

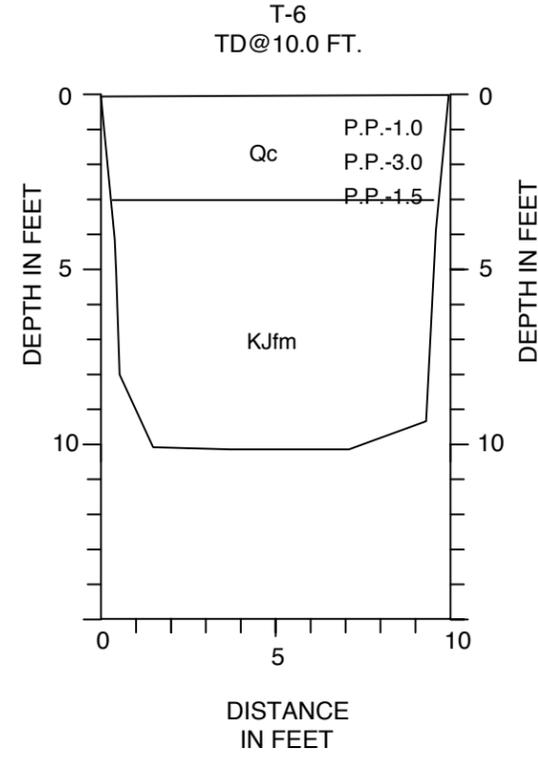
COLLUVIUM (Qc)
 Reddish brown sandy CLAY, slightly moist
 FRANCISCAN COMPLEX (KJfm)
 Light gray to light brown metavolcanic, severely weathered, moderately soft, slightly moist, dense at 8'

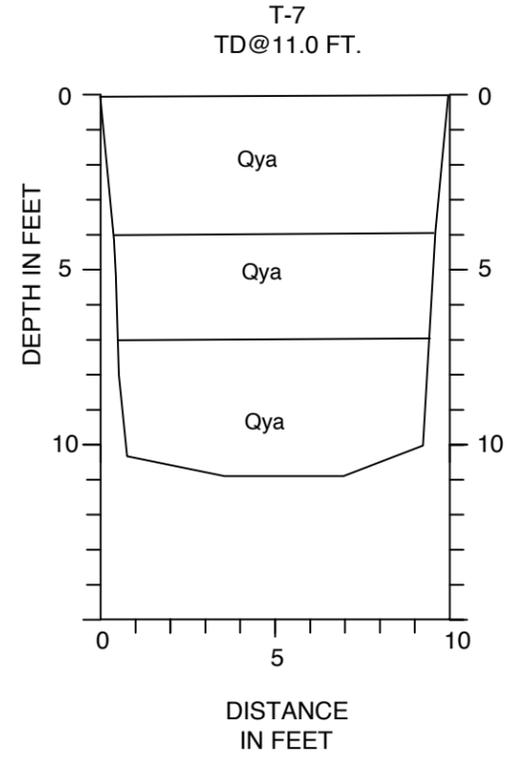
ALLUVIAL DEPOSITS (Qya)
 Dark brown sandy CLAY, slightly moist, caliche in upper 1'
 ALLUVIAL DEPOSITS (Qya)
 Light brown to olive brown sandy CLAY, slightly moist
 ALLUVIAL DEPOSITS (Qya)
 Light olive brown to dark brown sandy CLAY, dry to slightly moist, firm
